New Forest Wetland Restoration Projects:

Summary Information on Completed Projects

Compiled by the Forestry Commission
October 2014

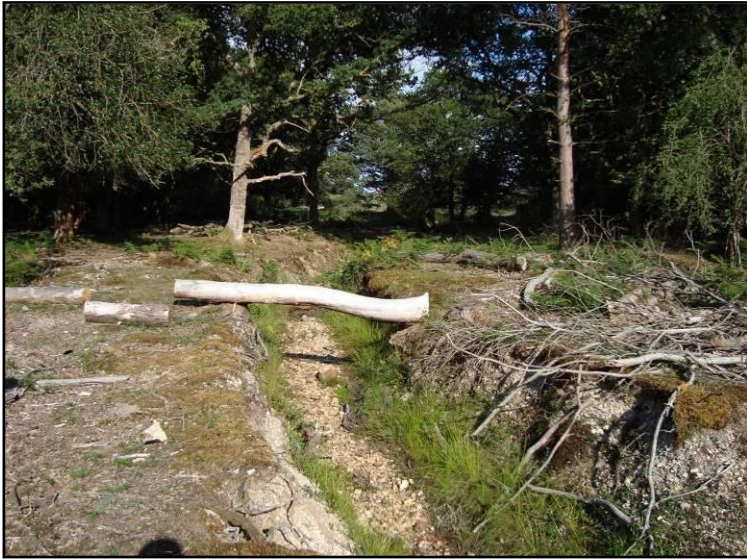
Photo 1 – Akercome Bottom, August 2010
Eroded artificial drain with limited seasonal inundation.

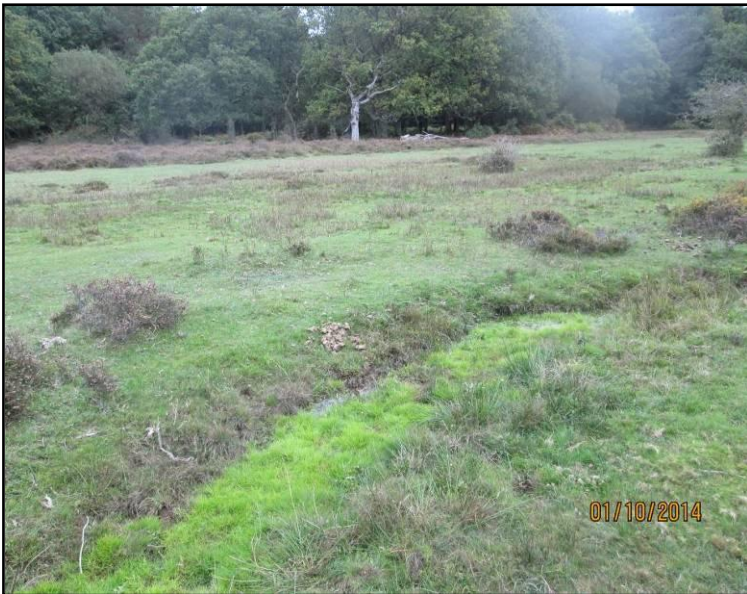
Photo 2 – Akercome Bottom, October 2014
Restored meander with in-channel vegetation, connectivity with floodplain habitats restored. No erosion or gravel deposition on the lawn.

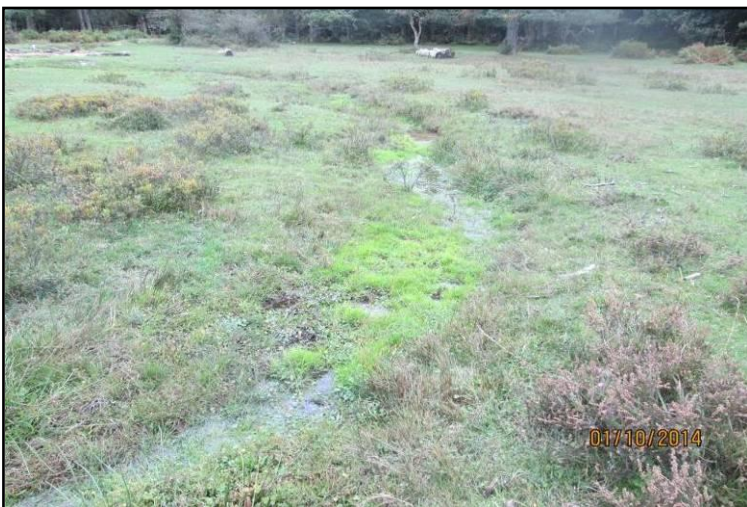
Photo 3 – Akercome Bottom, October 2014
Water still present in the system, following driest September on record.

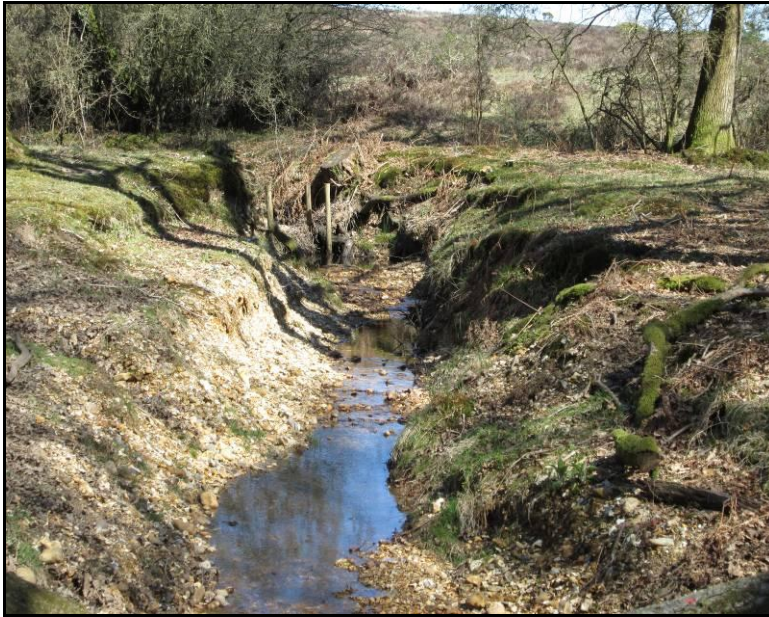
Photo 1 – Buckherd Bottom, March 2013
Eroded channel through pasture woodland, before restoration.

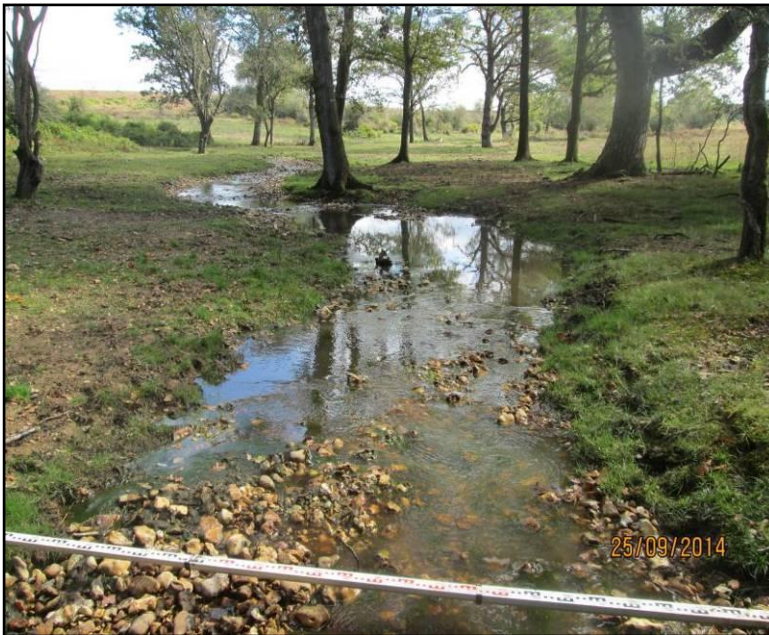
Photo 2 – Buckherd Bottom, September 2014.
Restored meander through pasture woodland, after restoration.

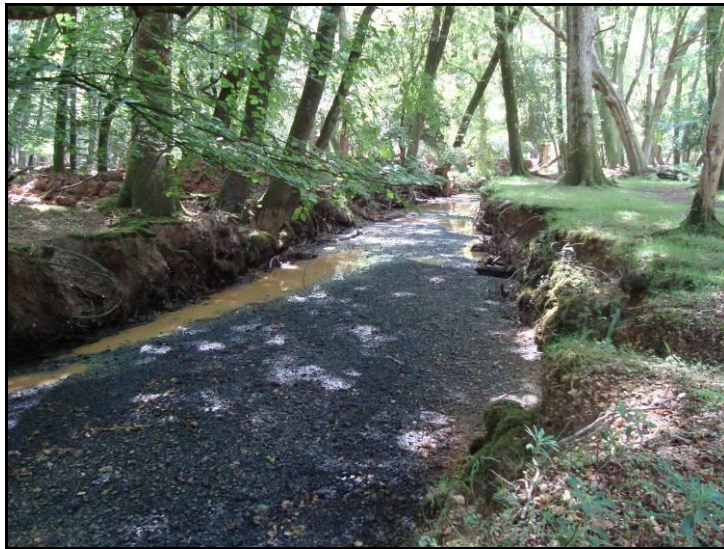
Photo 1 – Camel Green, July 2012
 Pre-restoration – the wide, straight artificial drain with little in-channel diversity.

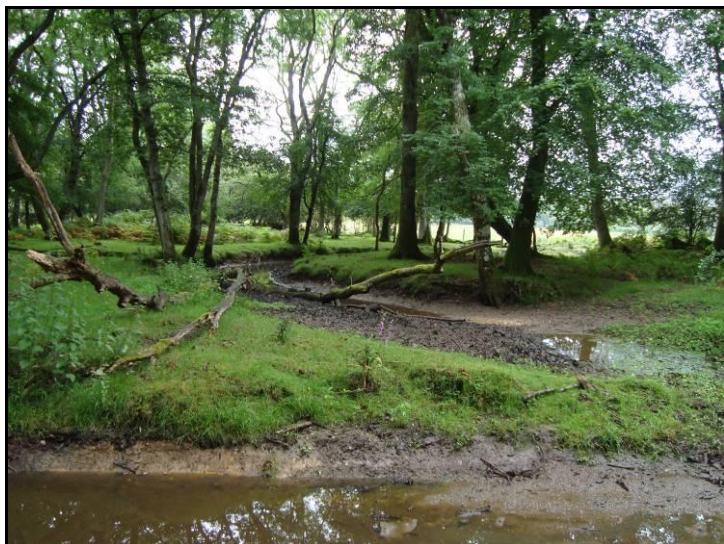
Photo 2 – Camel Green, July 2012
 Pre-restoration – the unrestored sinuous meander course (with much smaller dimensions) evident on the ground.

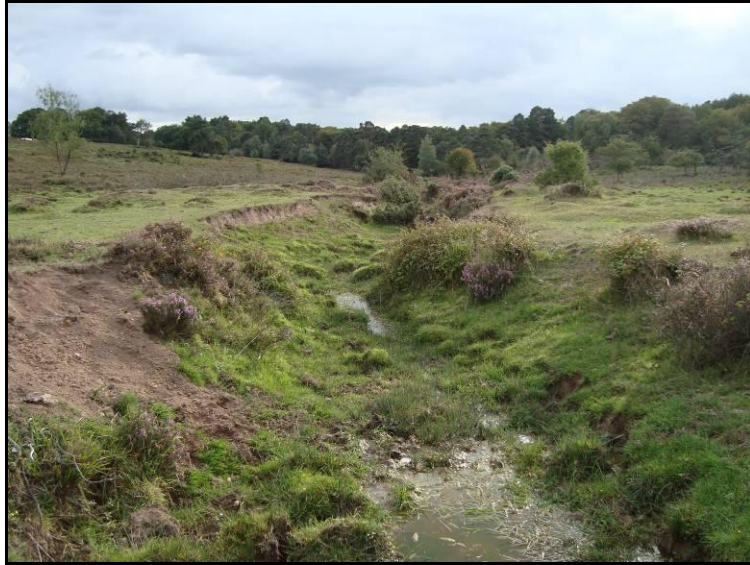
Photo 1- Claypits
Bottom, August
2010

Wide, eroded
channel through
heath and lawn
habitats, before
restoration.

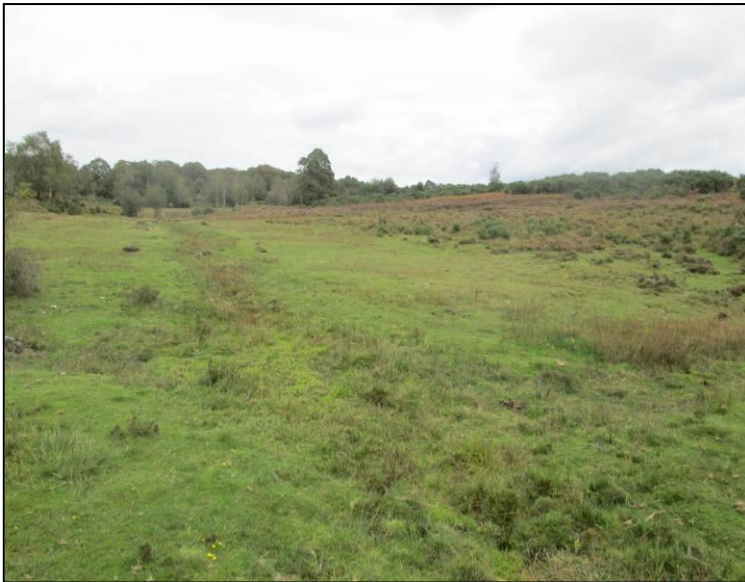
Photo 2 - Claypits
Bottom, October
2014

Restored shallow
channel through
heath and lawn
habitats.

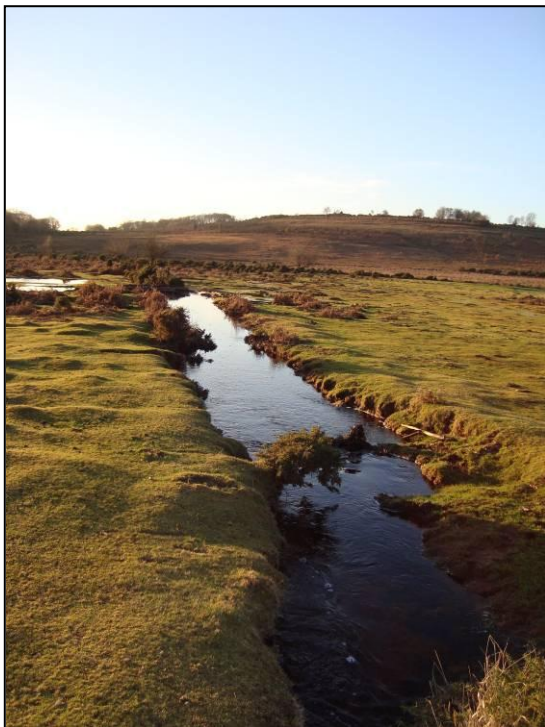
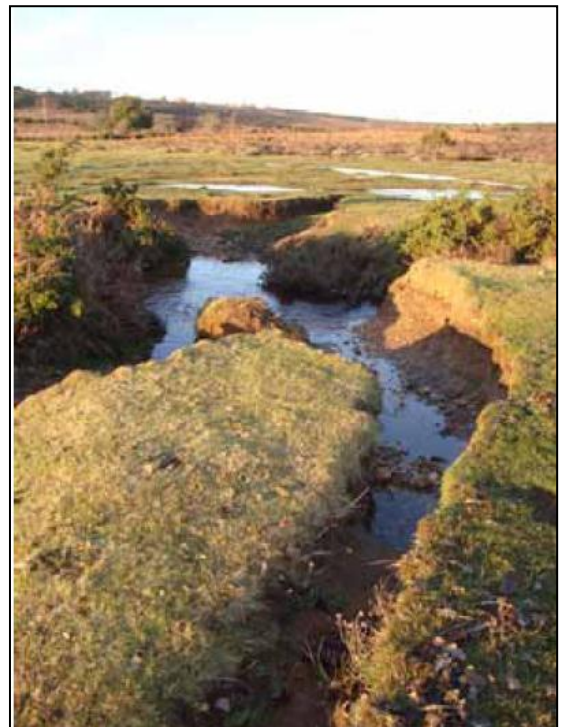
Photo 1 & 2 – Ditchend Bottom (Must Thorns tributary), January 2011
Prior to restoration there was limited seasonal inundation of the floodplain. The eroded Ditchend drain was over five feet deep and the Must Thorns drain was up to three feet deep in places.

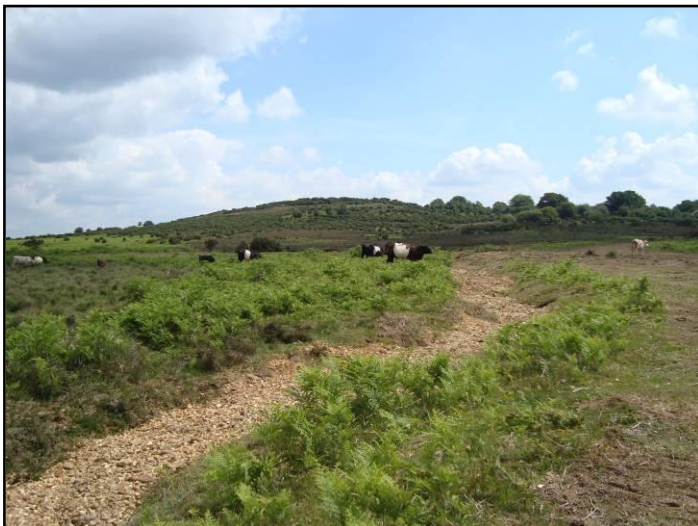
Photo 3 – Ditchend Bottom (Must Thorns tributary), July 2011
The meandering course upstream linked in to natural drainage channels flowing through the dry heath to the south (shown here in dry summer months).

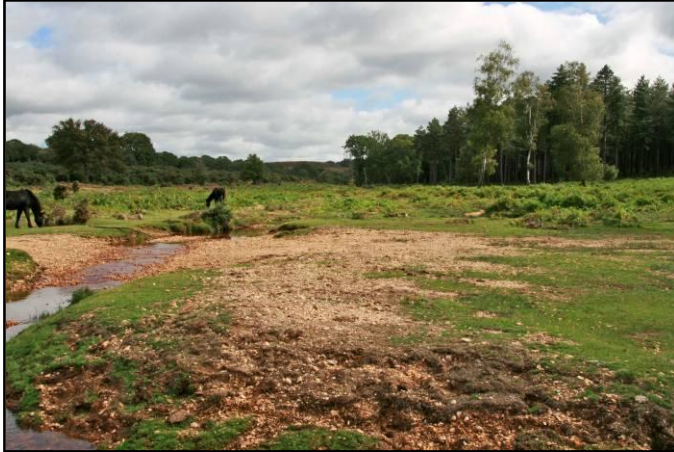
Photo 4 – Ditchend Bottom (Must Thorns tributary), October 2011

In the autumn, after restoration, water returning to the stream at the gravel ford crossing.

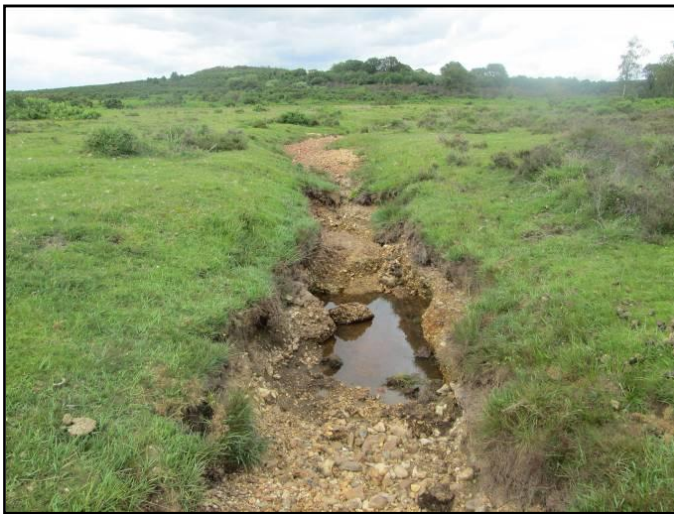
Photo 5 – Ditchend Bottom, July 2014

Routine monitoring by the FC identified that sections of the Ditchend Brook/Must Thorns drain restoration were showing localised signs of instability and erosion (which had previously had minor maintenance completed in 2012).

- The wet winter of 2013/14 tested the system to the limit and on going monitoring showed that these nick points were again being eroded and extending downstream, as energy in the watercourse was excessively contained in the restored channel. Further repairs involved additional bed level raising to reduce the capacity of the watercourse channel along 150m (over three stretches) of the Ditchend Brook and a 360m length of the Must Thorns drain. If the channel's bed level is raised to promote floodplain inundation during times of high flows, the flow can be slowed to reduce the stream's ability to transport sediment. The larger stone cobbles used as bed substrate replicates the situation found in naturalised high energy stream locations, with the larger stones being less likely to be transported by the water.

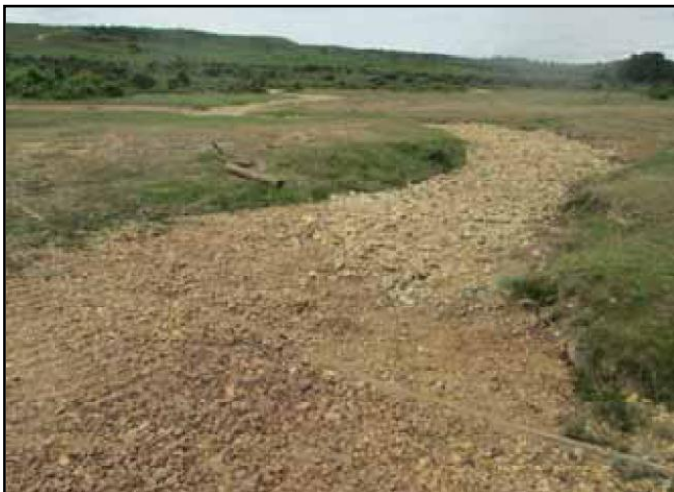
Photo 6 – Ditchend Bottom (Must Thorns tributary), August 2014

The restored channel is now on average 14cm deep throughout the Must Thorns tributary, and 30cm deep on the Ditchend Brook to allow the water to spill out sooner and reduce the amount of energy in the channel. Larger cobbles have been used to replicate the type of substrate consistent with a high energy environment.

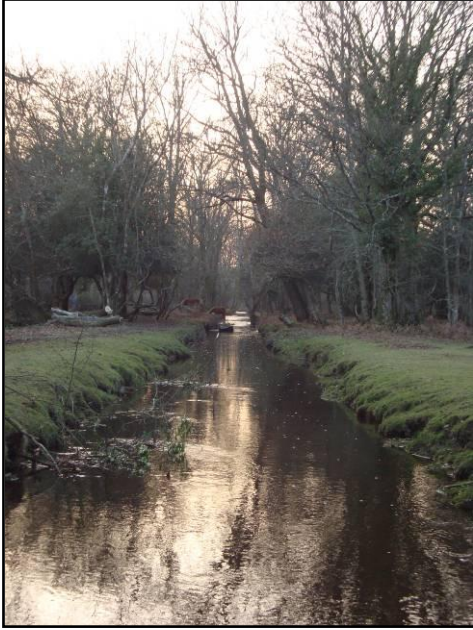
Photo 1 - Fletchers Thorns, February 2011
Artificial straight, wide drain which was limiting floodplain inundation, with the erosive force constricted to the channel.

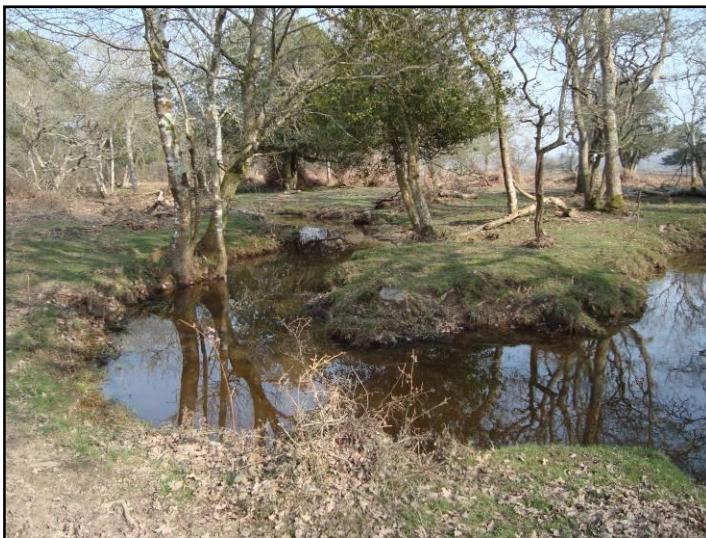
Photo 2 - Fletchers Thorns, March 2012
The stream can now interact more naturally with its floodplain and the flow is slower due to increased length of channel

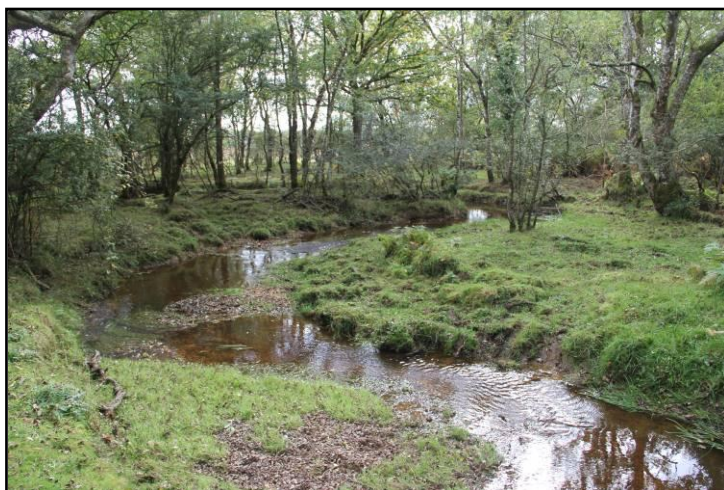
Photo 3 - Fletchers Thorns, October 2014
In its current state, the restoration has had limited incision and erosion as well as contributing to more stable flows downstream

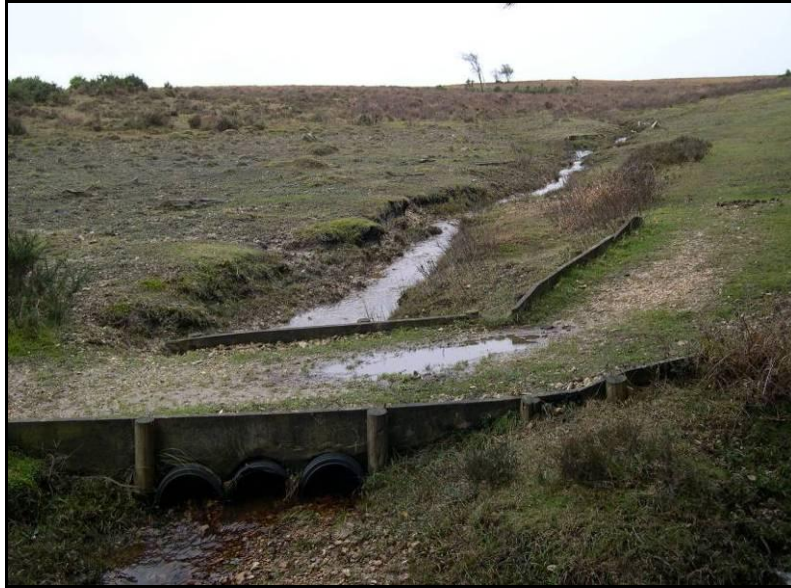
Photo 1 - Hawkhill Mire, March 2013
Artificial drainage channel in mire, before restoration.

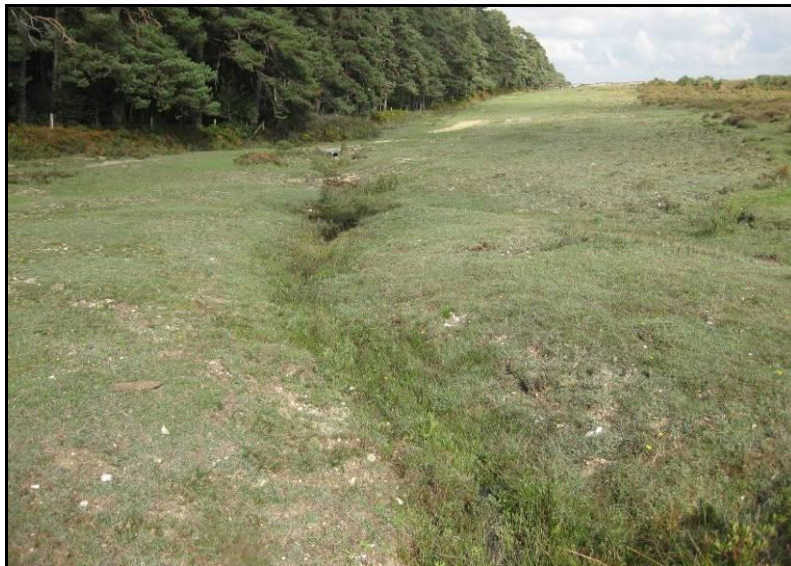
Photo 2 - Hawkhill Mire, October 2014
Eroding channel infilled upstream of passageway, after restoration.

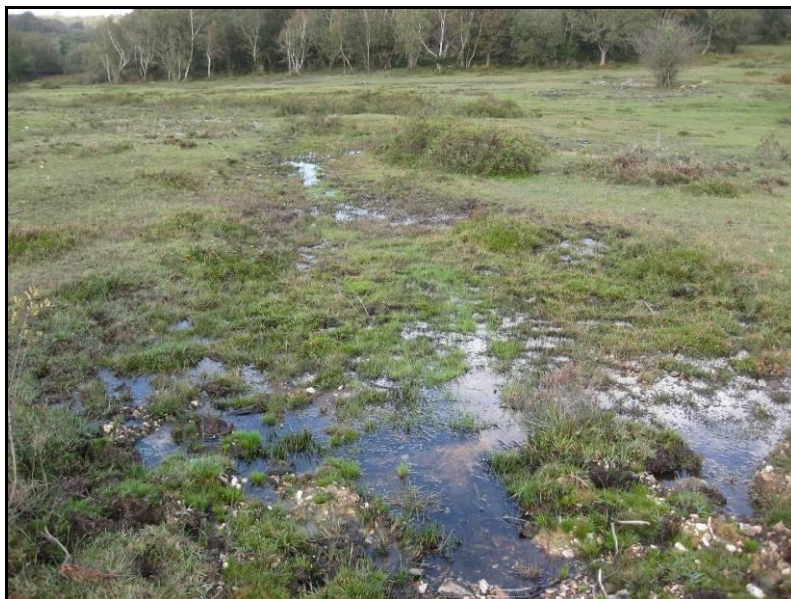
Photo 3 - Furzey Mire, October 2014
Eroding channel infilled with heather bales, after restoration.

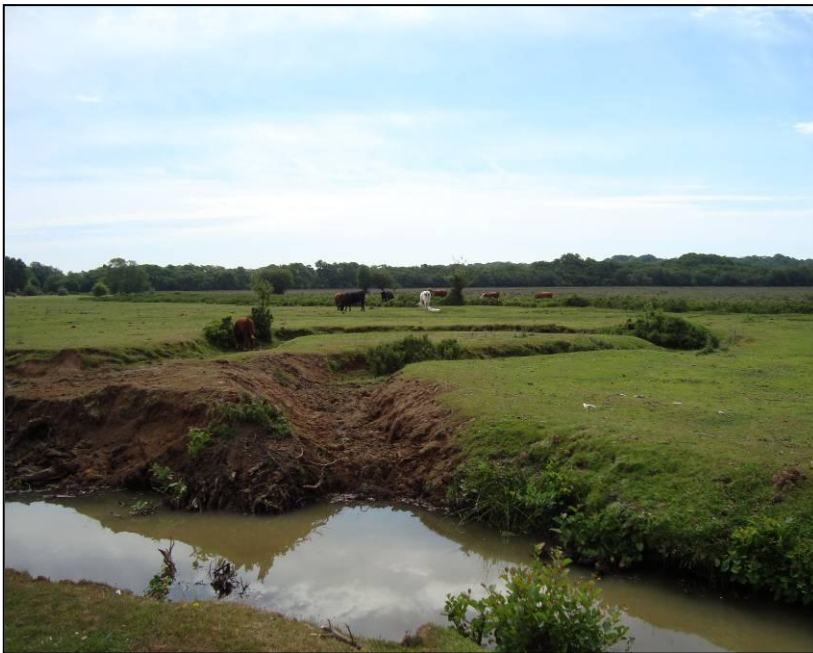
Photo 1 -
Longwater Lawn,
July 2010
Deeply incised
channel and
remnant
meander.

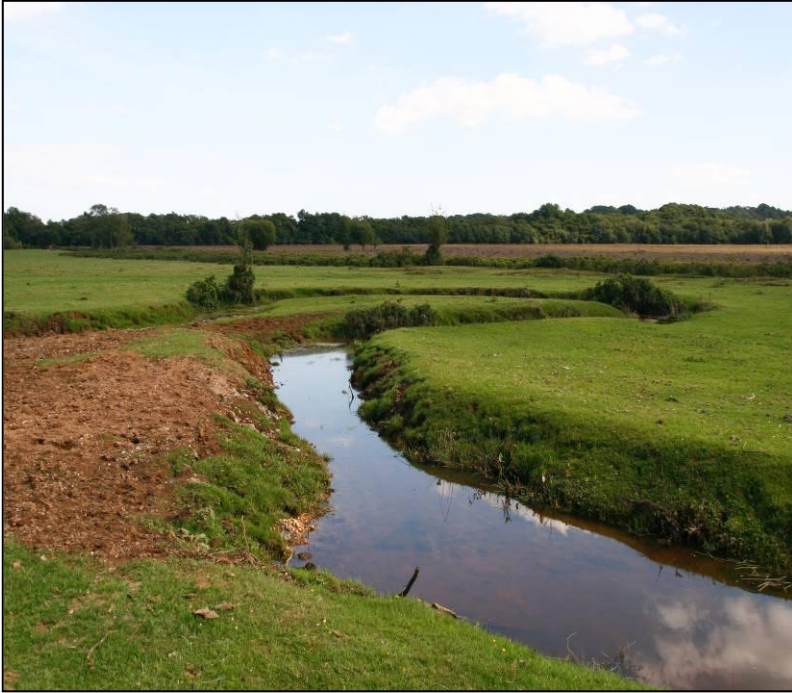
Photo 2 - Longwater
Lawn, September
2010

Shallower reinstated meander on lawn slowing flow. This clay plug was subsequently fenced to encourage revegetation.

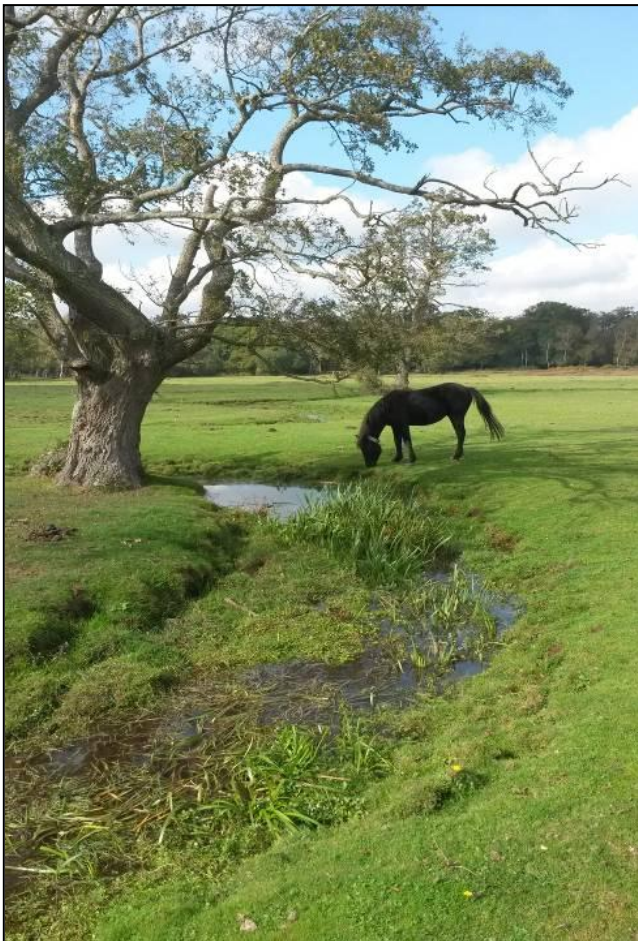
Photo 3 - Longwater
Lawn, October 2014

Diverse meandering channel with slow flow allowing in channel vegetation to develop.

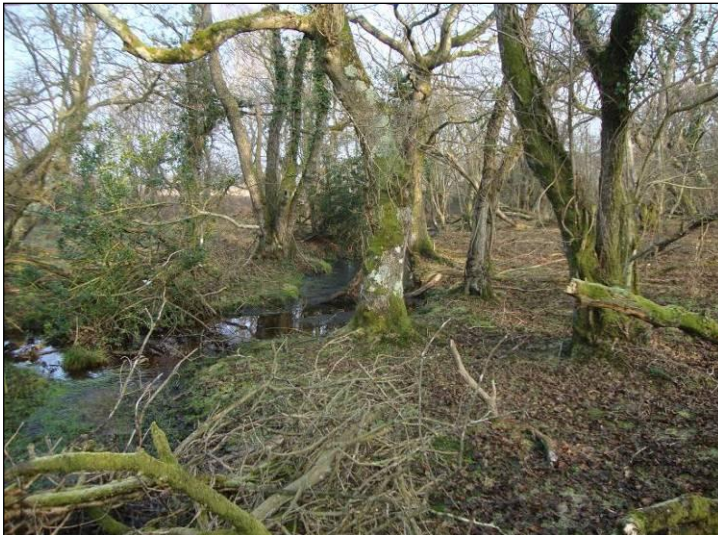
Photo 1 – Penny Moor, March 2012
Remnant meanders evident in riverine woodland at the eastern end of the site.

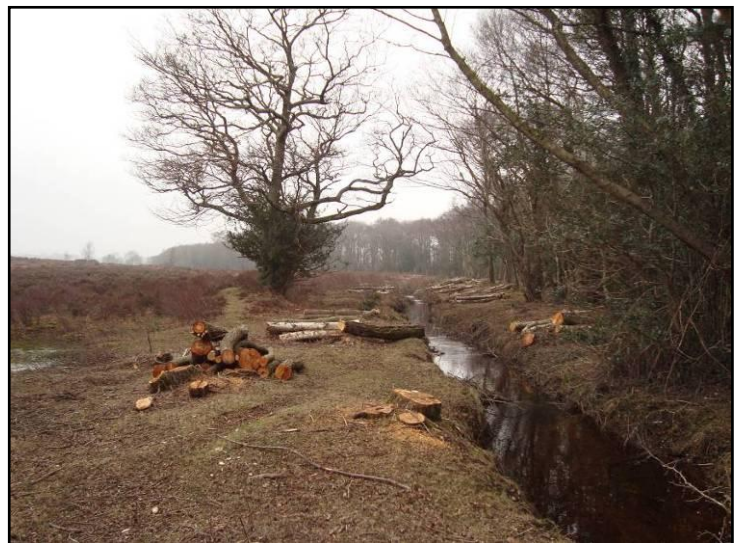
Photo 2 – Penny Moor, March 2012
Artificial drain at the eastern end of the site. Colonising birch felled to restore wet heath and lawn habitat.

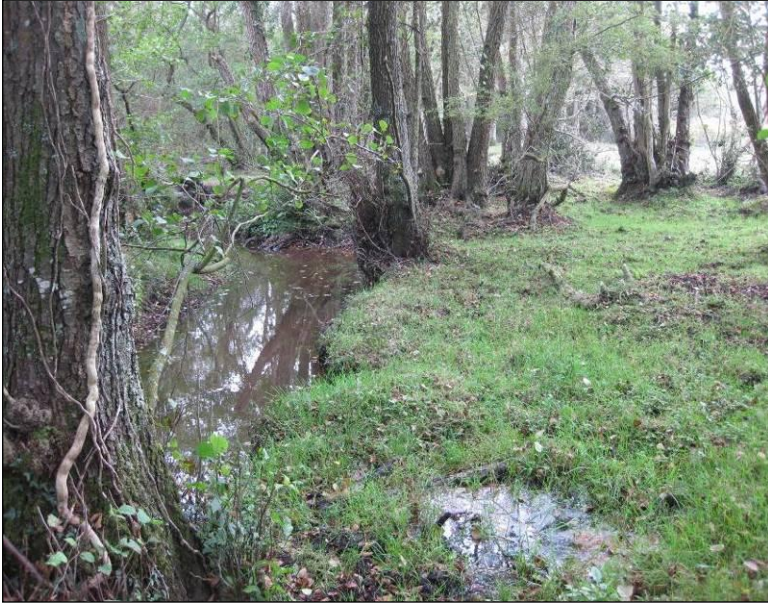
Photo 3 – Penny Moor, October 2014
Restored meander in the riverine woodland at the eastern end of the site.

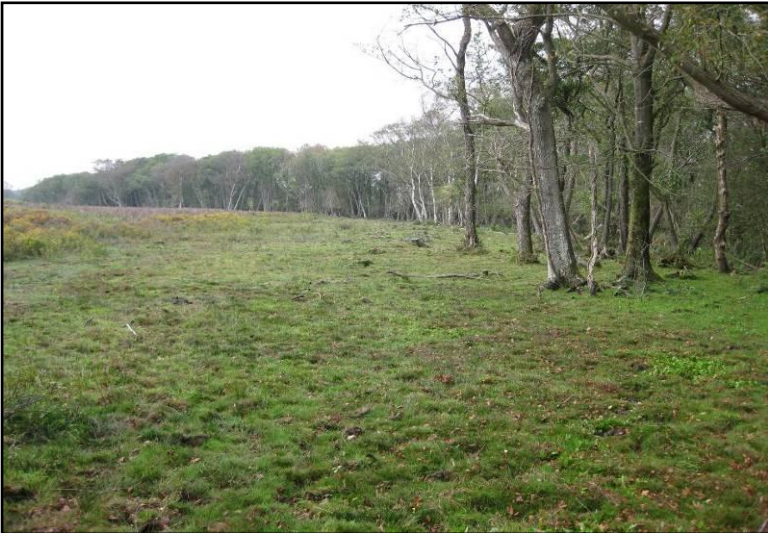
Photo 4 – Penny Moor, October 2014
Infilled drain line at the eastern end of the site.

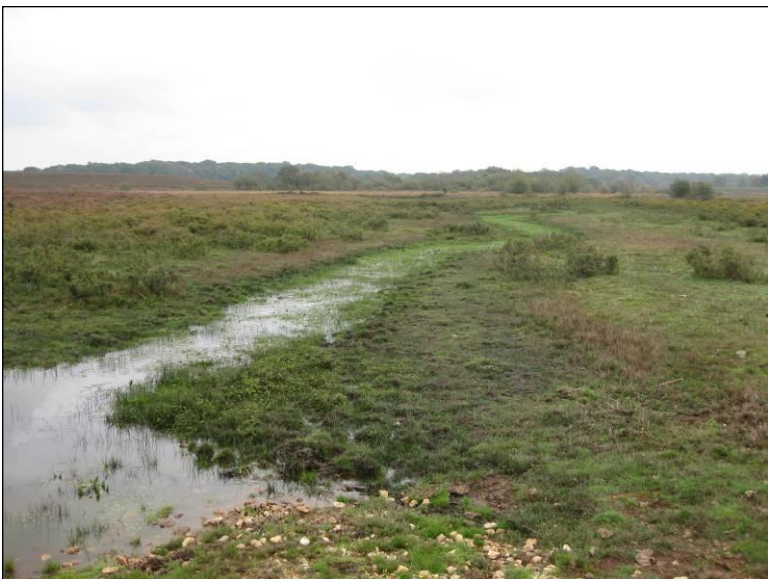
Photo 5 – Penny Moor, October 2014
Restored meander at the western end of the site.

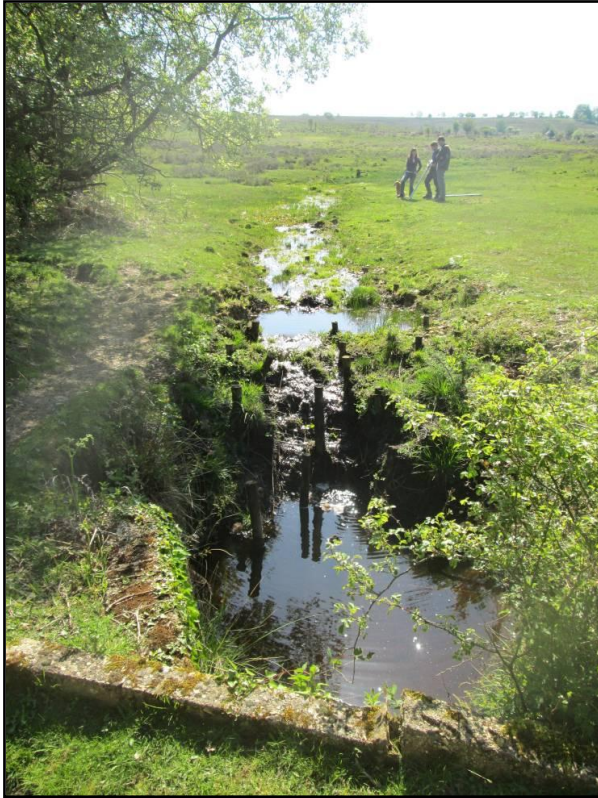
Photo 1- Picket Bottom, May 2014
Eroding end point of earlier mire restoration, taken from the bridge, before restoration.

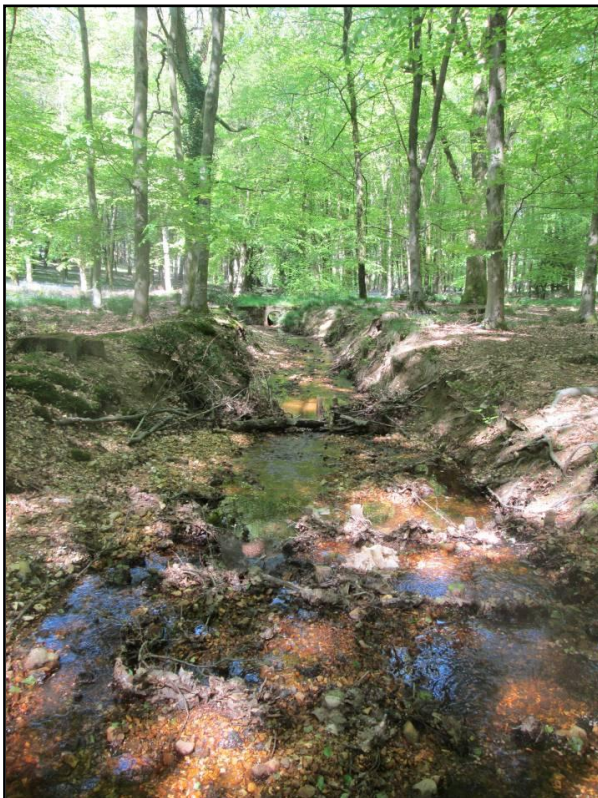
Photo 2 - Little Linford Inclosure, May 2014.
Eroded artificial drain, before restoration.

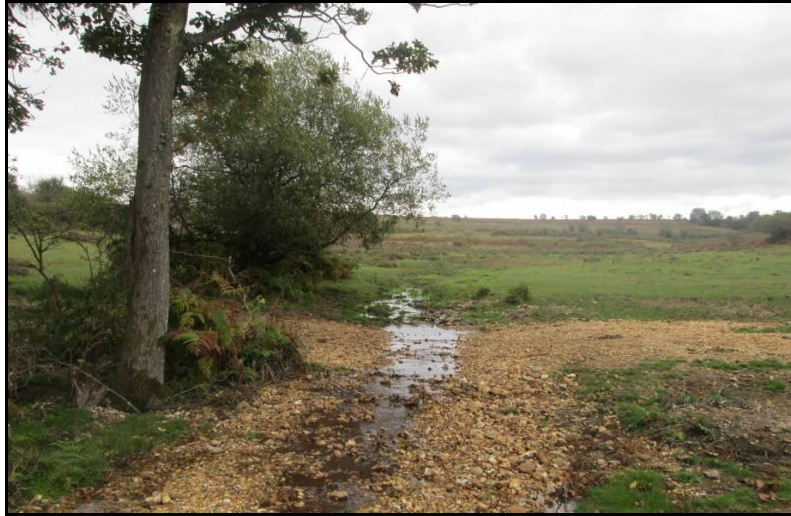
Photo 3 - Picket Bottom, October 2014

Concrete bridge on the Open Forest has been replaced with a gravel ford, bed level raised and channel narrowed, three months after restoration.

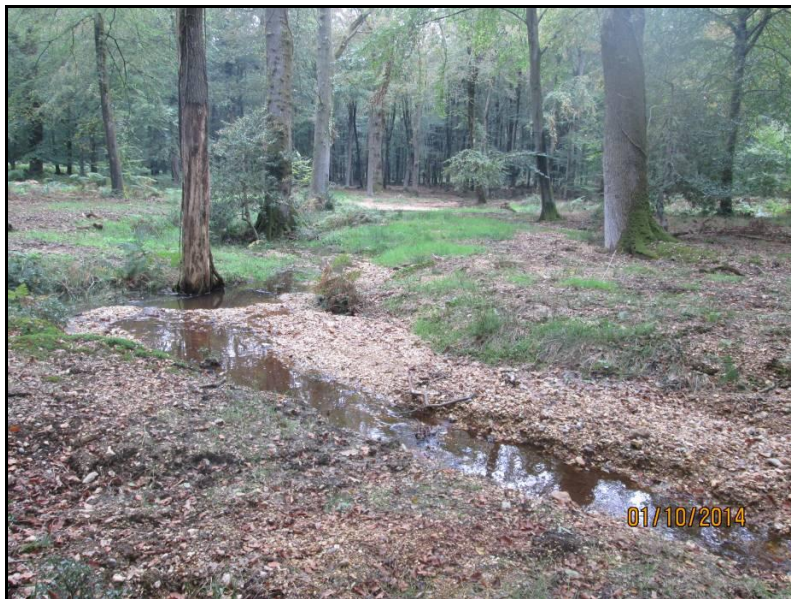
Photo 4 - Little Linford Inclosure, October 2014.

Restored meanders, three months after restoration.

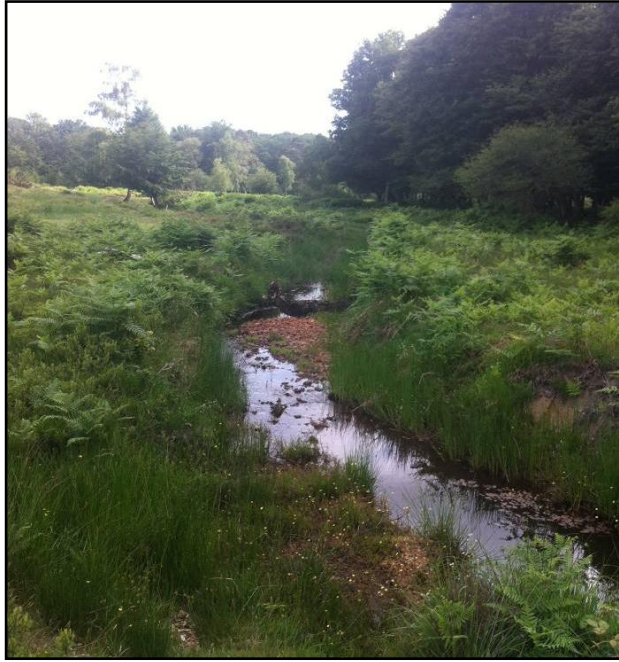
Photo 1 - Soldiers Bog, April 2013
Eroded channel with poor in-channel diversity and unstable gravel shoals, before restoration.

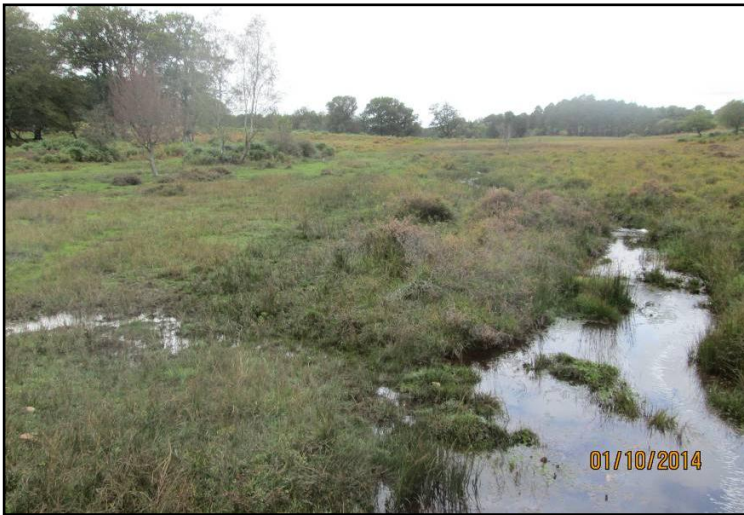
Photo 2 - Soldiers Bog, October 2014.
Restored meanders through wet heath, after restoration.

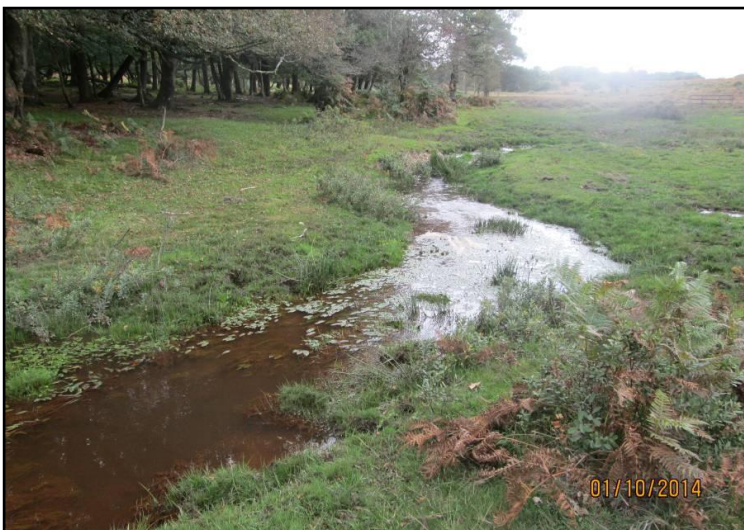
Photo 3 - Soldiers Bog, October 2014.
Restored meander through lawn, after restoration.

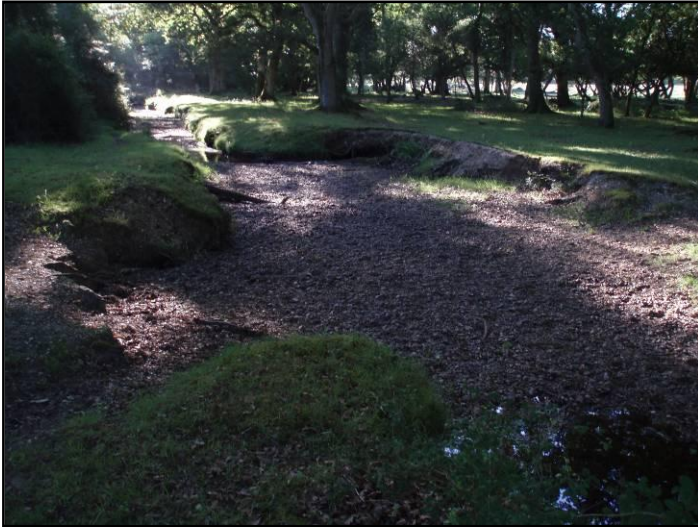
Photo 1 – Markway, July 2006
Artificial straightened drain which was limiting floodplain inundation and with the erosive force constricted to the channel. Significant deposition of upstream material is shown here.

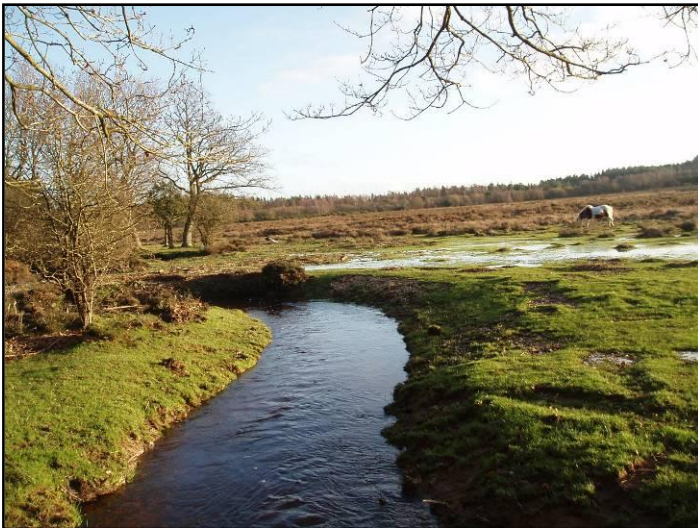
Photo 2 – Markway, December 2006
Restored meander connected to floodplain, with limited erosion and deposition.

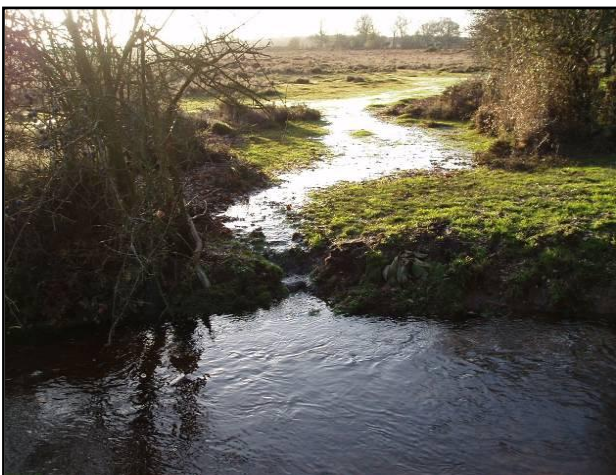
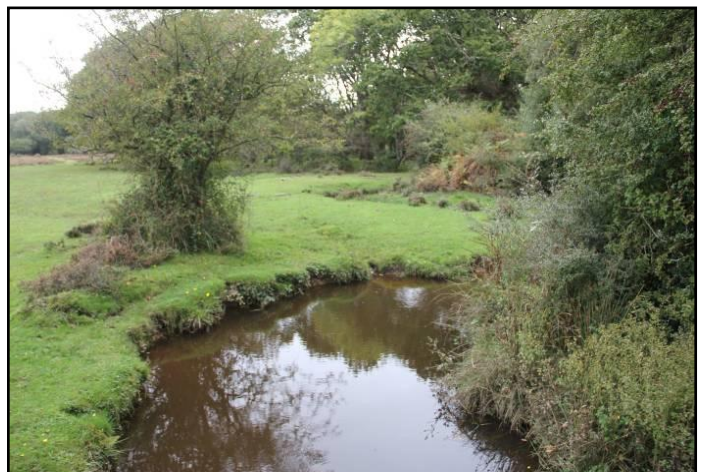
Photos 3 and 4 – Markway, December 2006 (Left) and October 2014 (Right)
No erosion as water seeps back into the restored meander from the connected floodplain. The system has been stabilised as demonstrated by the lack of a nick point from the same seepage point 8 years later.
