CASE STUDY 2: STONY MOORS MIRE RESTORATION

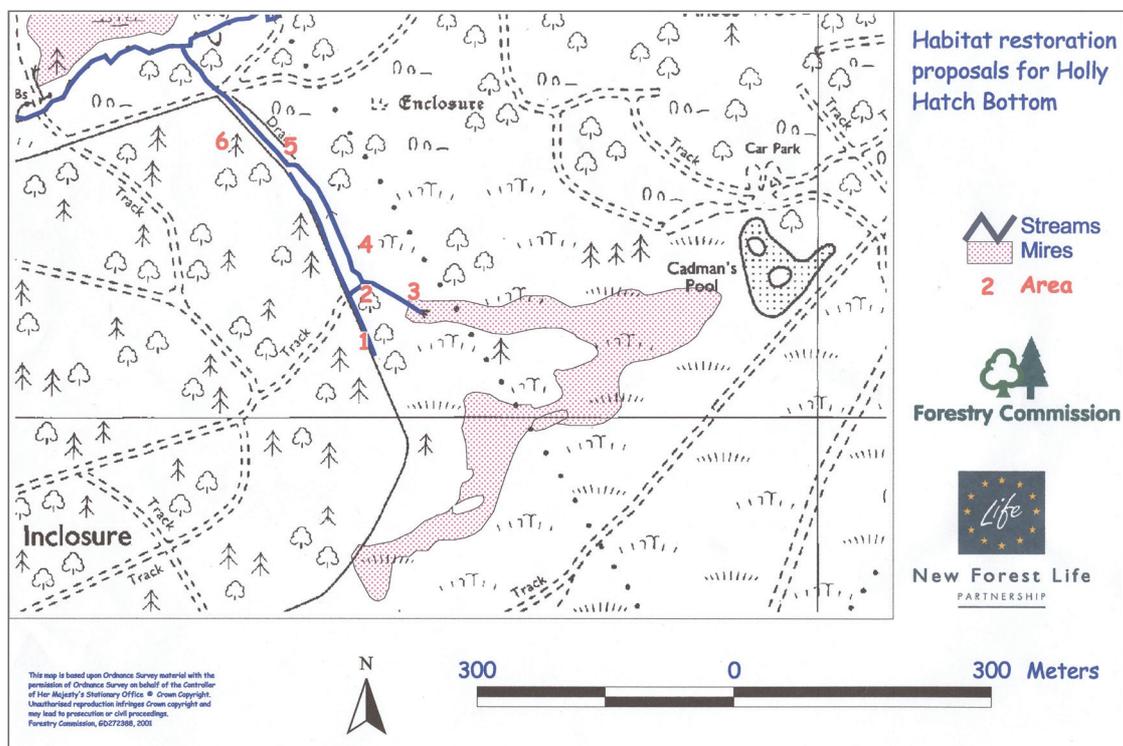
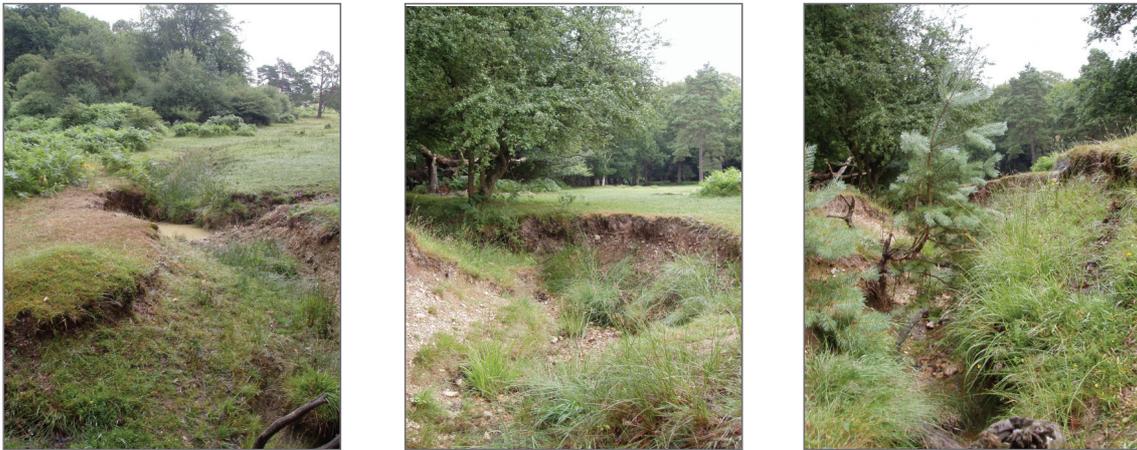
Over deepened and eroded drainage channels prior to restoration

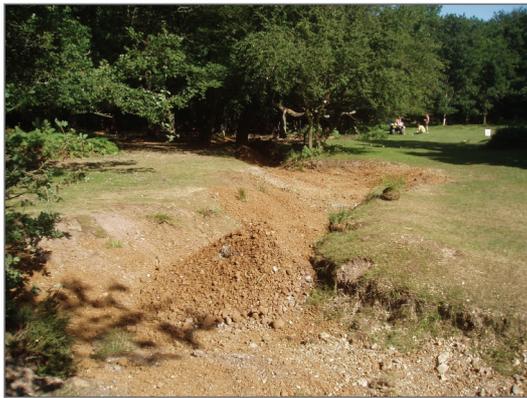
Infilling with material

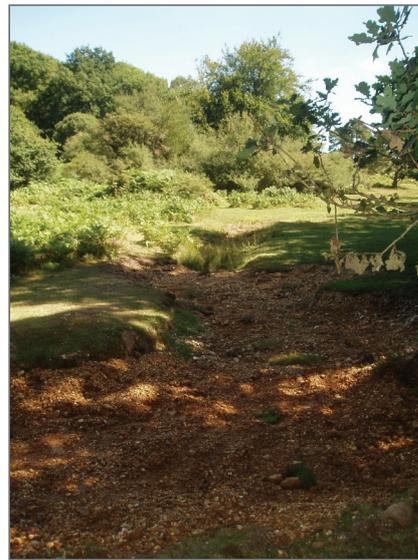
After restoration

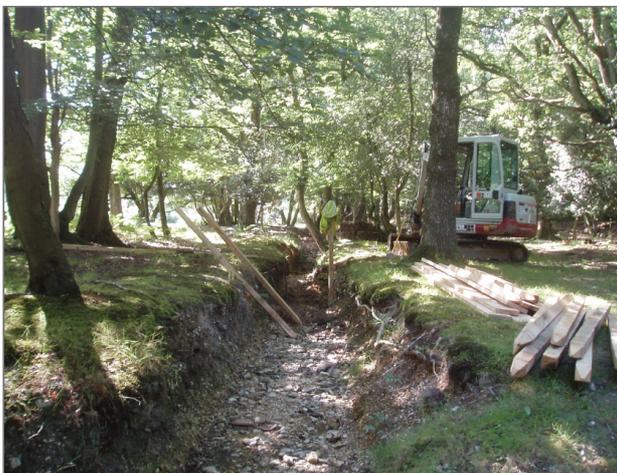
Prepared watercourse for bed-level raising

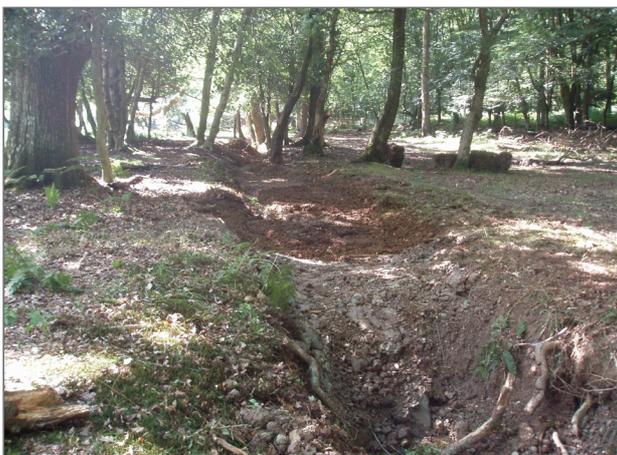
Installing clay plugs

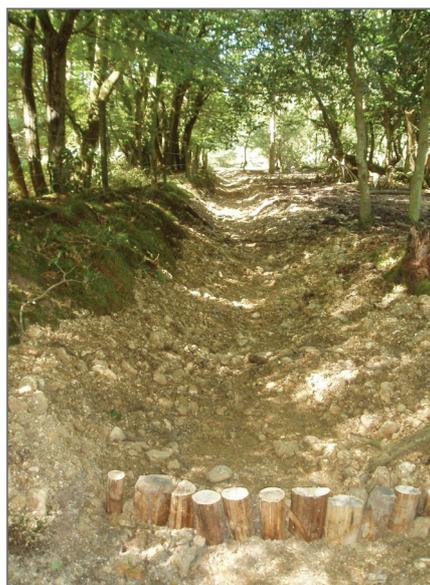
Chestnut post dams to prevent movement of material

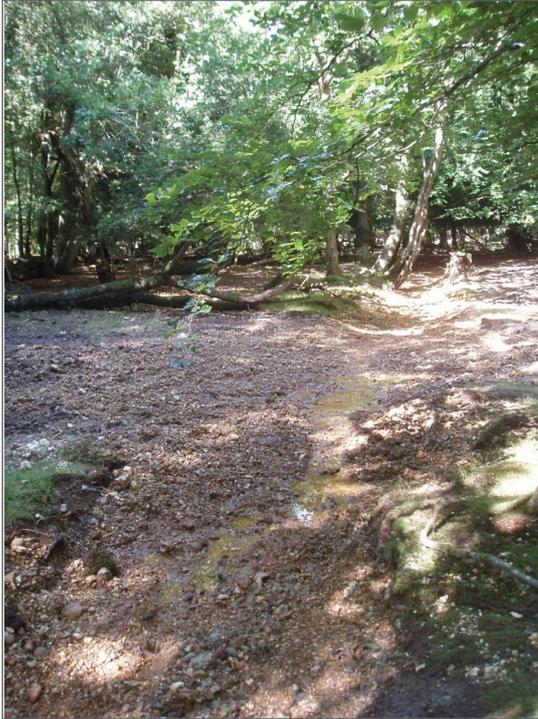
Ditch post restoration

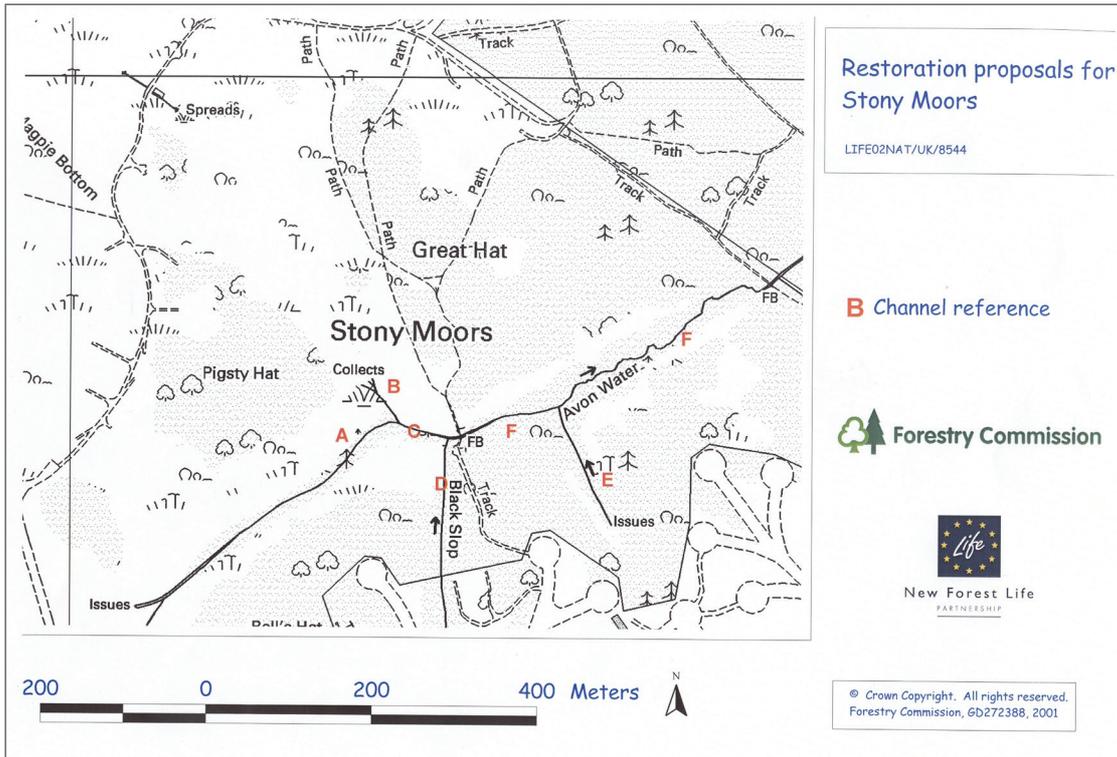
Figure A

The works focused on seven drainage channels and ten areas of scrub clearance as shown in Figures A & B.

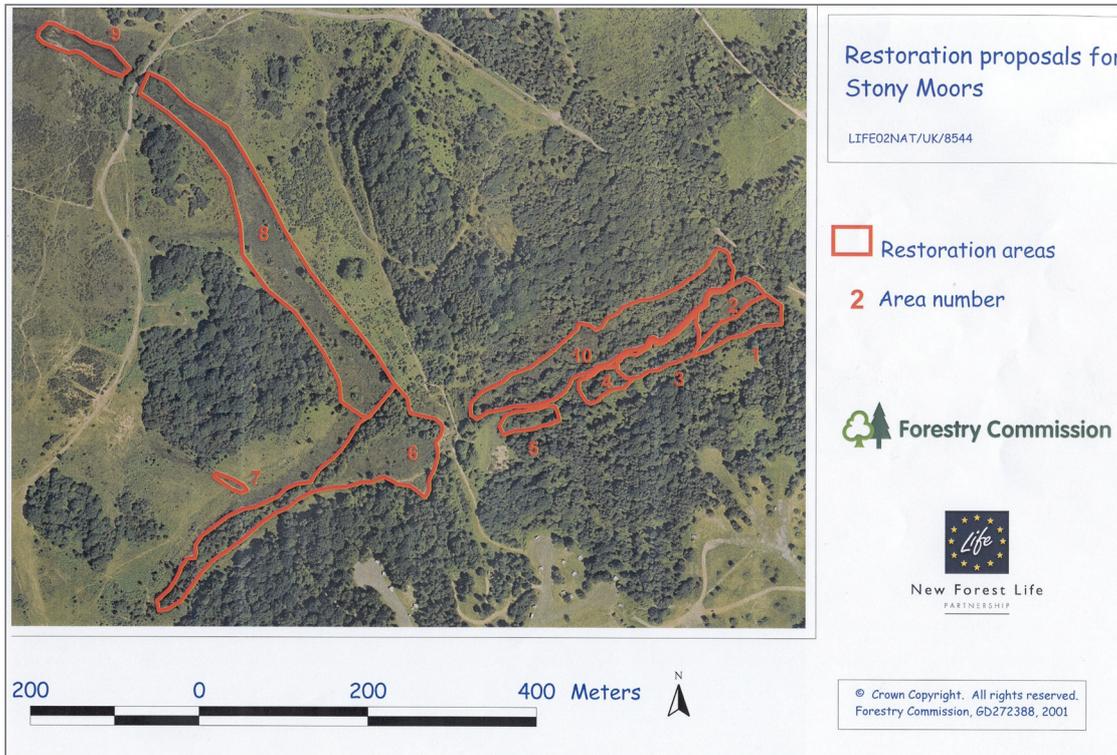
Figure B

Over the remaining ten areas highlighted on Figure B, 8.8 hectares of vegetation clearance and scrub management was carried out to restore areas of mire that had been colonised by pine and willow. Selective oak and birch were also removed. Thinning was also carried out to increase the light levels to ground flora.
