The Noads Mire – case study: Monitoring wetland restoration in the New Forest using fixed point photography and geomorphological surveys

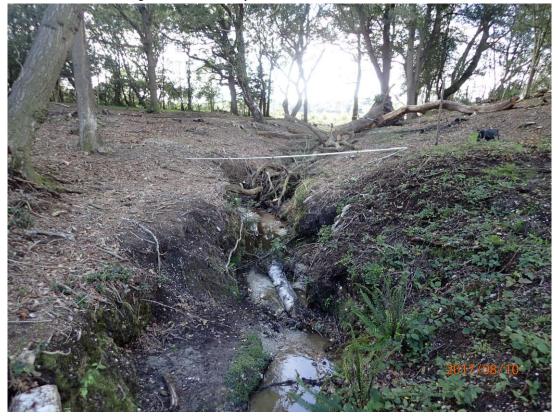
The Noads – facing downstream pre-restoration (2017)

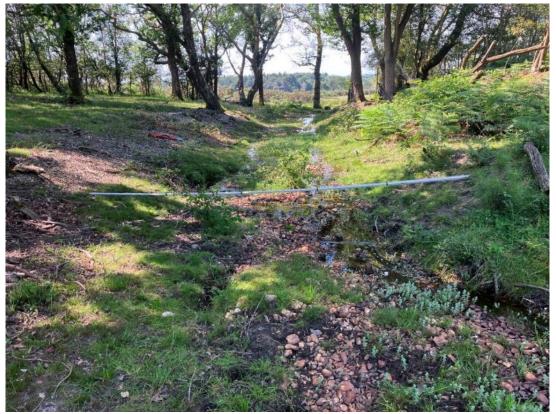
The Noads – facing downstream post-restoration (2024)

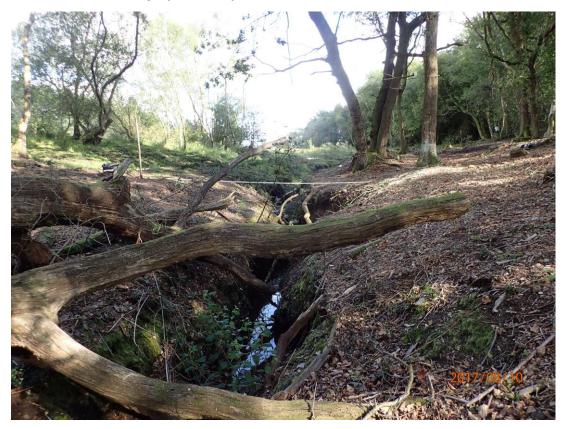
The Noads – facing upstream pre-restoration (2017)

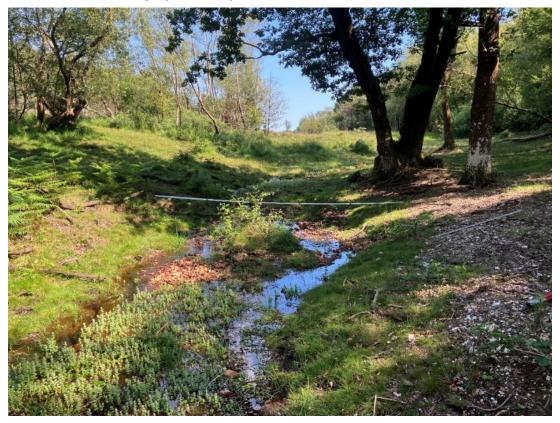
The Noads – facing upstream post-restoration
