Mire restoration using vegetation clearance

CASE STUDY 3: HOLMSLEY INCLOSURE STREAM RESTORATION

CASE STUDY 4: MARKWAY STREAM RESTORATION

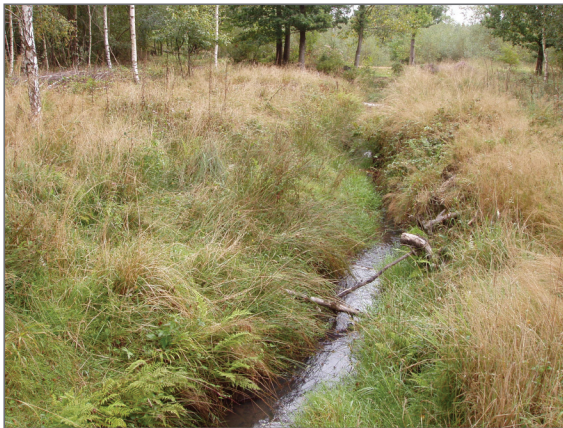
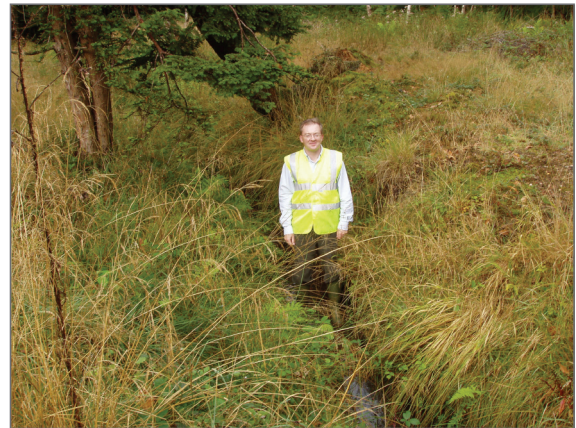
Deeply incised channel

- ◆ 8.8 hectares of scrub management and vegetation clearance
- ◆ Raising of bed levels for approximately 500m in the existing Stony Moors stream between the Inclosure boundary and the fords on the public road. Levels were raised to within 0.4m of the surrounding floodplain to restore winter flooding on the flood plain. This was achieved using clay plugs and backfilling with imported hoggin and available bank spoil. Due to the steep gradient additional support was given to the infill in the form of log weirs, oak boards and live willow.
- ◆ Side drains were blocked with spoil except those that supported prime butterfly habitat.

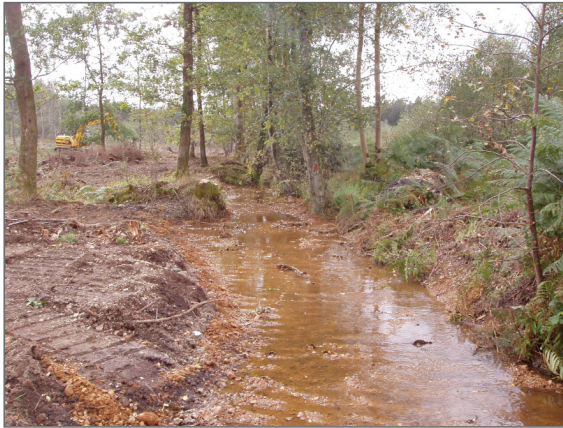
Bed level raising in progress

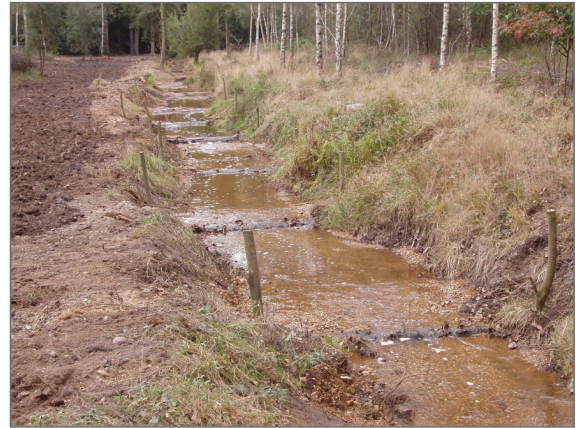
Use of log weirs
to support bed material

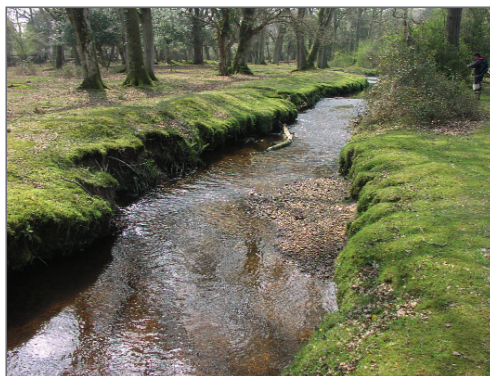
Above L - Former channelised channel upstream of A35

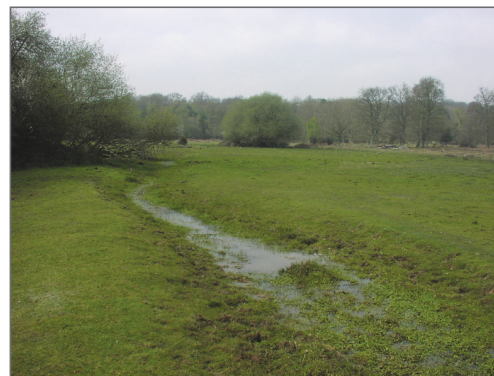
Above R - Infilled channelised reach downstream of A35

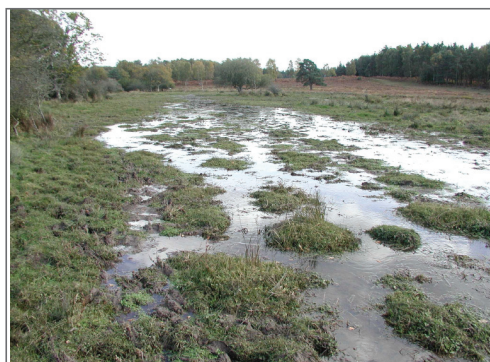
Left - Diffuse flow downstream of Markway bridge where river is migrating from former engineered channel
