3. Restoration of Hydrological Function and Reconnection with the Floodplain

3.2 Restoration Objectives

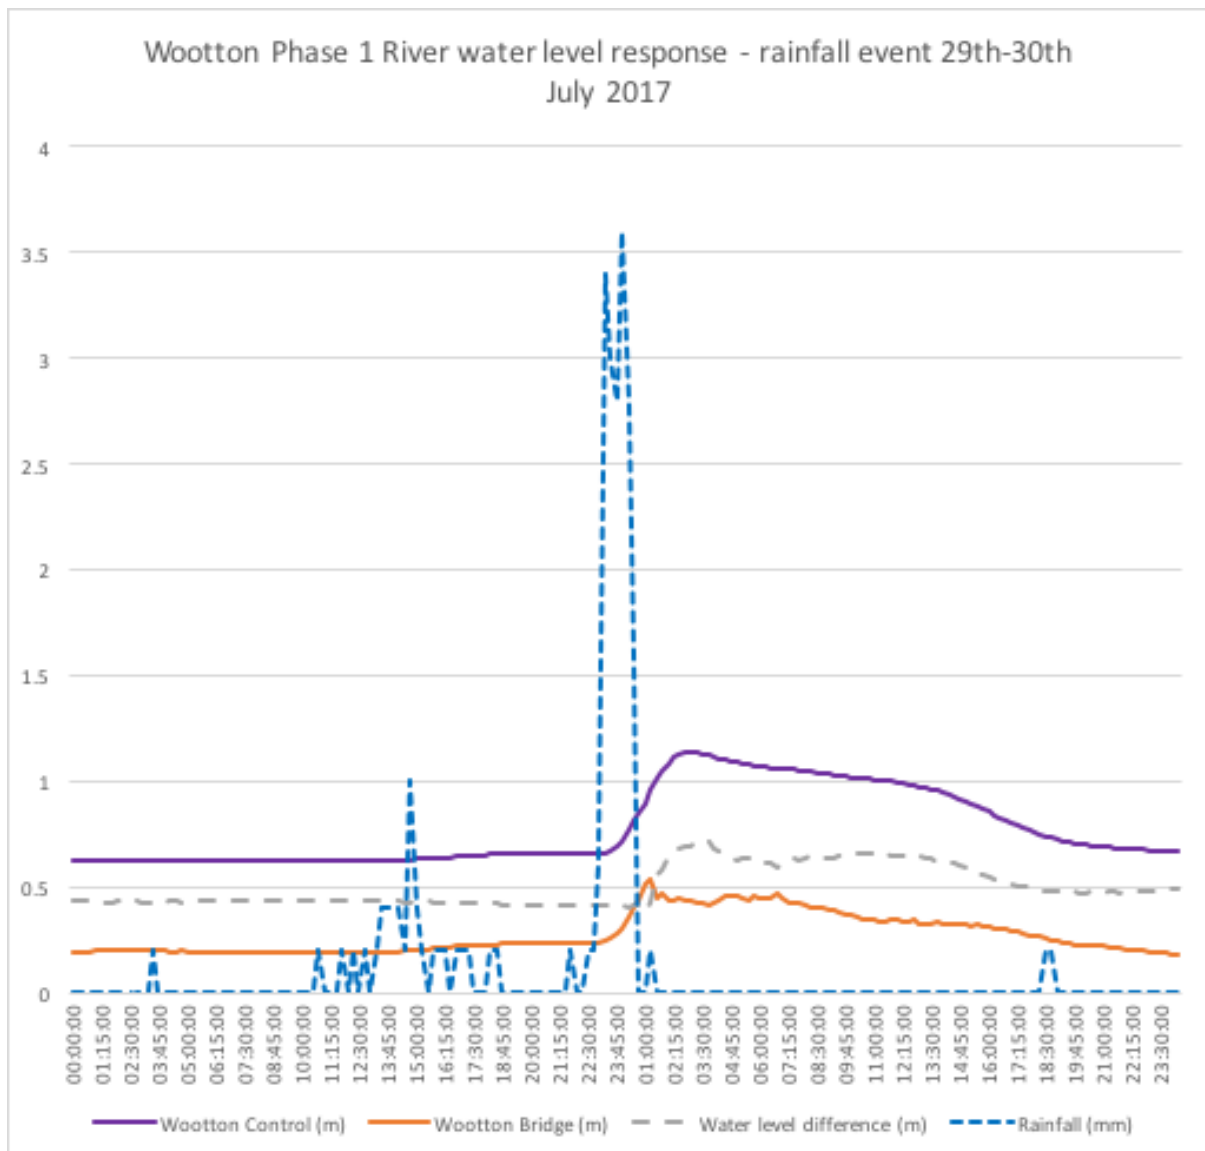
Figure 3.7: Wootton Phase 1 River level response – Rainfall event 29th-30th July, 2017

Prior to the rainfall event starting TLC footage in the morning at 06:58 shows the river at normal level still well within its banks.

Some small showers occurred between 10:00am and 18:45 and footage captured at 16:58 shows a very slight rise in river levels. The data logger upstream records a rise of 1cm and the downstream data logger a rise of 3cm.

The main peak of the rainfall event occurred overnight when it was not possible for the camera to capture visible images but the hydrographs show a rapid response to the heavy rain and the first clear image in the morning taken at 06:58, approximately 5 hours after the peak rainfall ceased shows the river flowing out of bank and actively engaging with the floodplain. The patterns in the hydrograph, where the distance between the upstream and downstream river levels graphs suddenly increases after the peak rainfall suggests that the river has started to overtop its banks and engage with the floodplain around 01:15 hours.

Two hours later the camera starts to capture the river levels starting to fall with river levels reducing 2cm upstream and 4cm downstream

Footage from 09:00 and 13:00 hours shows that river levels are still high but falling with more of the higher bankside features gradually being exposed. The patterns in the hydrograph still show that the river is engaging with the flood plain.

From 16:00 hours onwards the differences in the upstream and downstream river levels start to decrease and camera footage shows the river starting to fall back within its banks. The image at 19:00 was one of the last clear images captured before darkness fell.

Timelapse camera footage is available (Camera 2 – Phase 1 East) covering the rainfall event of 29/07/2017 which formed part of the data logger analysis detailed above. By this date, the Phase 1 restoration had already taken place in 2016 between the Control data logger and the Wootton Bridge data logger so a comparison of river level data and synchronised timelapse photographs show how the river visually responded to the rainfall event and in turn influenced the hydrographs. Figure 3.7 shows the water level response from the logger data capture relative to the rainfall event. The river response has already been described in detail in Section 3.5.1 but the timelapse camera images allow a visual analysis of how the river responded.

Analysis of timelapse footage relative to various rainfall events suggest that following the Phase 1 restoration the river close to the timelapse camera starts to overtop when the upstream Wootton Control hydrograph records a level of around 1m.

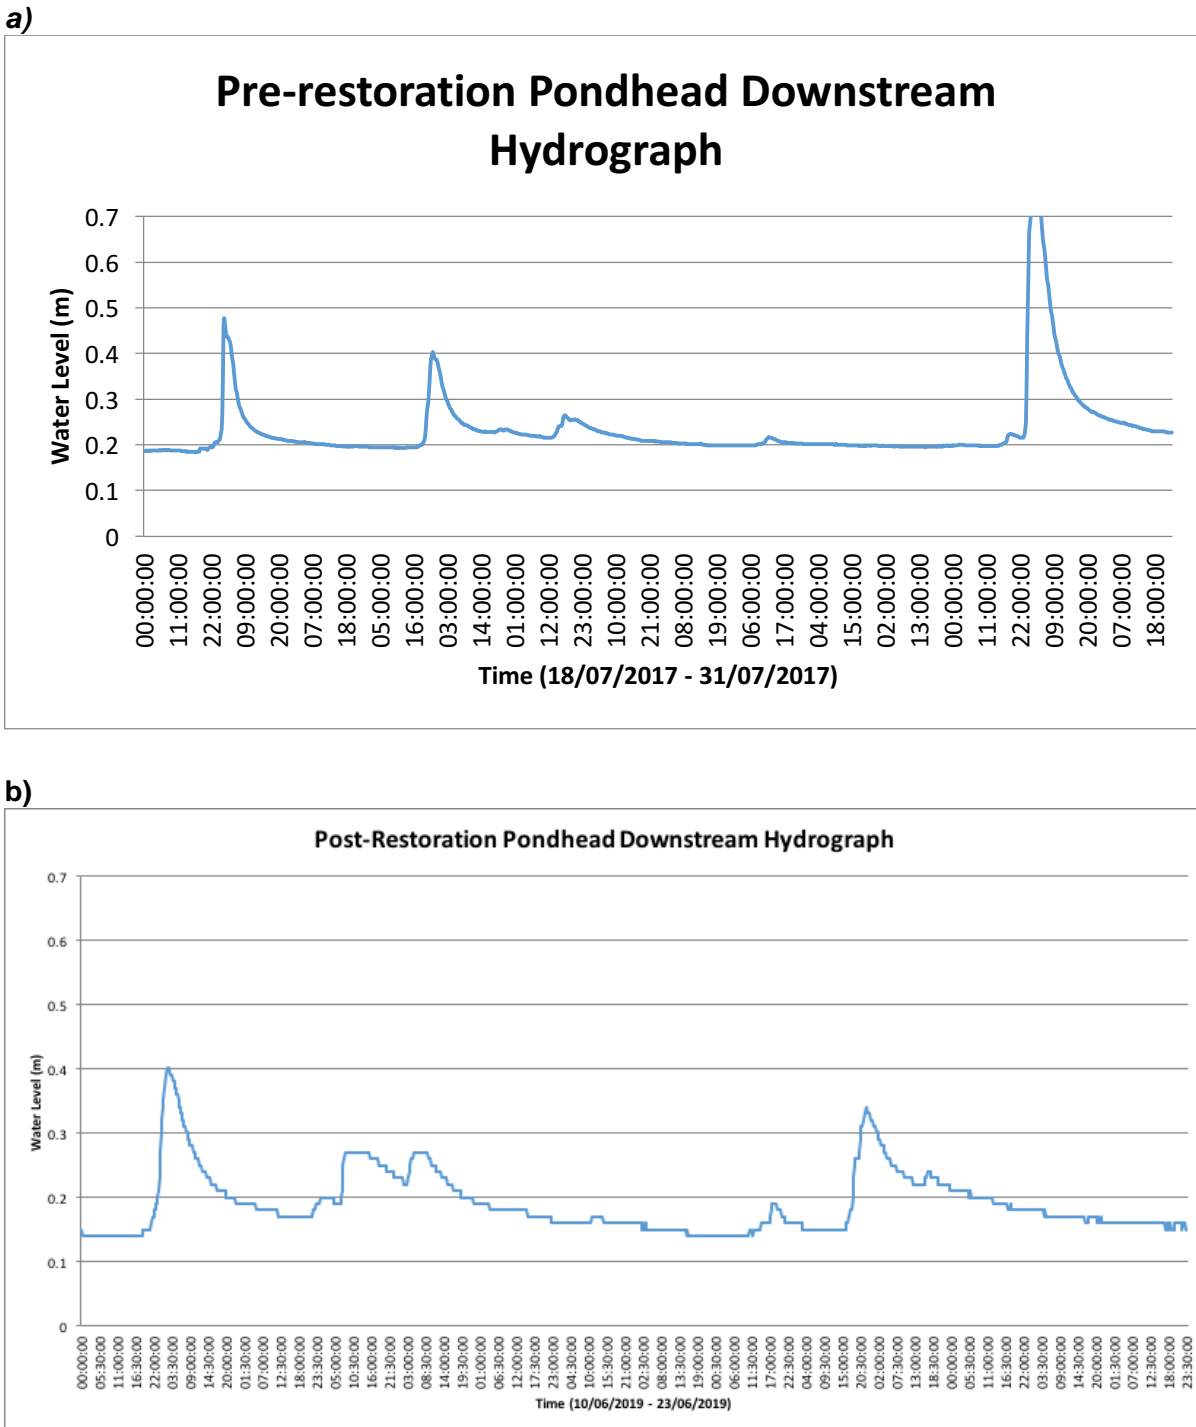
Figure 3.10: Hydrograph data relative to rainfall data (3 day sequence)

With the post restoration water level data from Pondhead it is possible to make direct comparisons between the hydrographs of the two data logger sites, based upon their different locations along the course of the river. It is clear that the post restoration water level hydrographs for the Pondhead Control data logger and Pondhead Downstream data logger (Figures 3.9, 3.10), follow an almost identical pattern. This does not follow the trend of the pre-restoration water levels hydrographs at Pondhead, which display more obviously reduced water level increases and a slower return rate to base water level when moving from the control to downstream data logger sites. Therefore, it can be presumed that the restoration work completed on the 0.7km stretch between the two data logger sites, has brought them to look increasingly similar.

Whilst concentrating specifically on the post-restoration rainfall event between 12th and 15th June 2019 and conducting a comparison of the length of time each site remains at its peak water level after heavy rainfall, it is clear that the stream at Pondhead follows a similar pattern to that found for the Avon Water at Wootton. Although it is only possible to compare the water level data from two loggers at Pondhead, it is evident that the downstream site remains at peak water level for a far longer duration than that of the upstream. The Pondhead Downstream site, with 0.7 km, of river restoration work having been undertaken upstream, remains at its peak water level of 0.27m for 7 hr 45mins. This far supersedes that of the Pondhead Control data logger site, which remains at its peak water level of 0.28m for 4hrs. This follows the same pattern of that of the Avon Water, at Wootton, after restoration and suggests that the restoration work completed successfully enables flow stabilisation and works as a form of natural flood management.

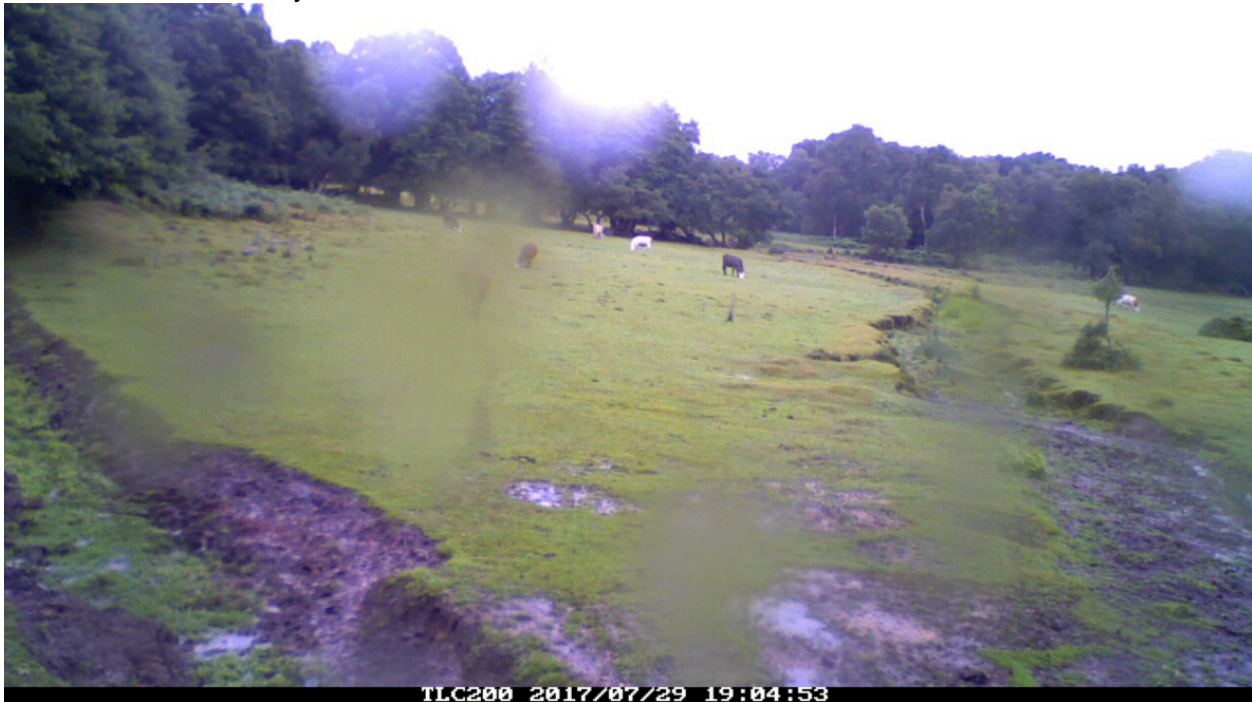
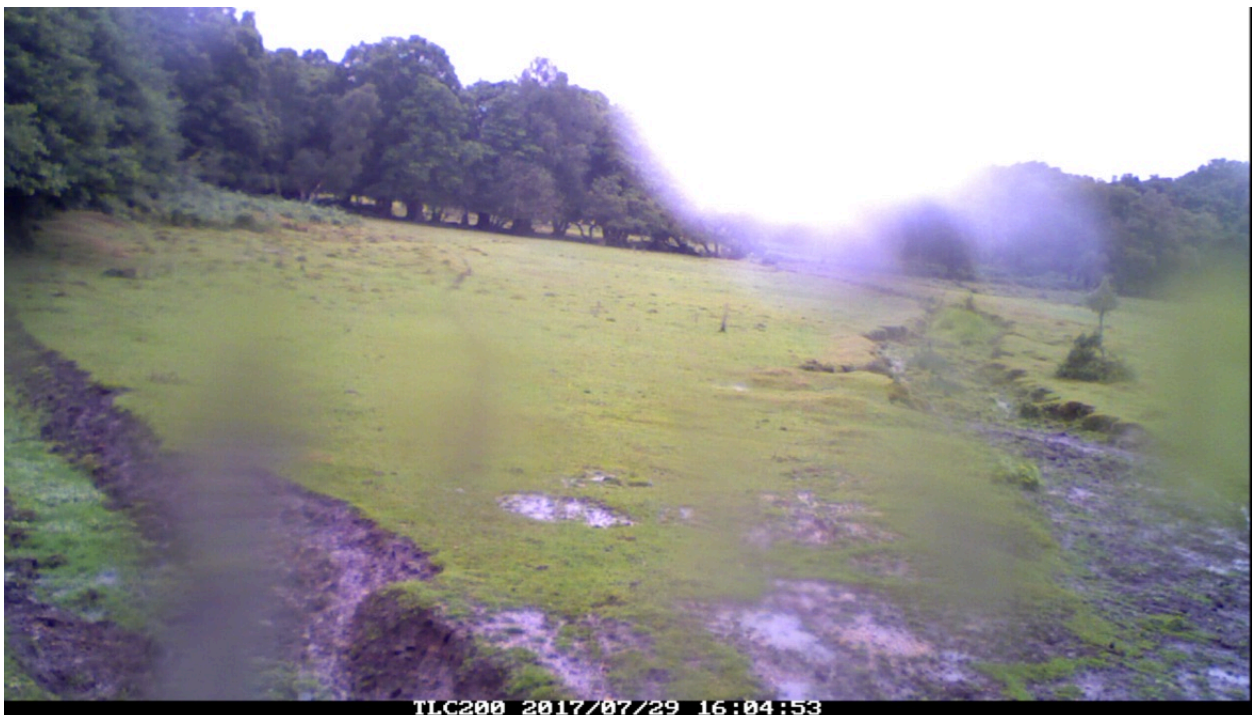
Camera 1 Link drain by farm

Footage for Camera 1 shows that there is absolutely no response within the dry link drains other than some puddles and wet ground as would naturally be expected during the entire rainfall event.

Like the Pre-restoration event, the footage for Camera 1 shows virtually no response within the dry link drains other than some standing water/puddles.

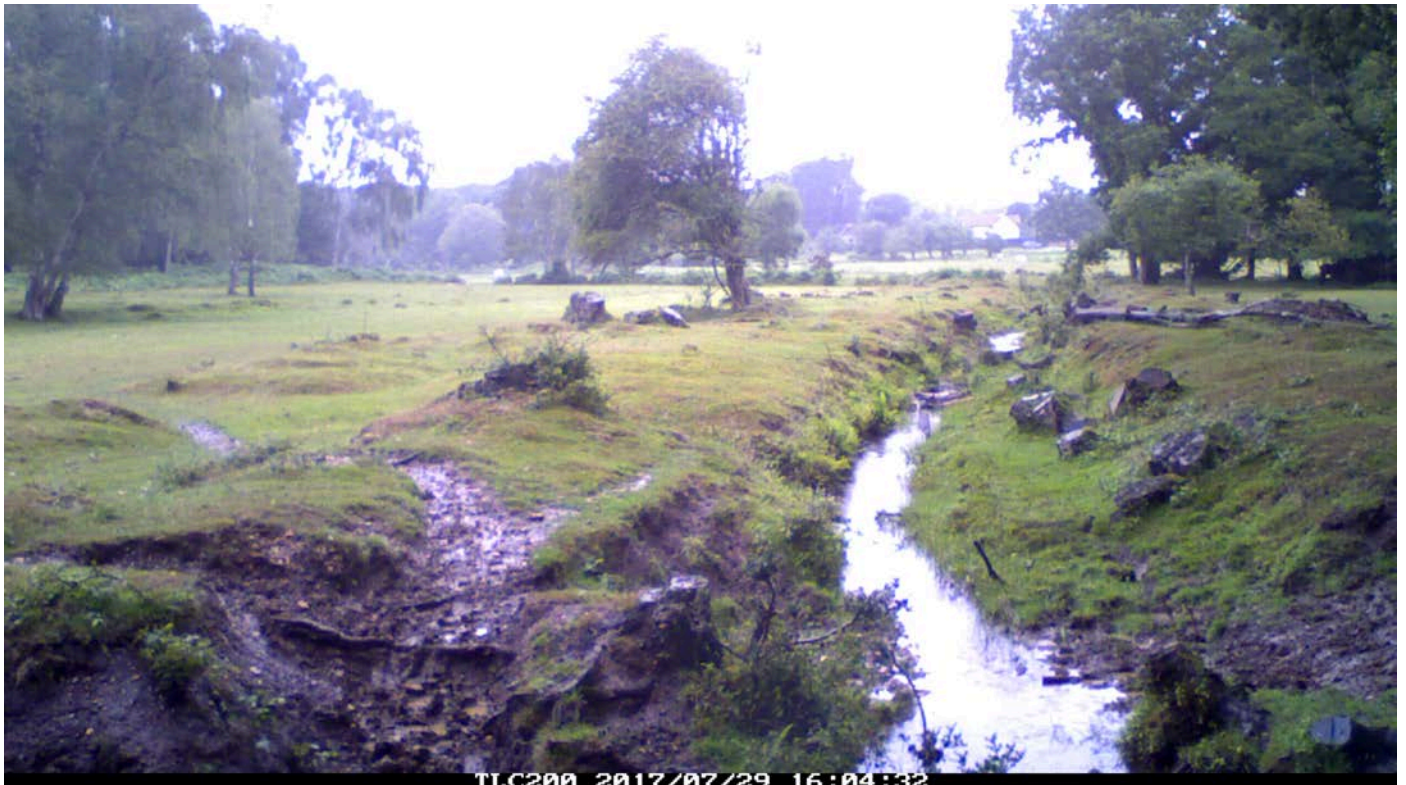
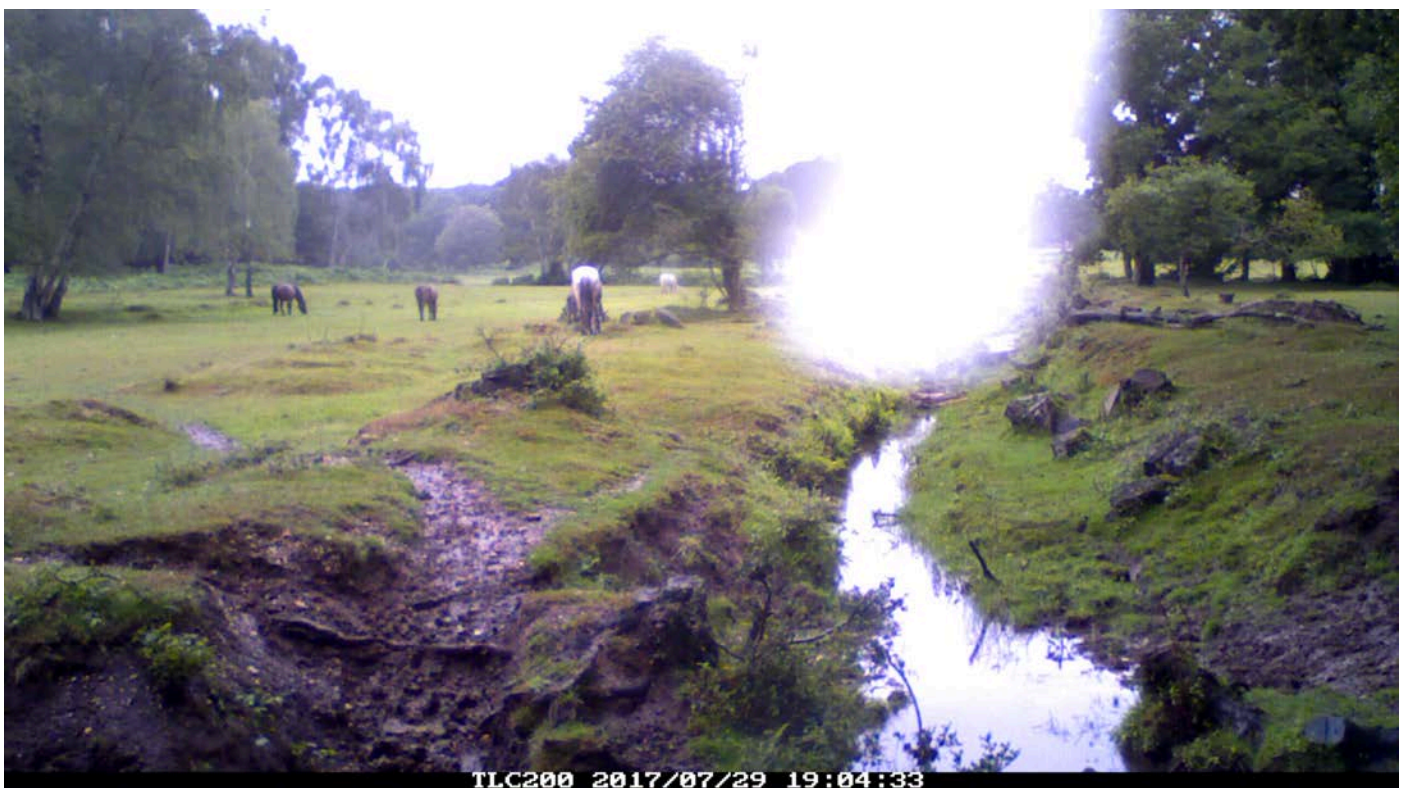
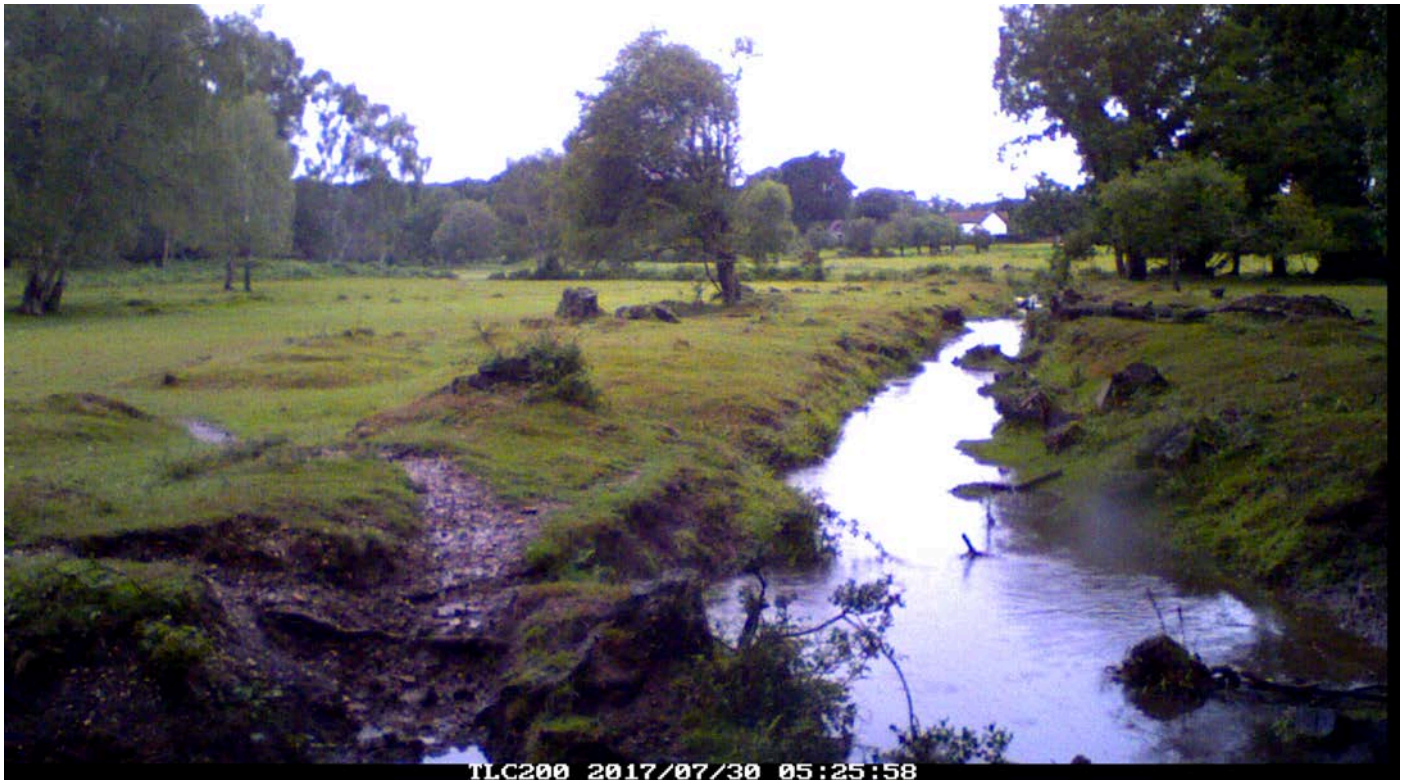
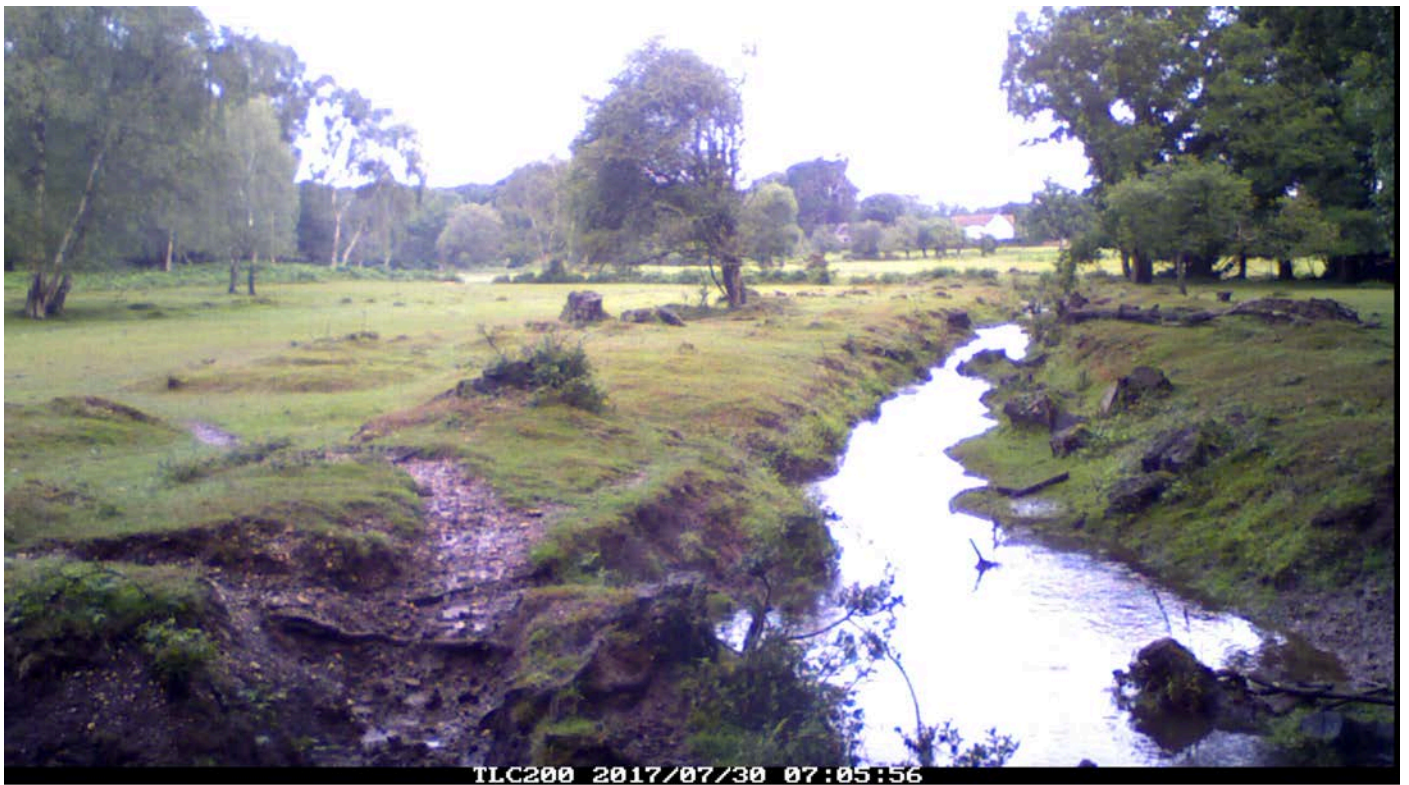
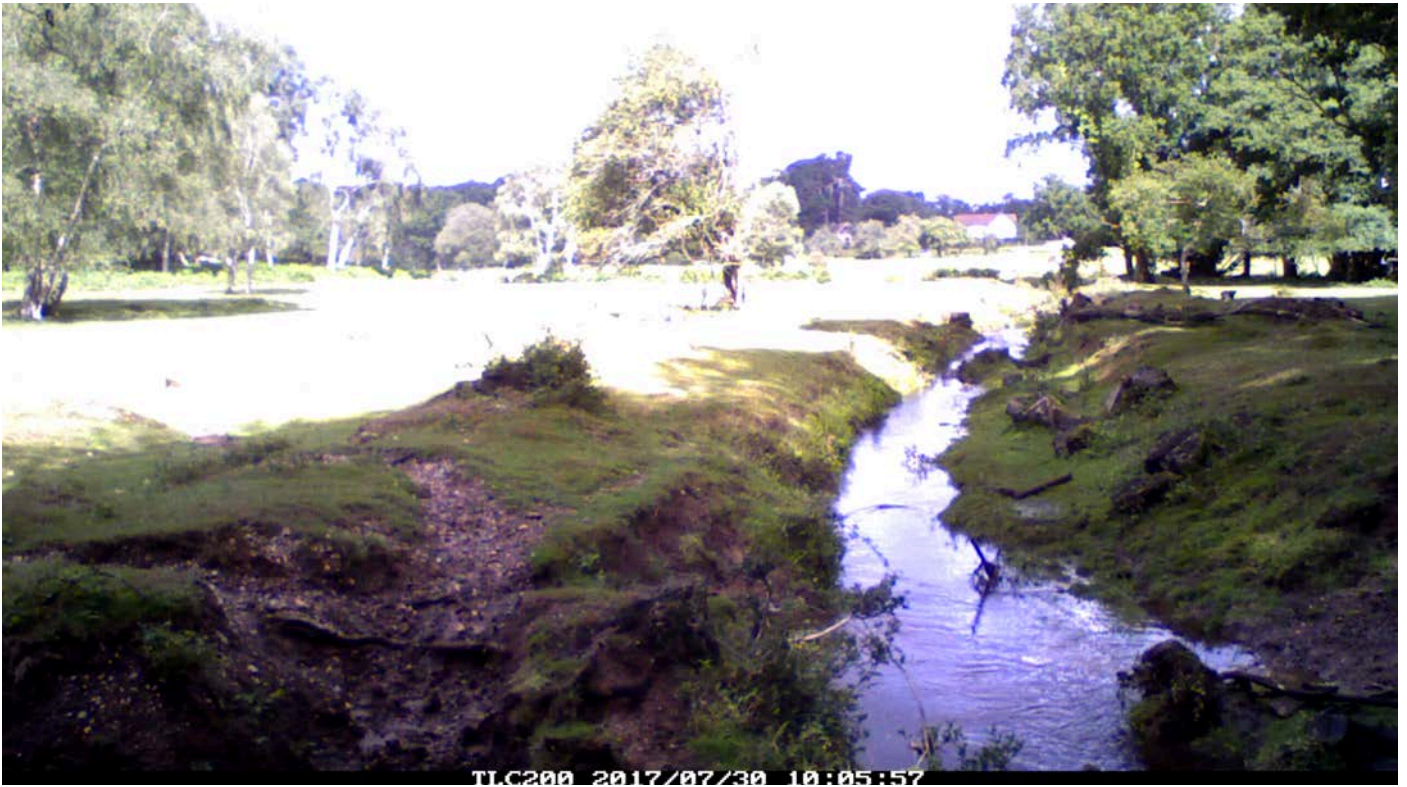
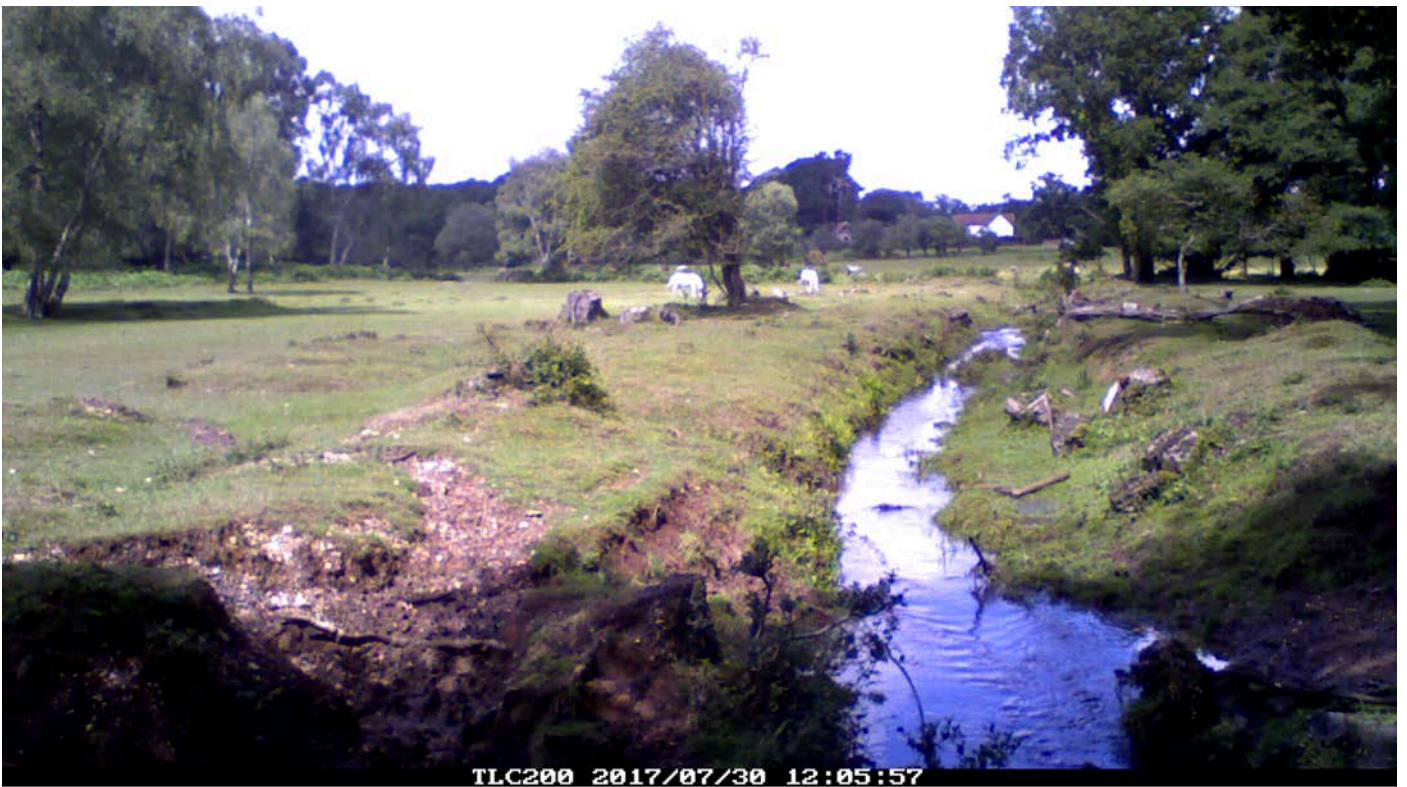
Camera 3 - Confluence

Footage for Camera 3 shows that there is little or no change to water levels within the channel during the day of the 29th July but by first light on the 30th July water levels have risen noticeably, potentially by several centimetres but the channel is still well within its banks.

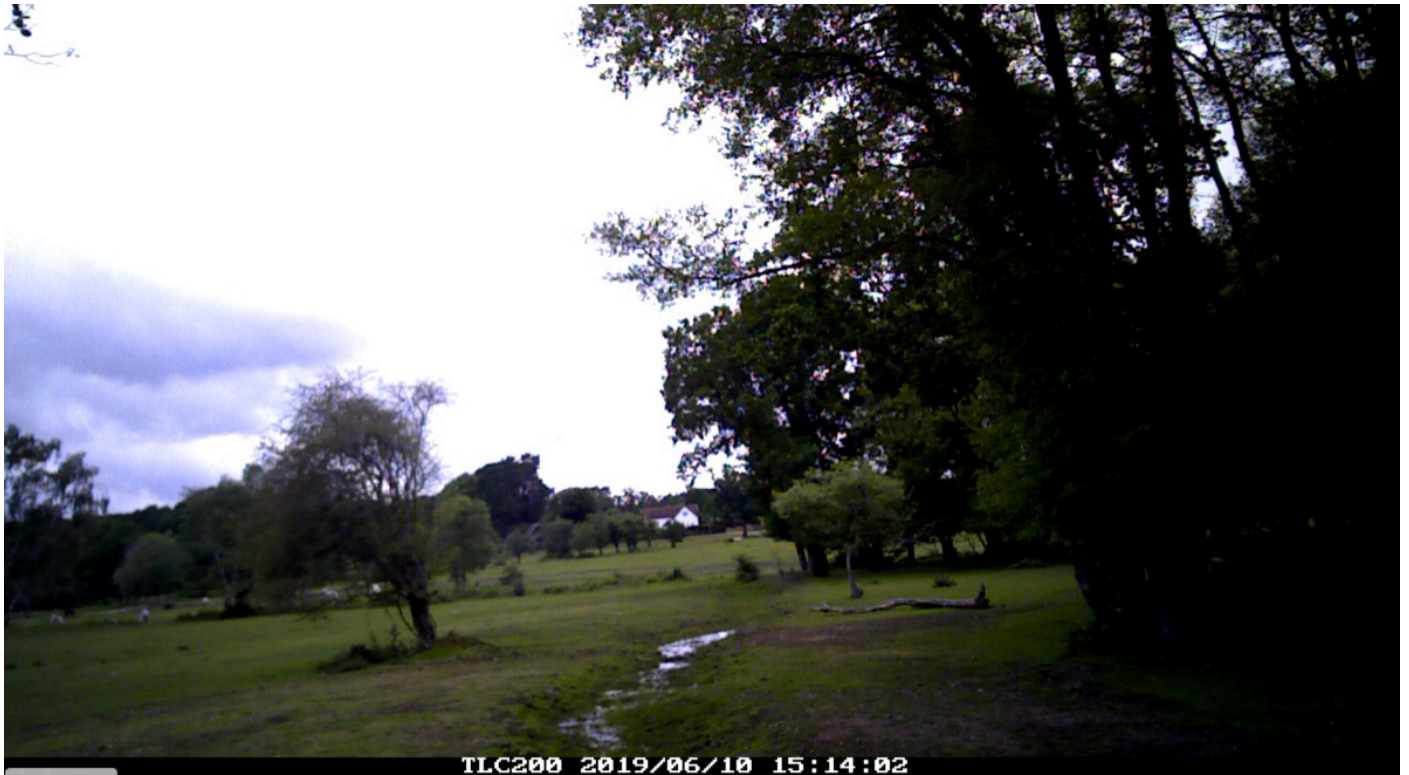
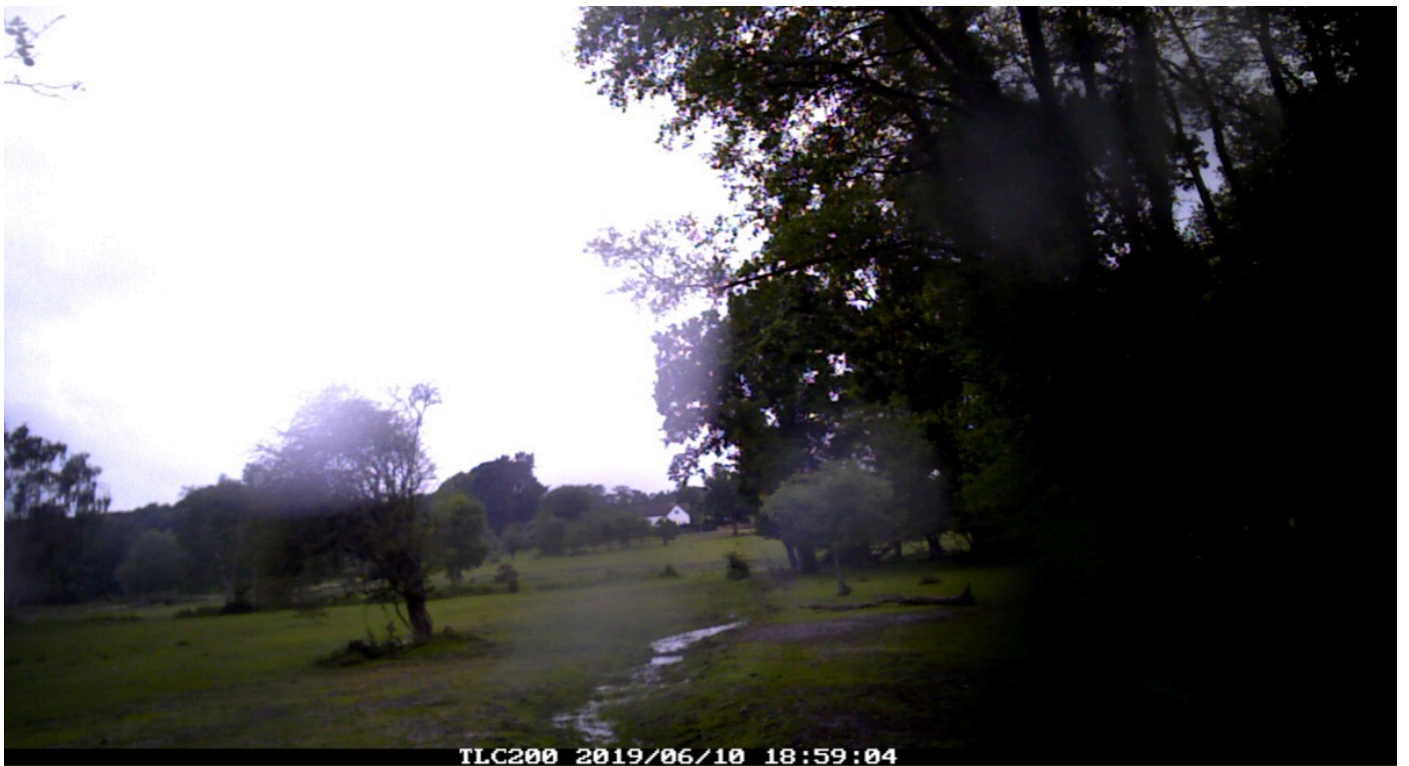
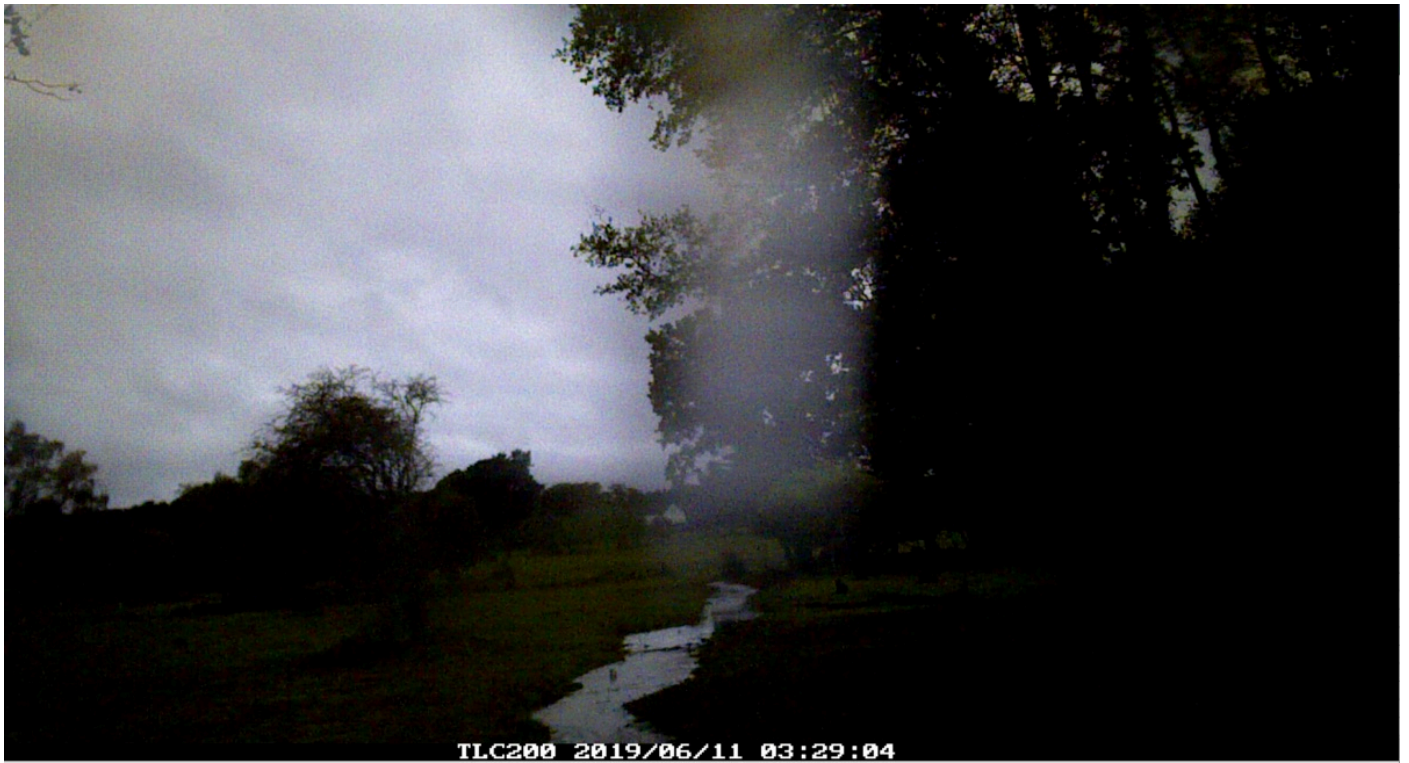
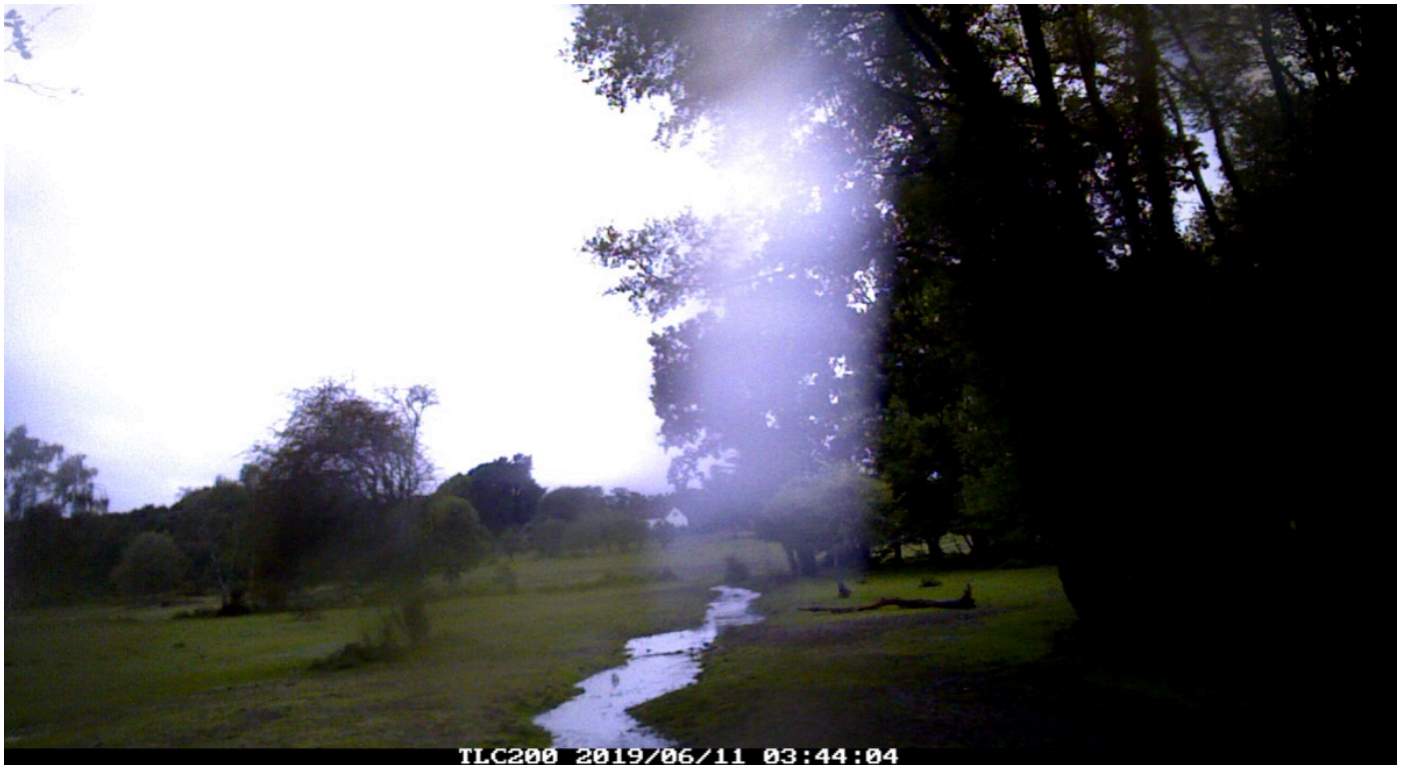
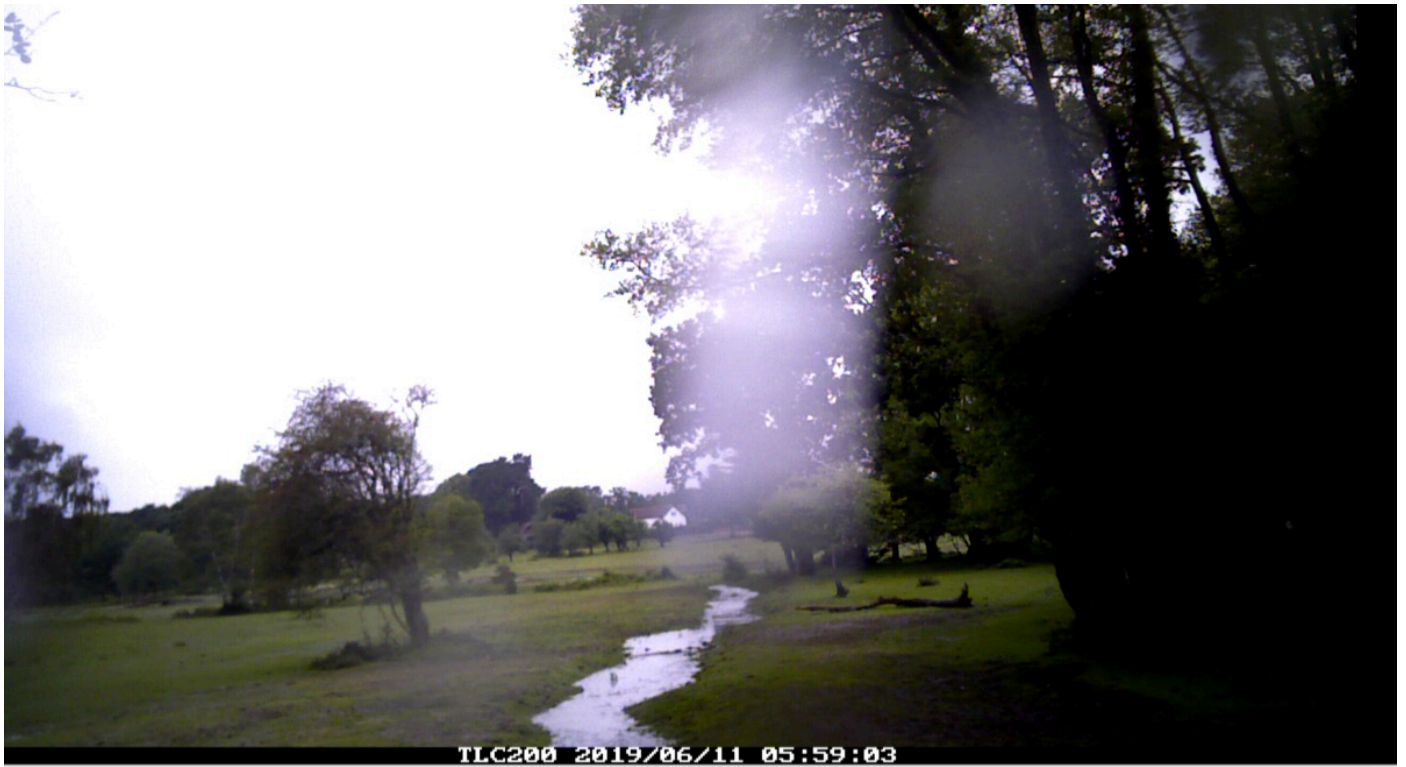
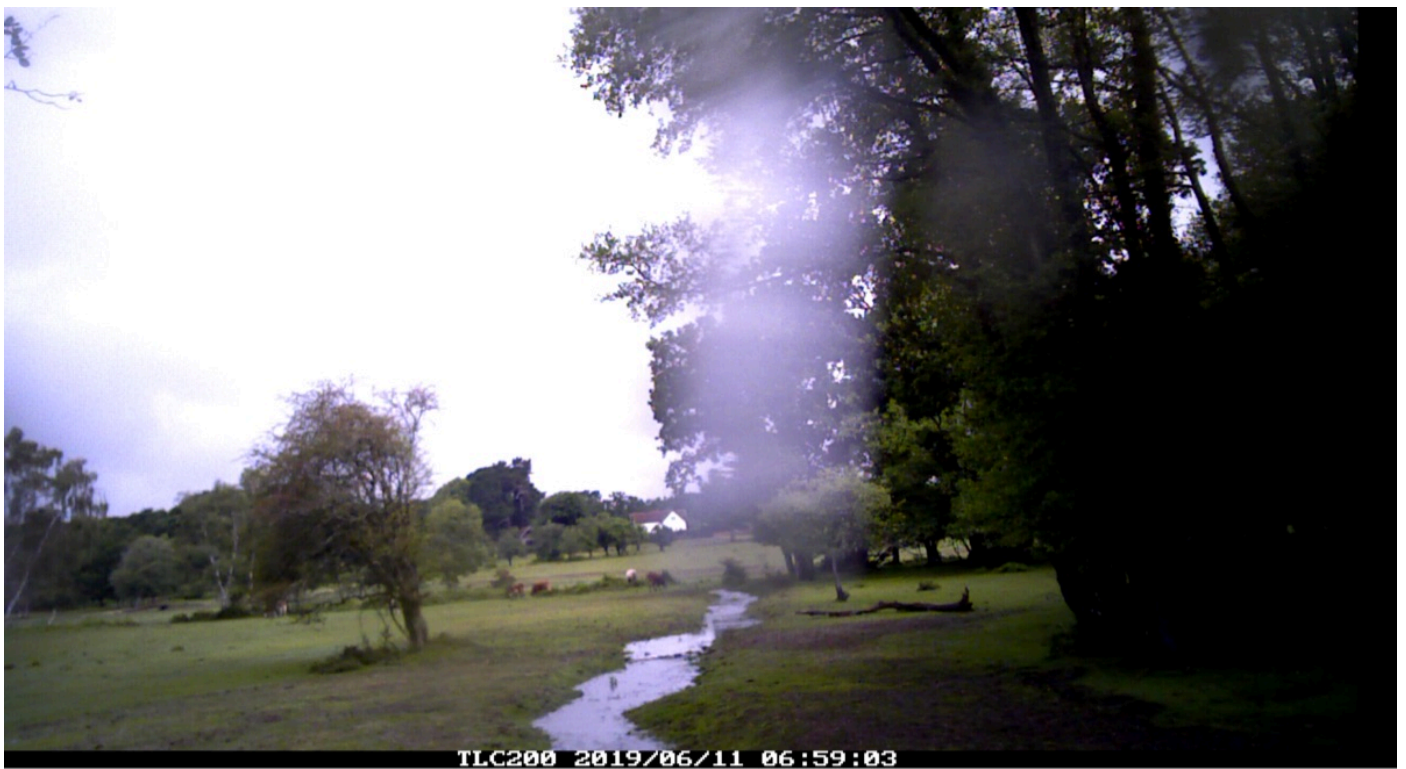
Camera 3 – Confluence

Camera 3 which shows the channel has undergone bed-level raising also shows a similar response to the pre-restoration event with the channel showing little response to the early part of the rainfall event with no significant change before nightfall of the 10th June. However, by first light at 03:29 in the morning water levels have risen to almost bank full and are stay up close to those levels until at least the afternoon.

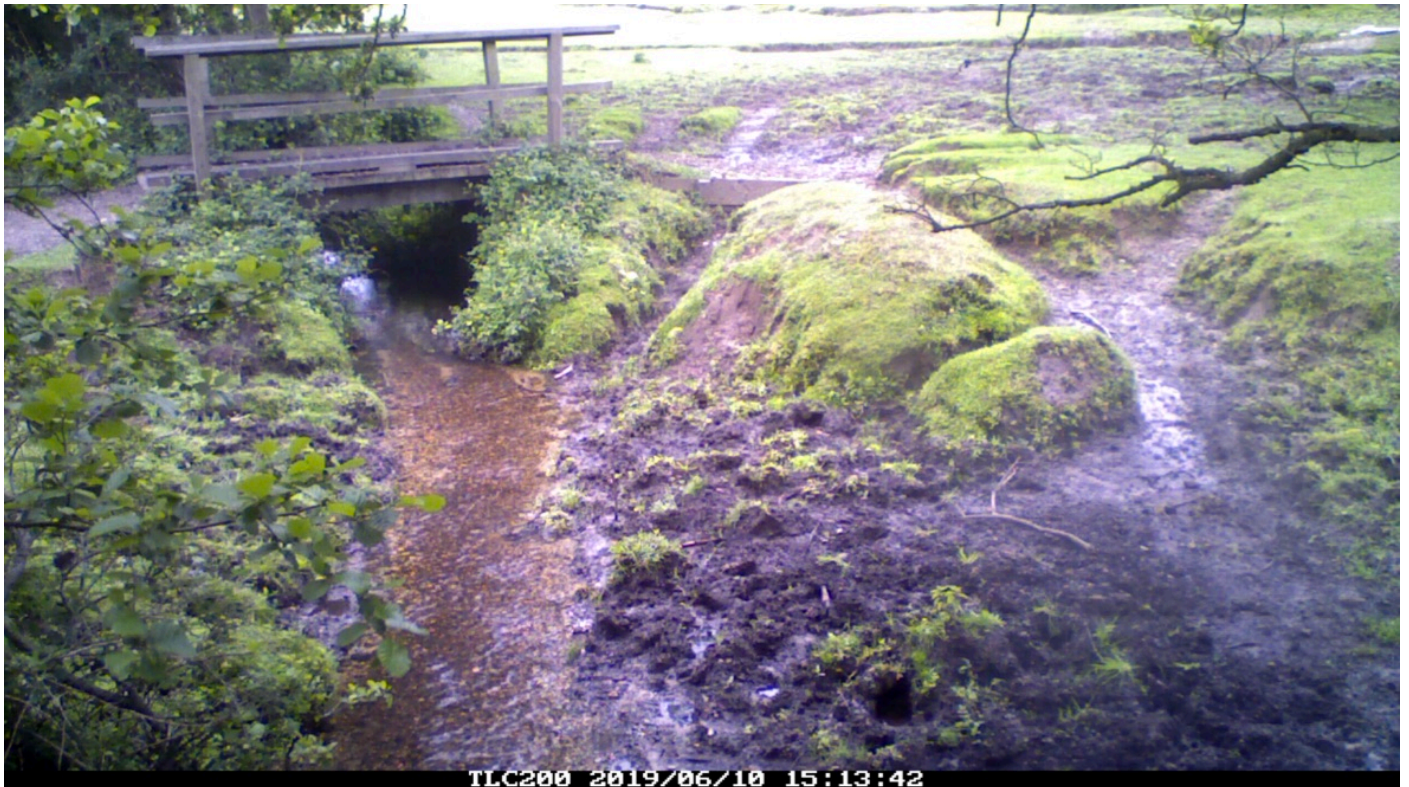
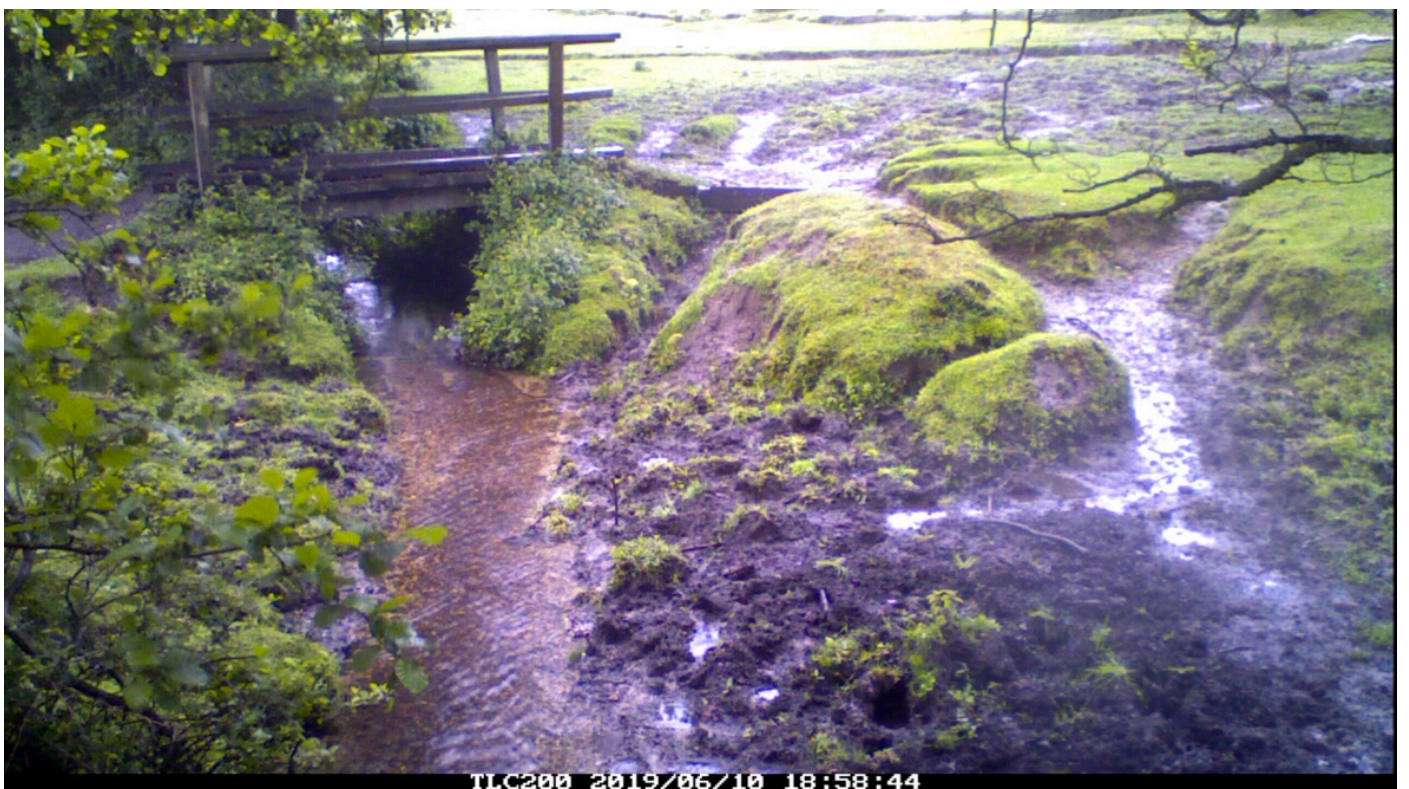
Camera 4 – Lyndhurst Drain

Camera 4 again shows little response within the Lyndhurst to the rain during the 10th June but by first light on the 11th June at 04:04 levels are significantly higher than the previous evening although the water is still in bank at the bridge. Within a couple of hours at 06:04 hours water levels are starting to subside and continue to do so as shown in images for 09:04 and 12:04 hours. By 12:04 hours water levels only appear to be a few centimetres higher than the previous day.
