3. Restoration of Hydrological Function and Reconnection with the Floodplain

3.2 Restoration Objectives

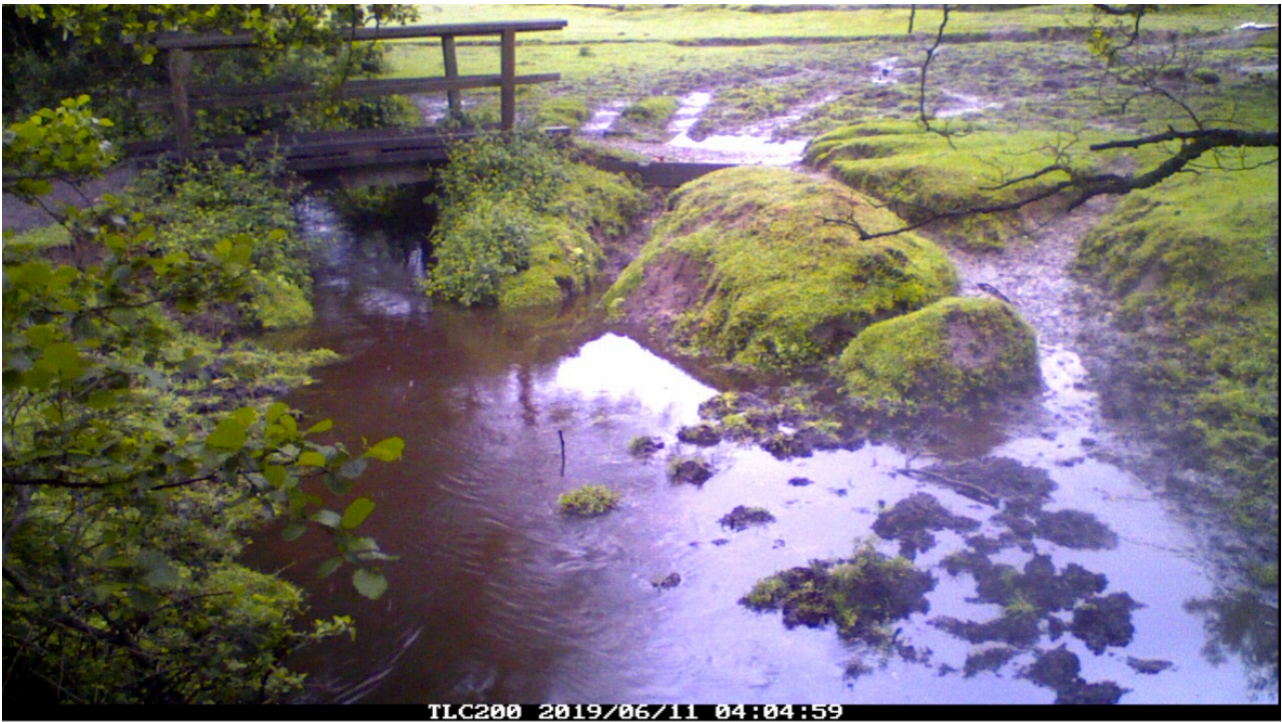
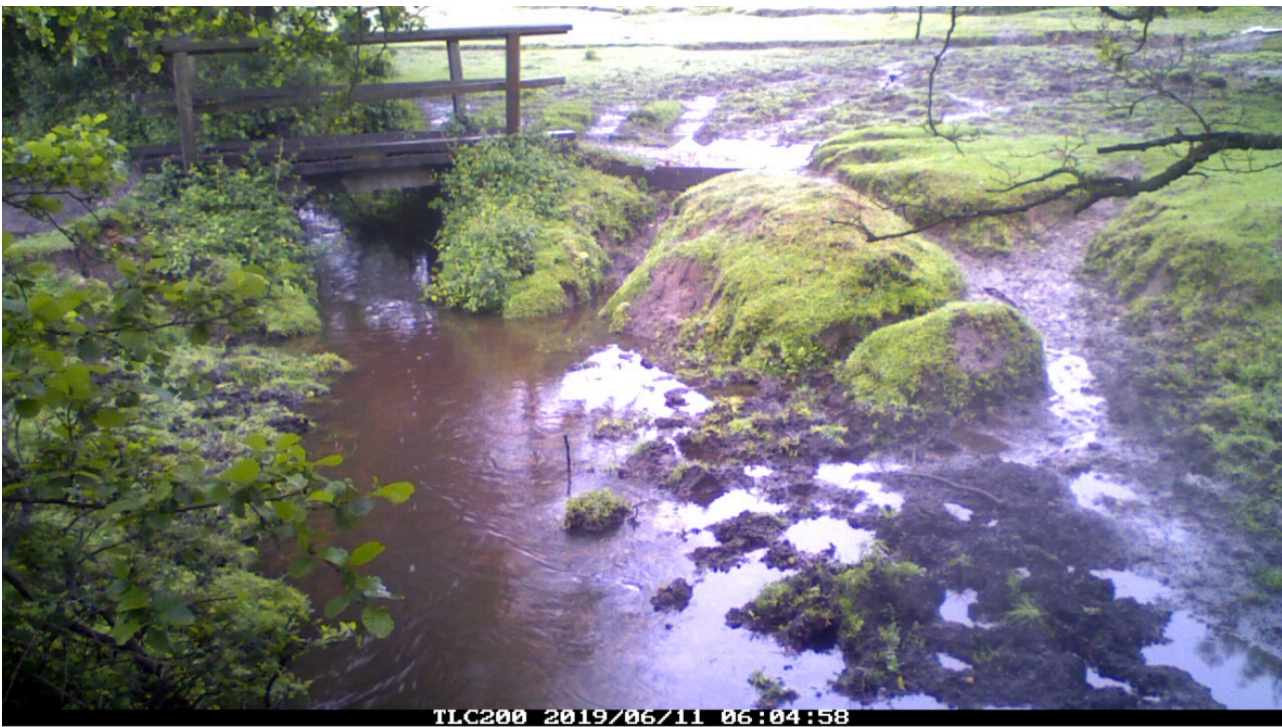
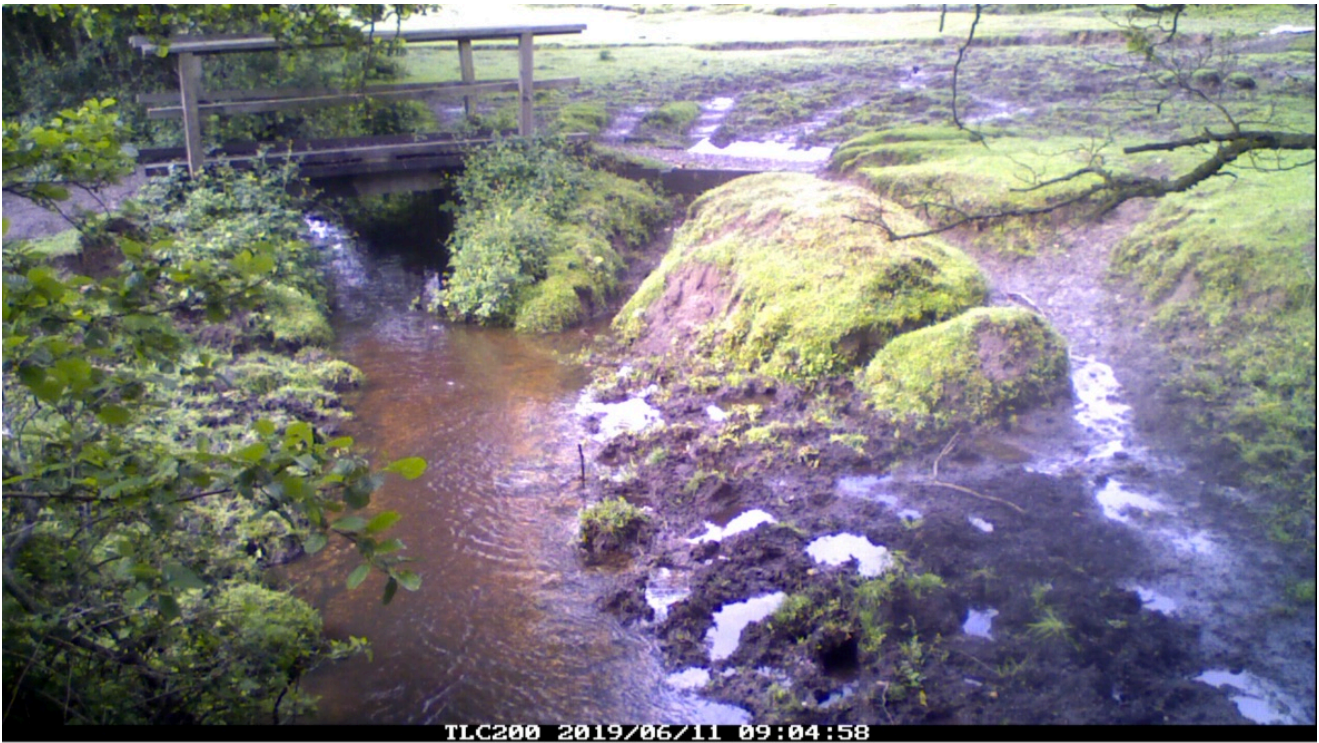
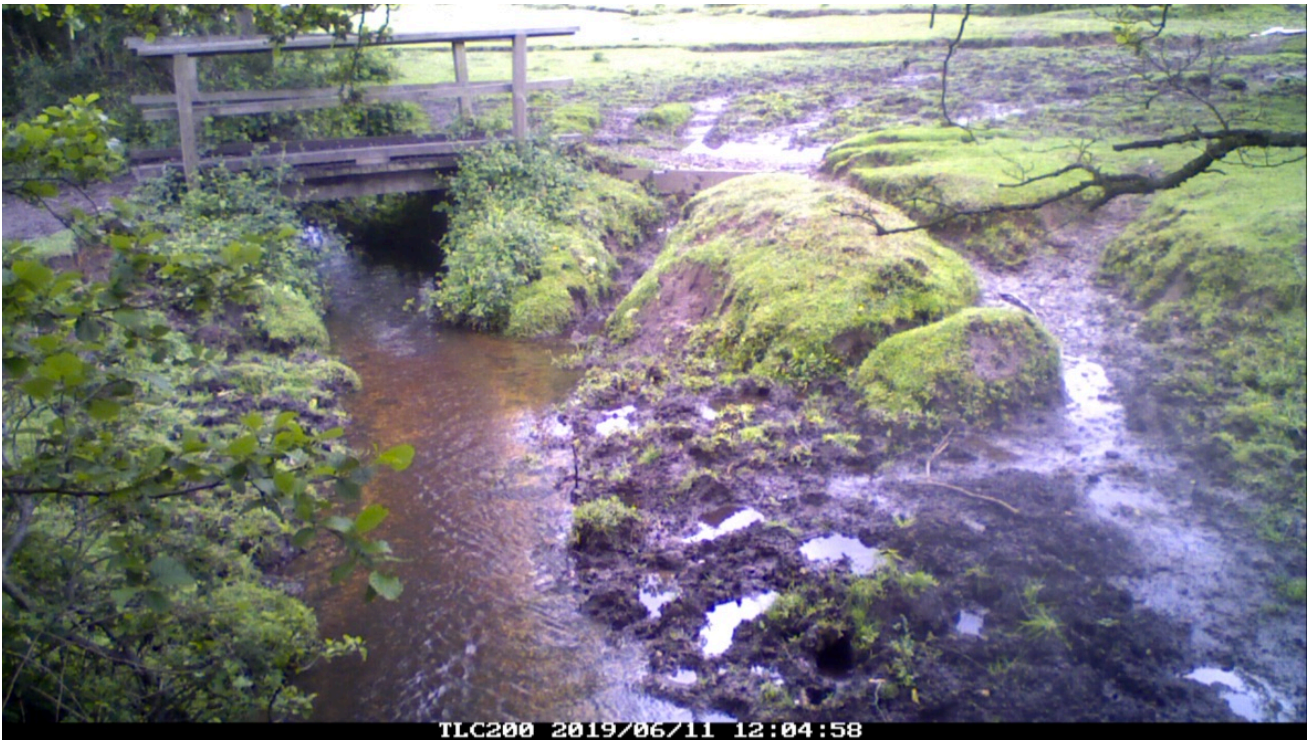
Camera 4 – Lyndhurst Drain

Camera 4 again shows little response within the Lyndhurst to the rain during the 10th June but by first light on the 11th June at 04:04 levels are significantly higher than the previous evening although the water is still in bank at the bridge. Within a couple of hours at 06:04 hours water levels are starting to subside and continue to do so as shown in images for 09:04 and 12:04 hours. By 12:04 hours water levels only appear to be a few centimetres higher than the previous day.

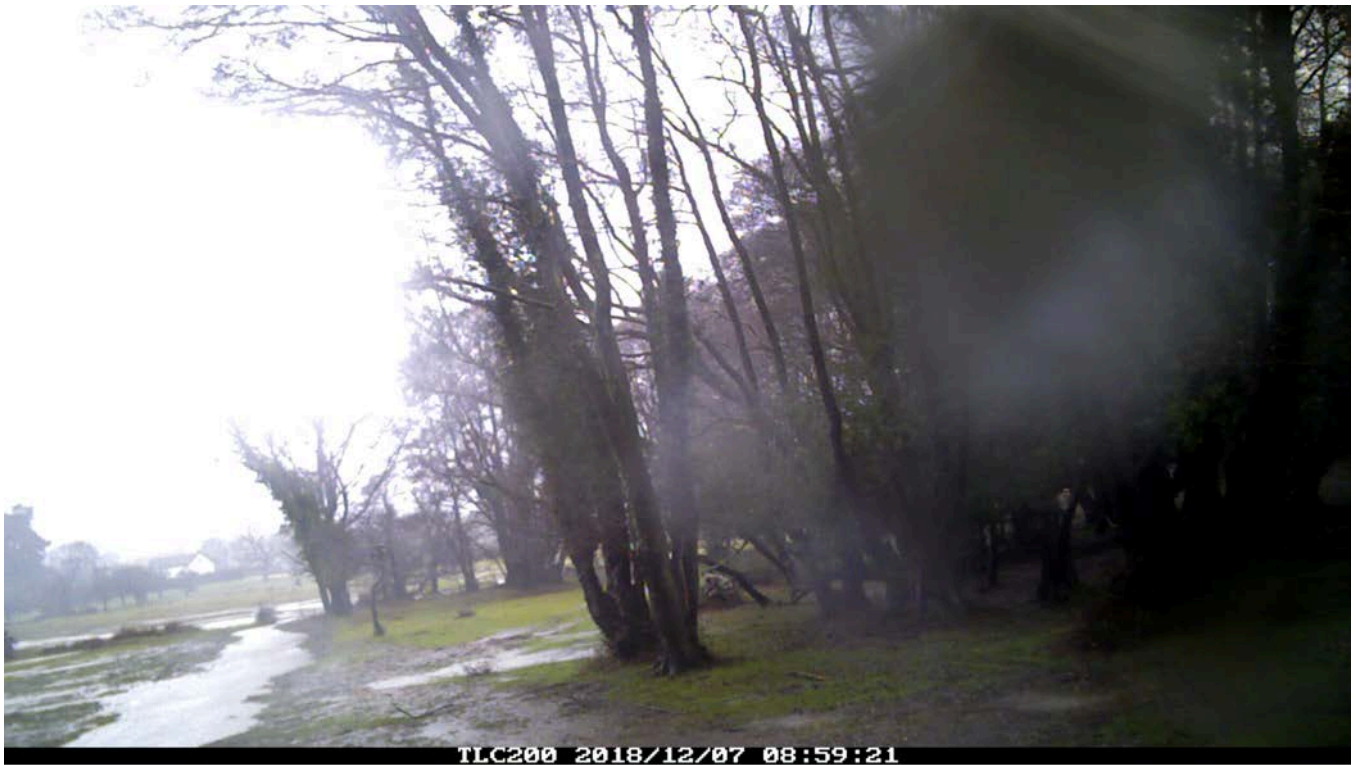
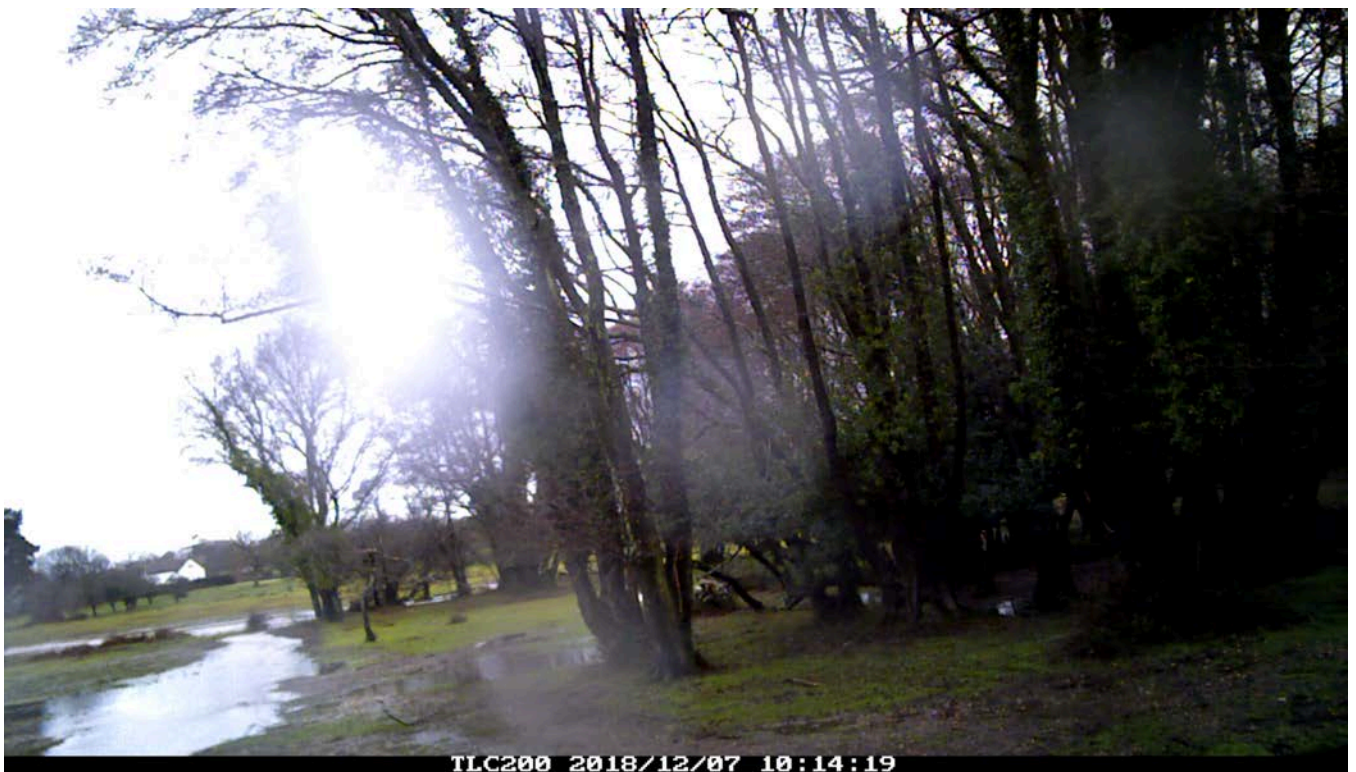
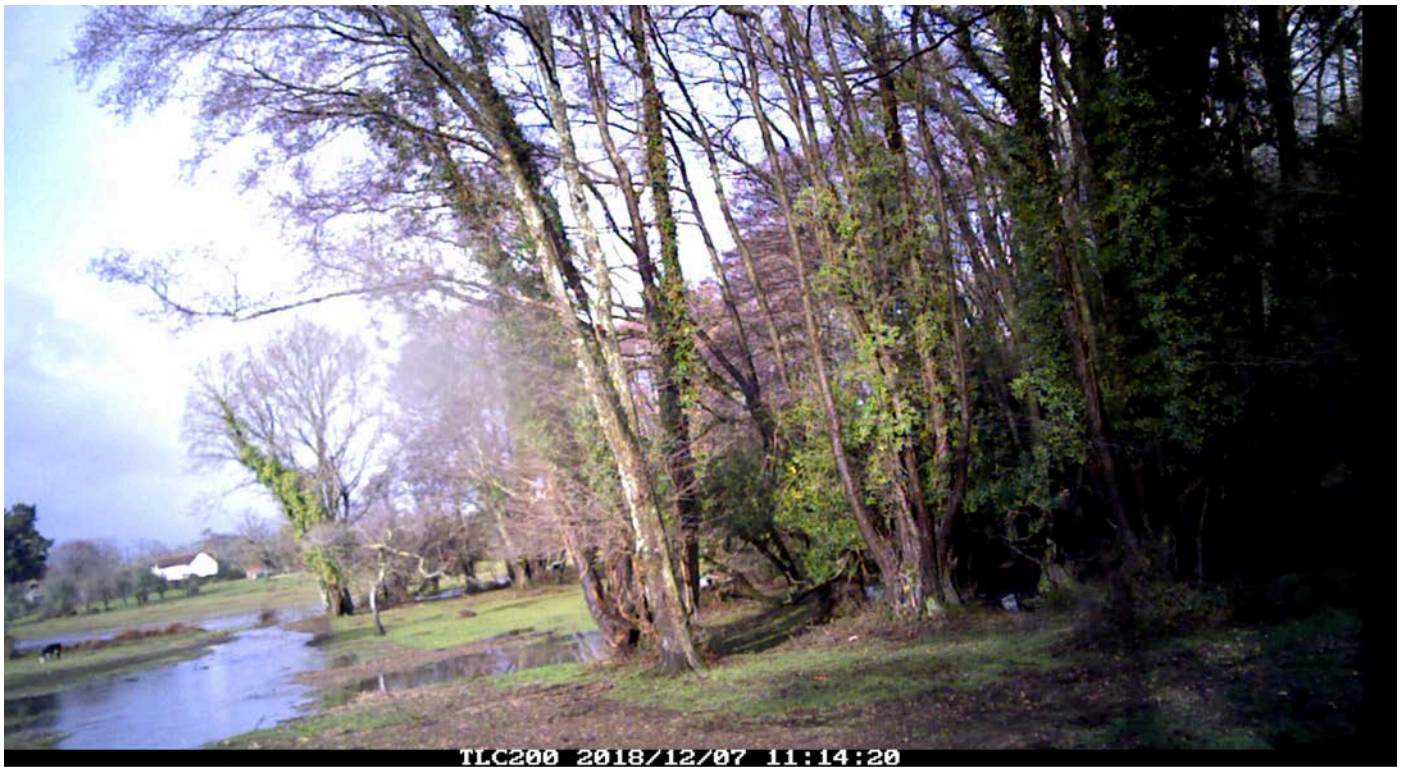
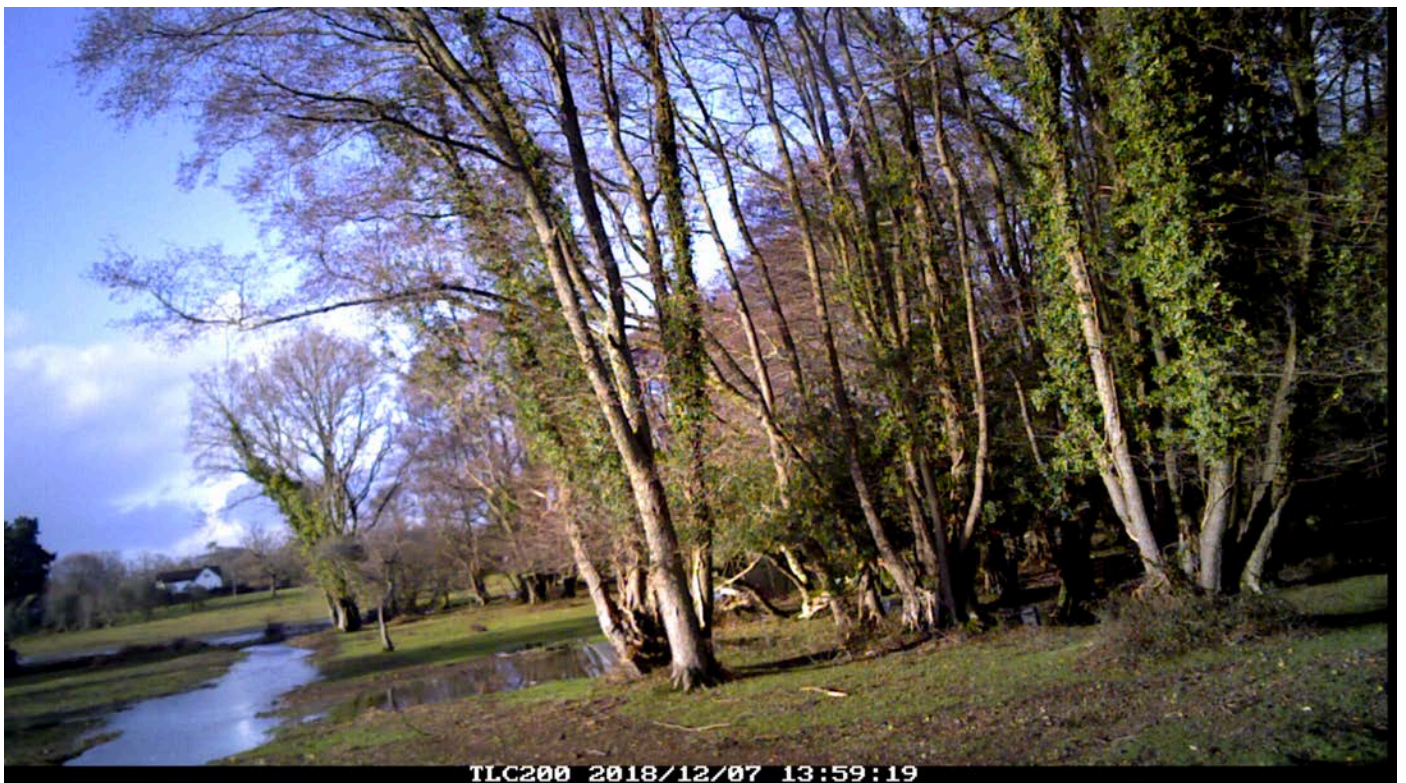
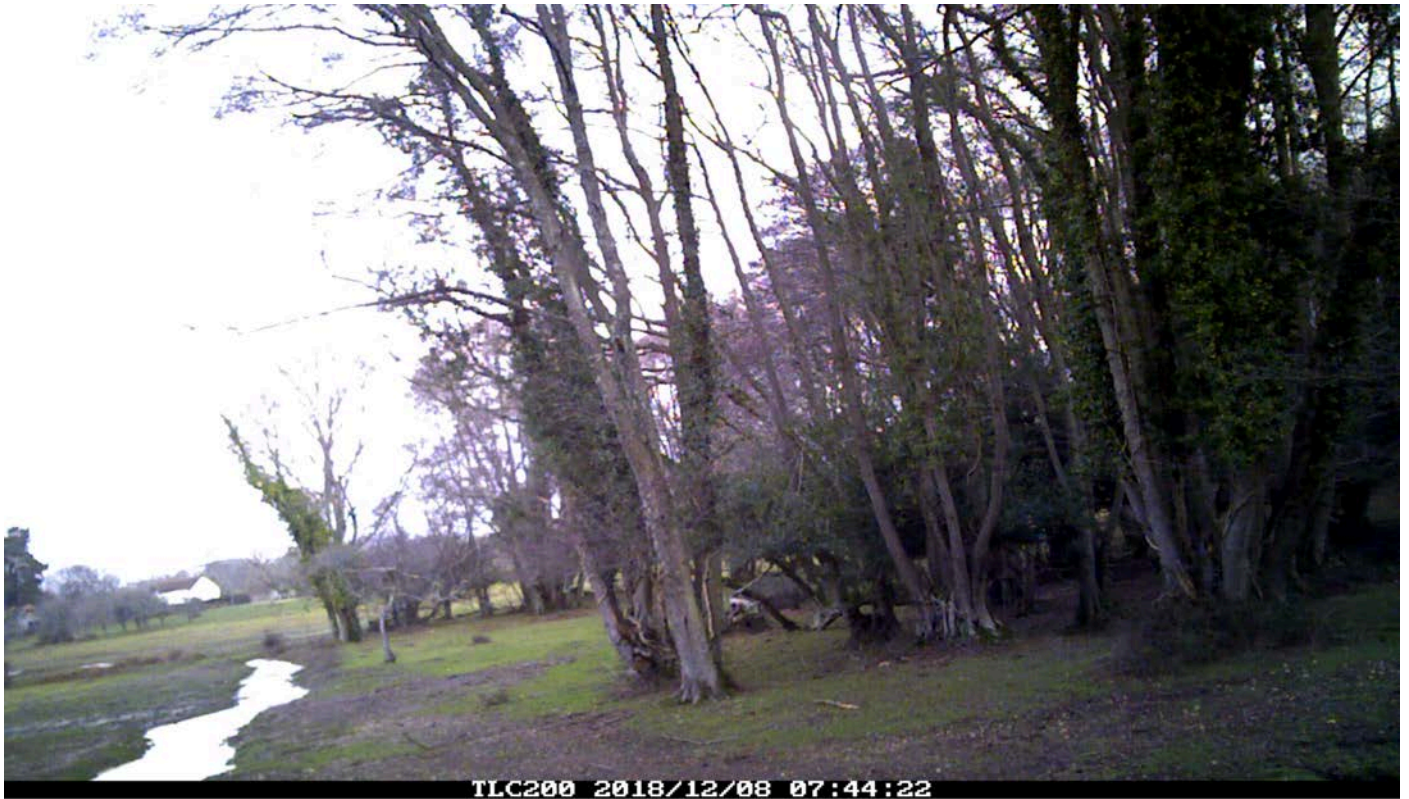
Pondhead Camera 3 - Confluence

With multiple timelapse cameras in place at the same time on both unrestored and restored river sections it is possible to visually compare the difference in responses of these sections to the same rainfall event to determine how different rivers are interacting with their floodplain. An event on 7th December, 2018 recorded 21.8mm of rain falling at the Southampton Weather Station which is similar in size to the events documented above (Figure 3.11). On the 7th of December, 2018, timelapse cameras were active at Wootton (Phase 1 East, Sheepwash Lawn and downstream of Sheepwash Lawn), Pondhead and Millersford and visually record how the rivers and streams reacted.

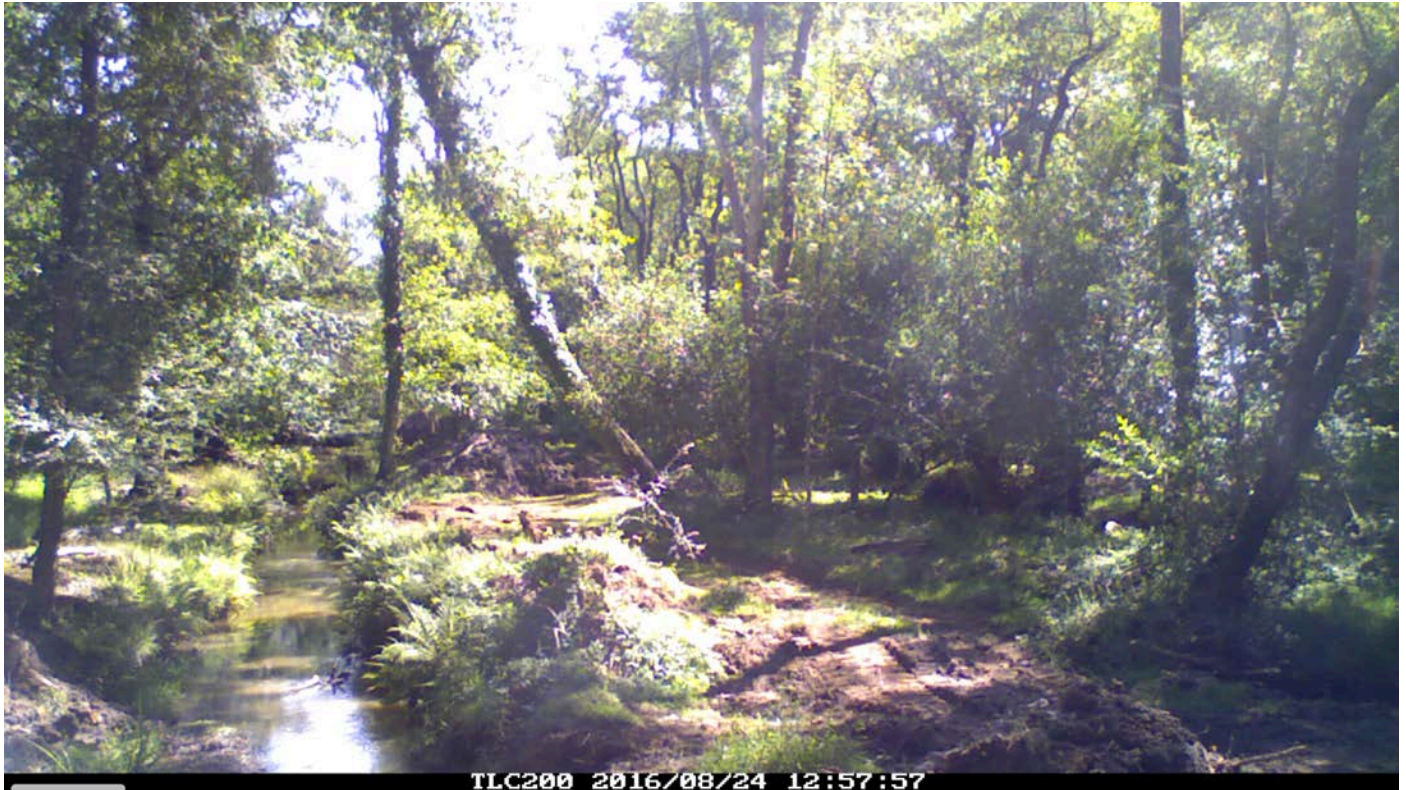
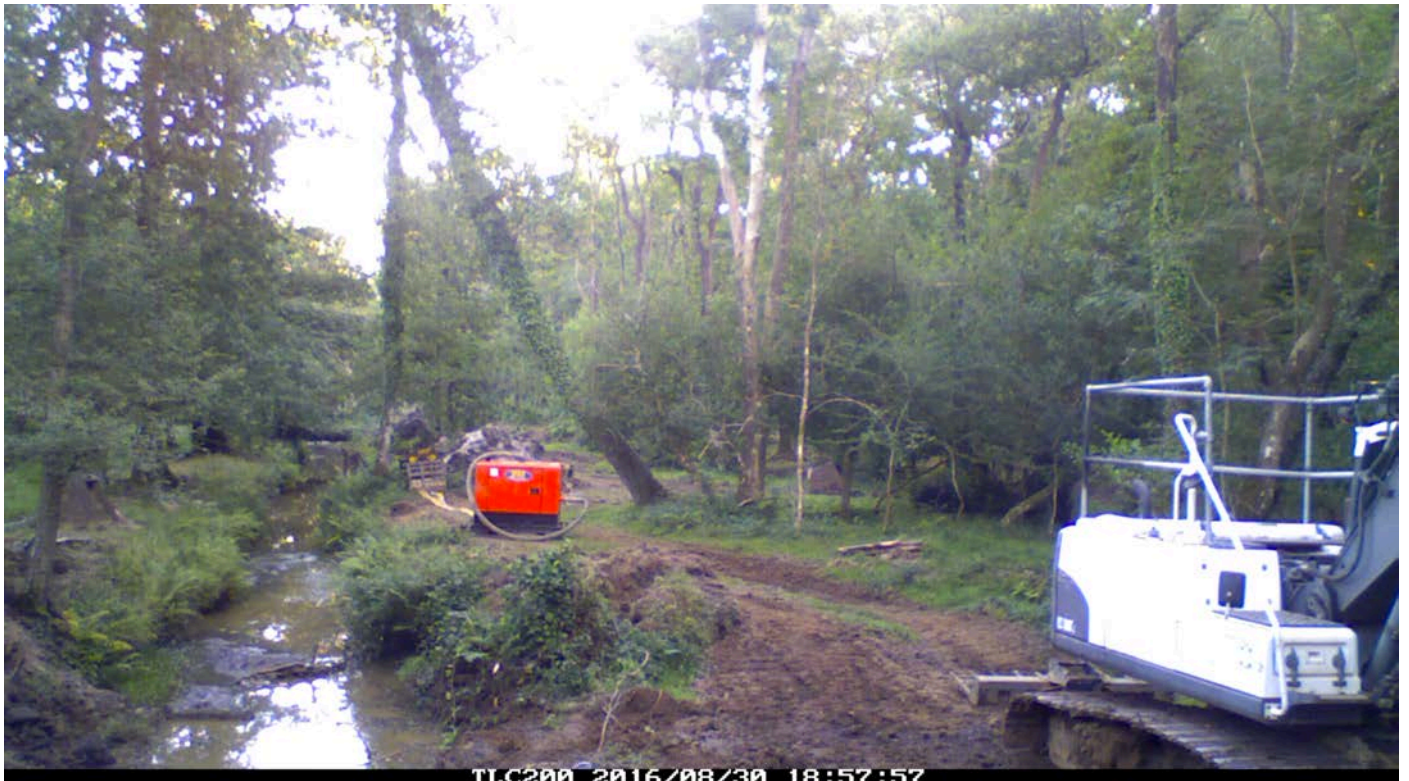
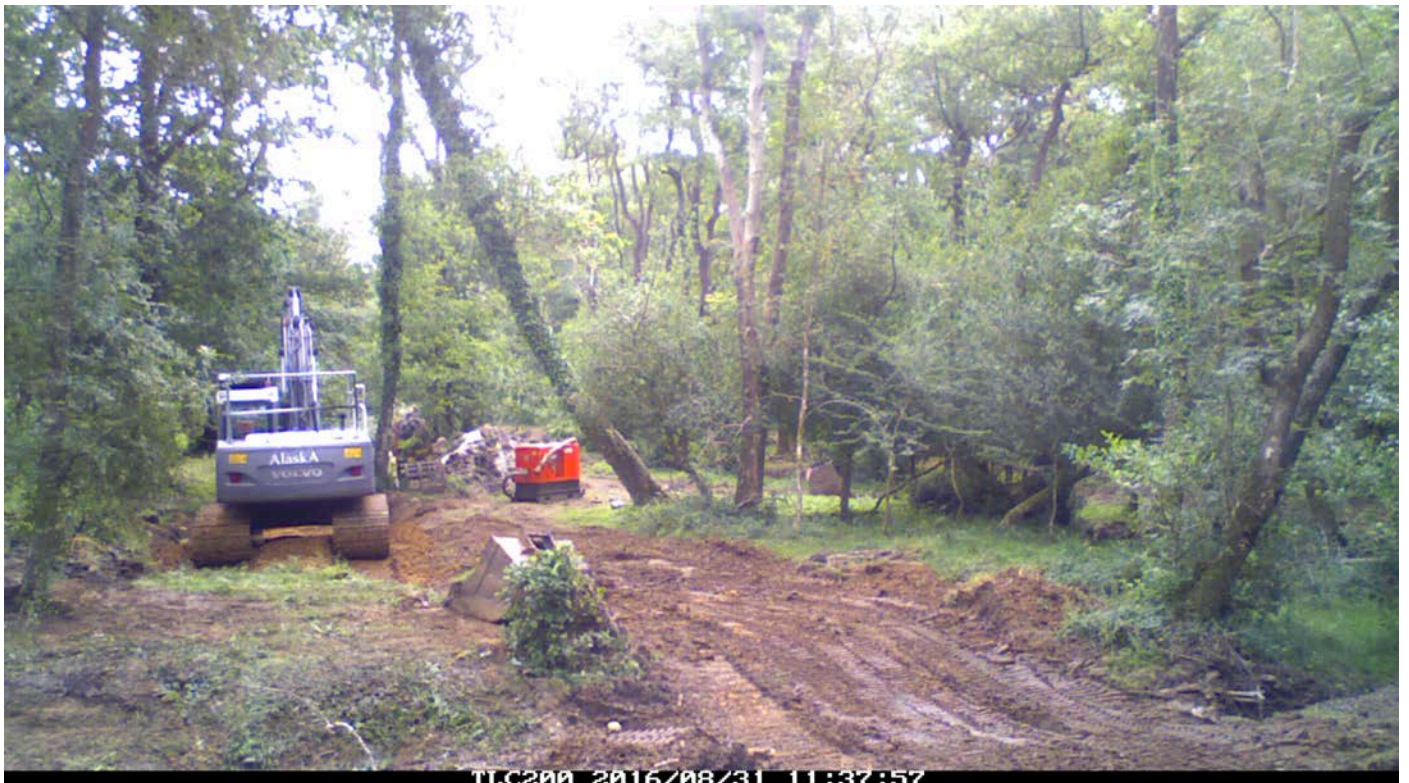
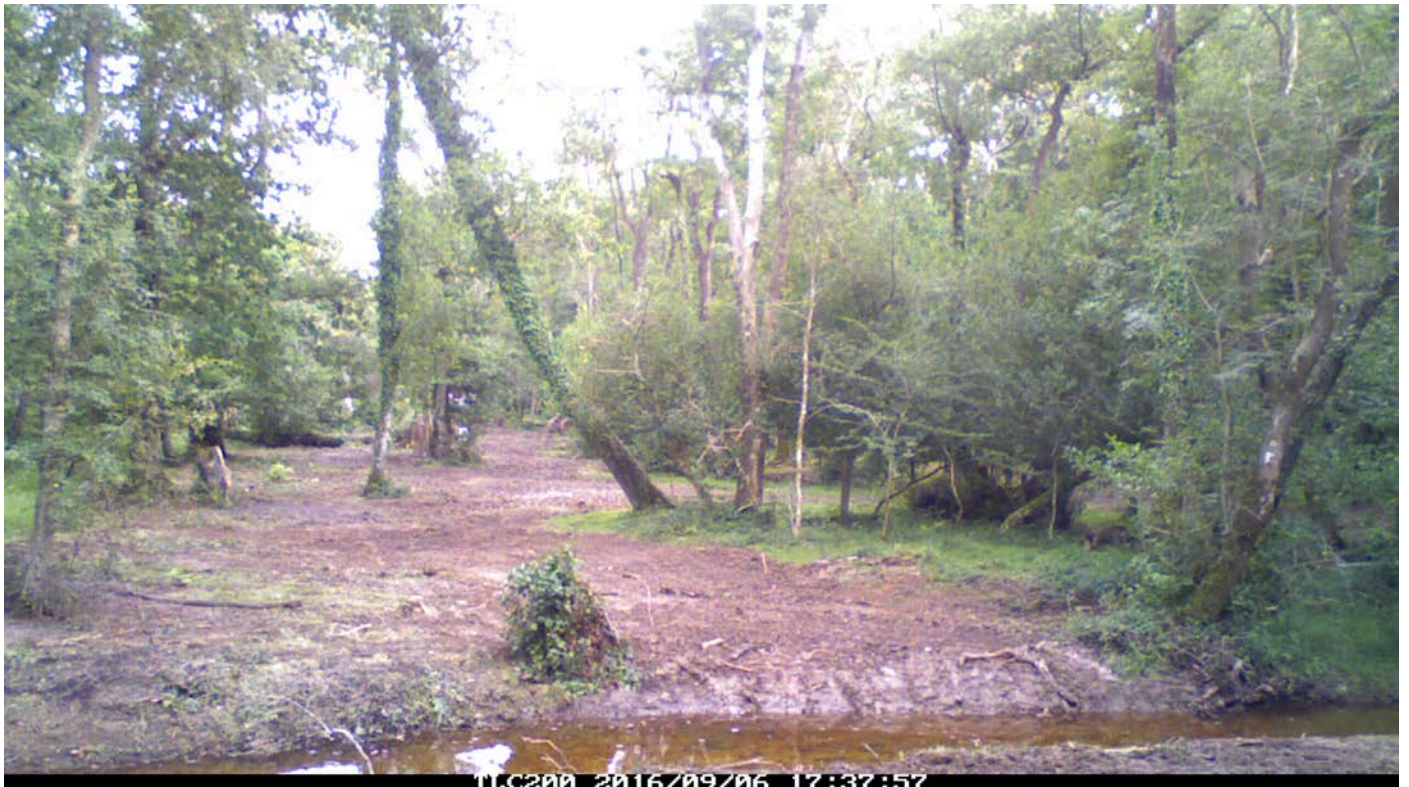
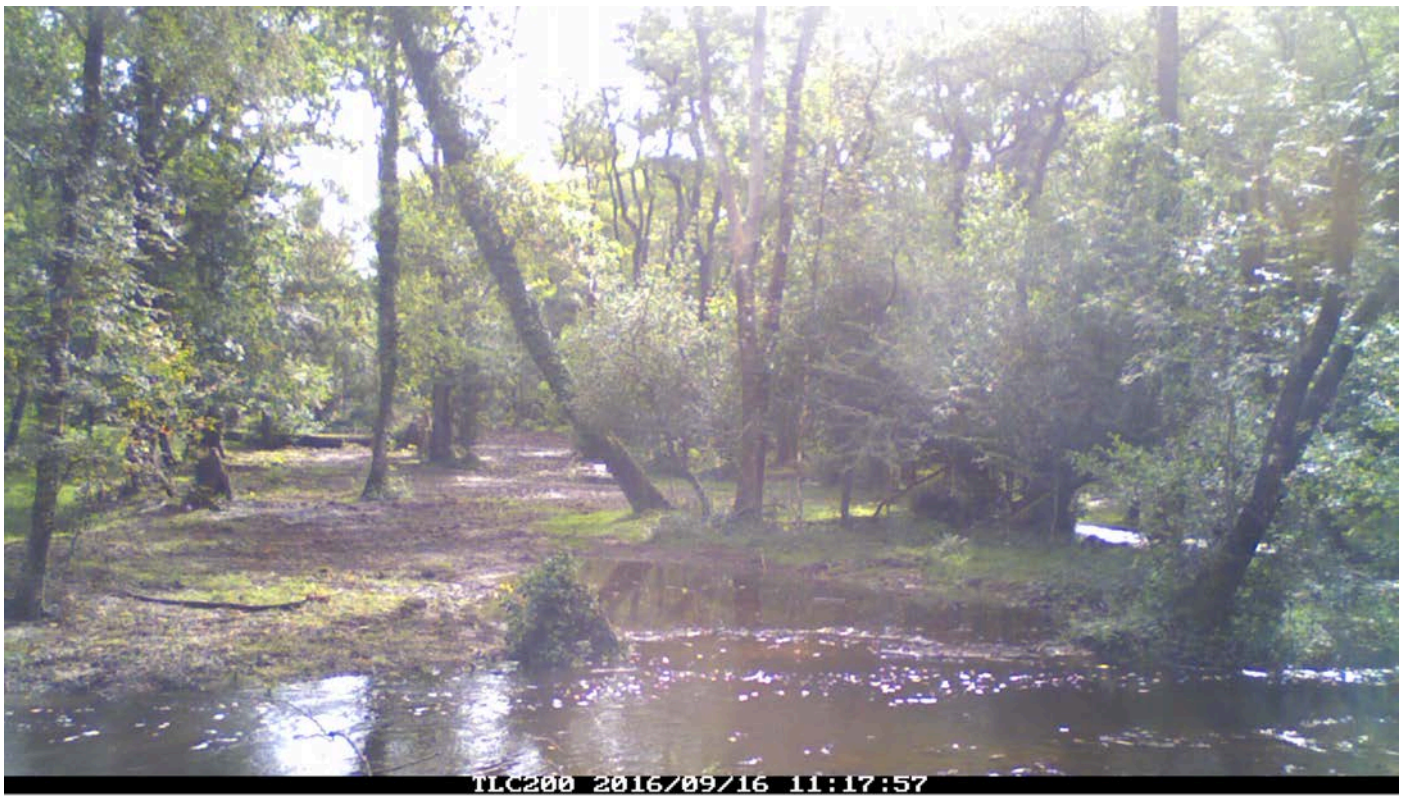
3.5.6 Wootton Phase 1 – Camera 1 (Same location as Wootton Camera 2 but facing the old infilled channel)

Analysis of timelapse camera footage has identified some interesting footage from Wootton Phase 1 when the camera was initially sited facing the straightened channel. The following images capture scenes from pre-restoration, restoration work in progress through to completion and the first significant flood and activation of the flood plain post restoration in the following weeks. The images capture the essence of what river restoration in the New Forest is trying to achieve.

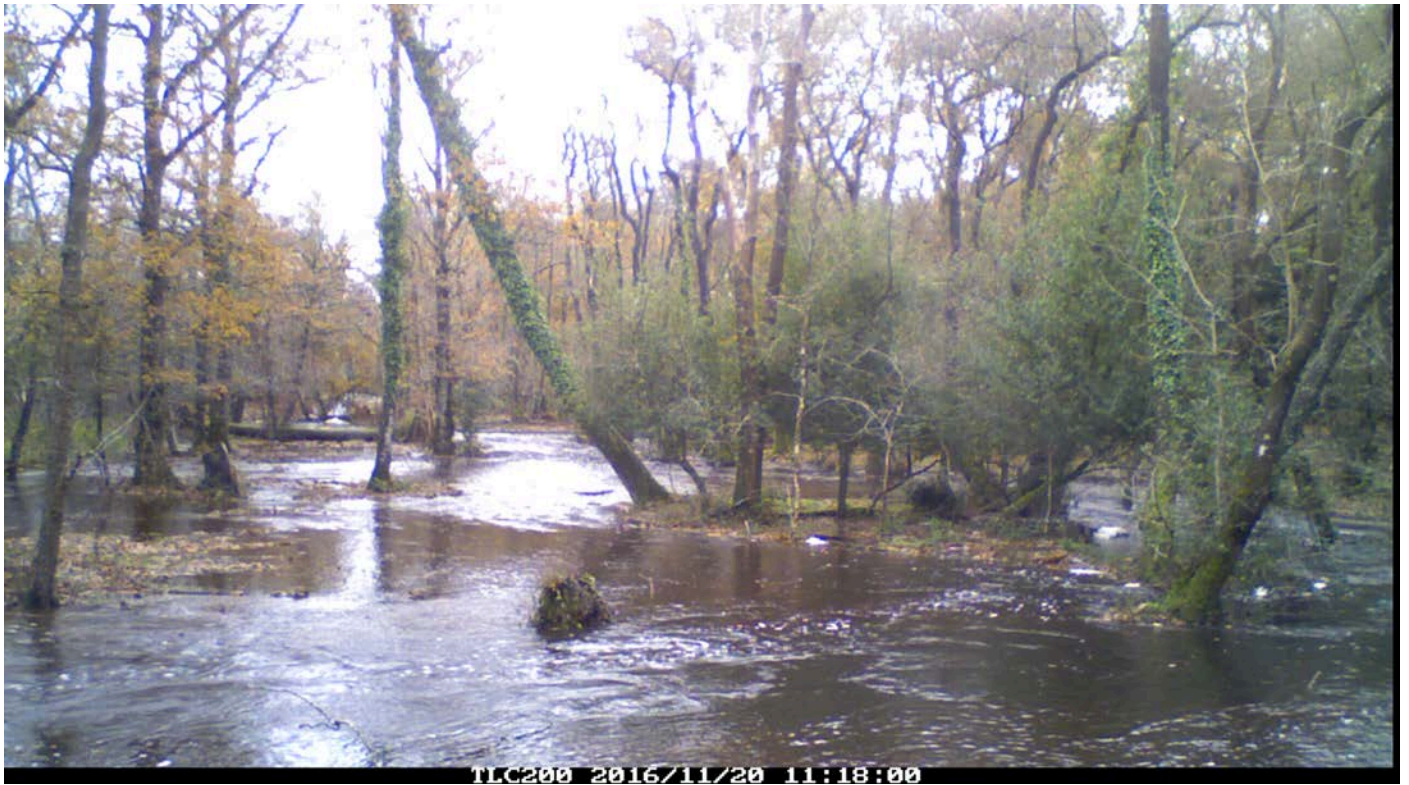
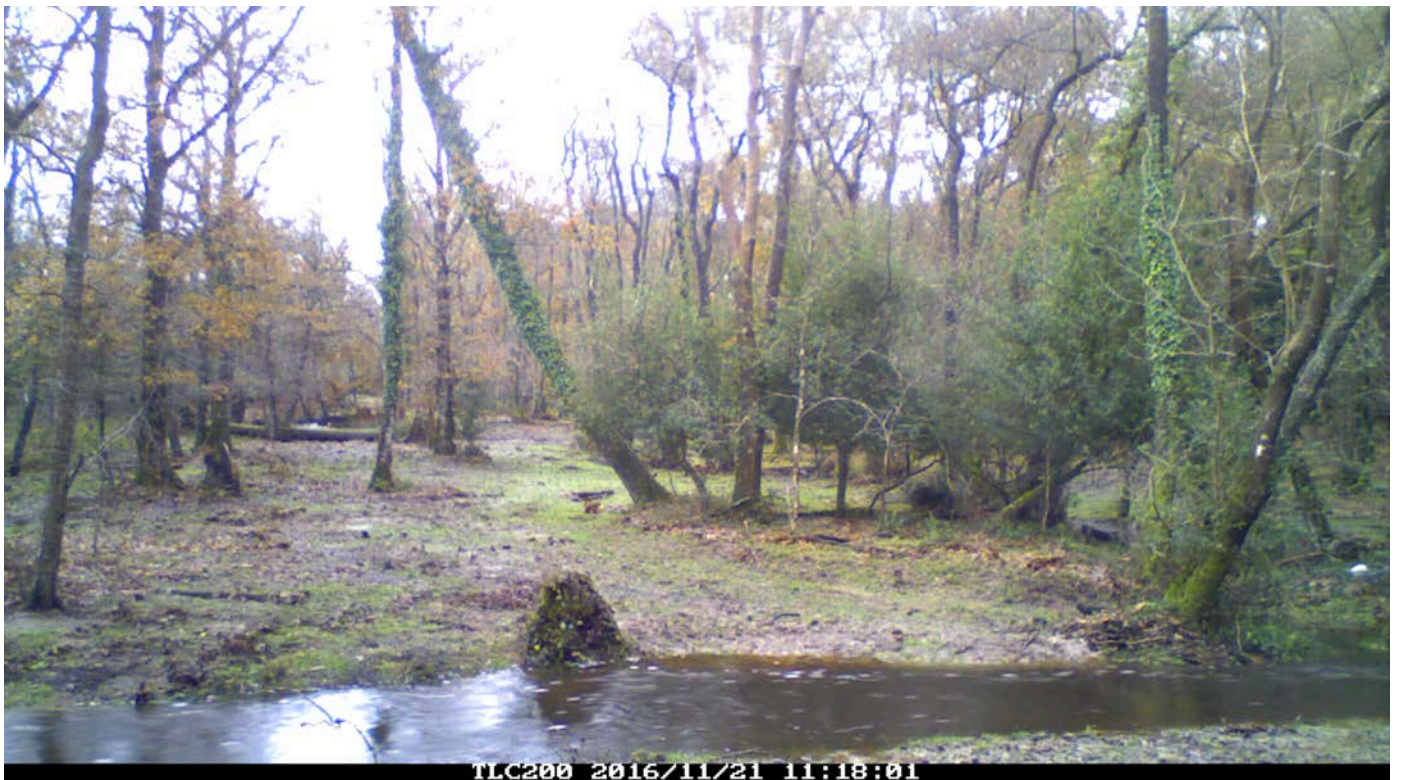
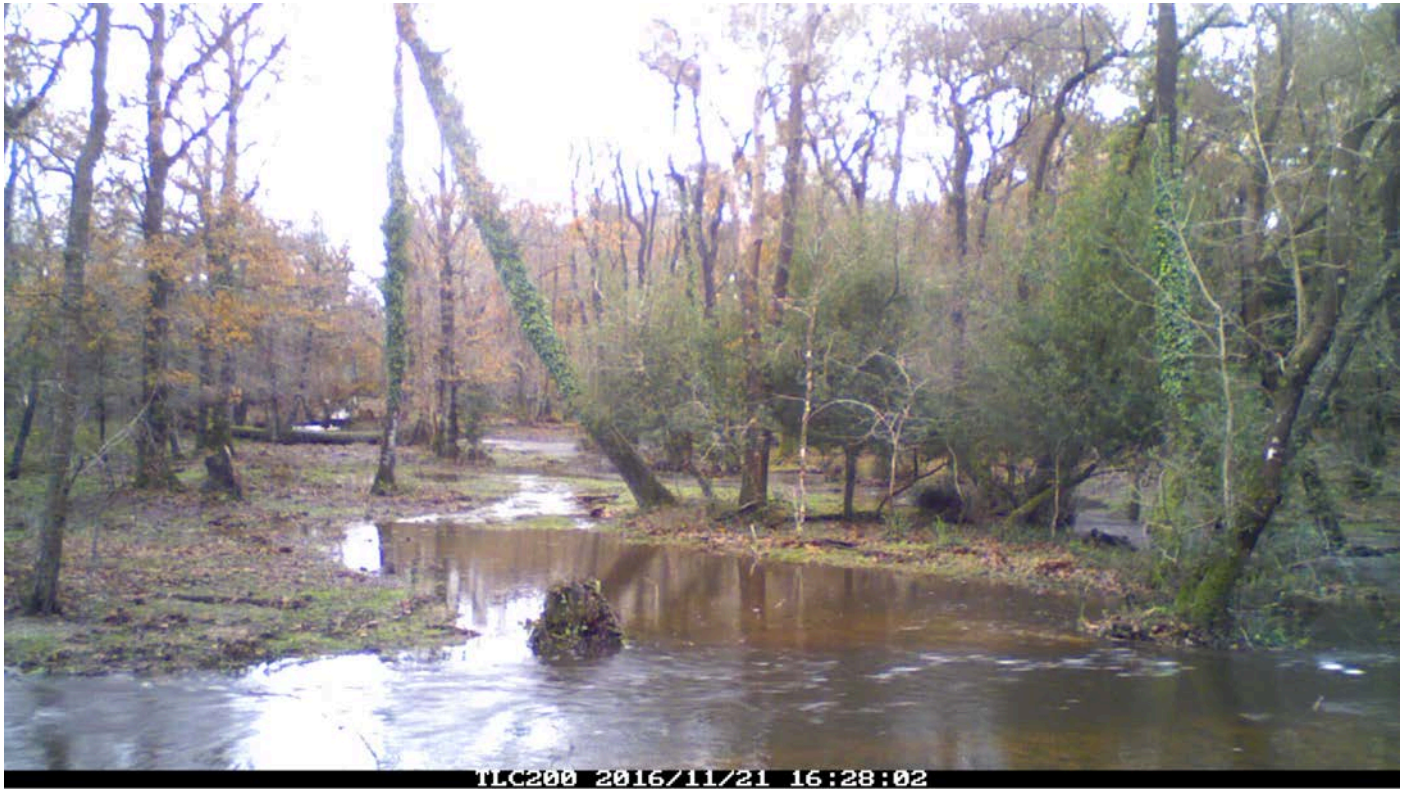
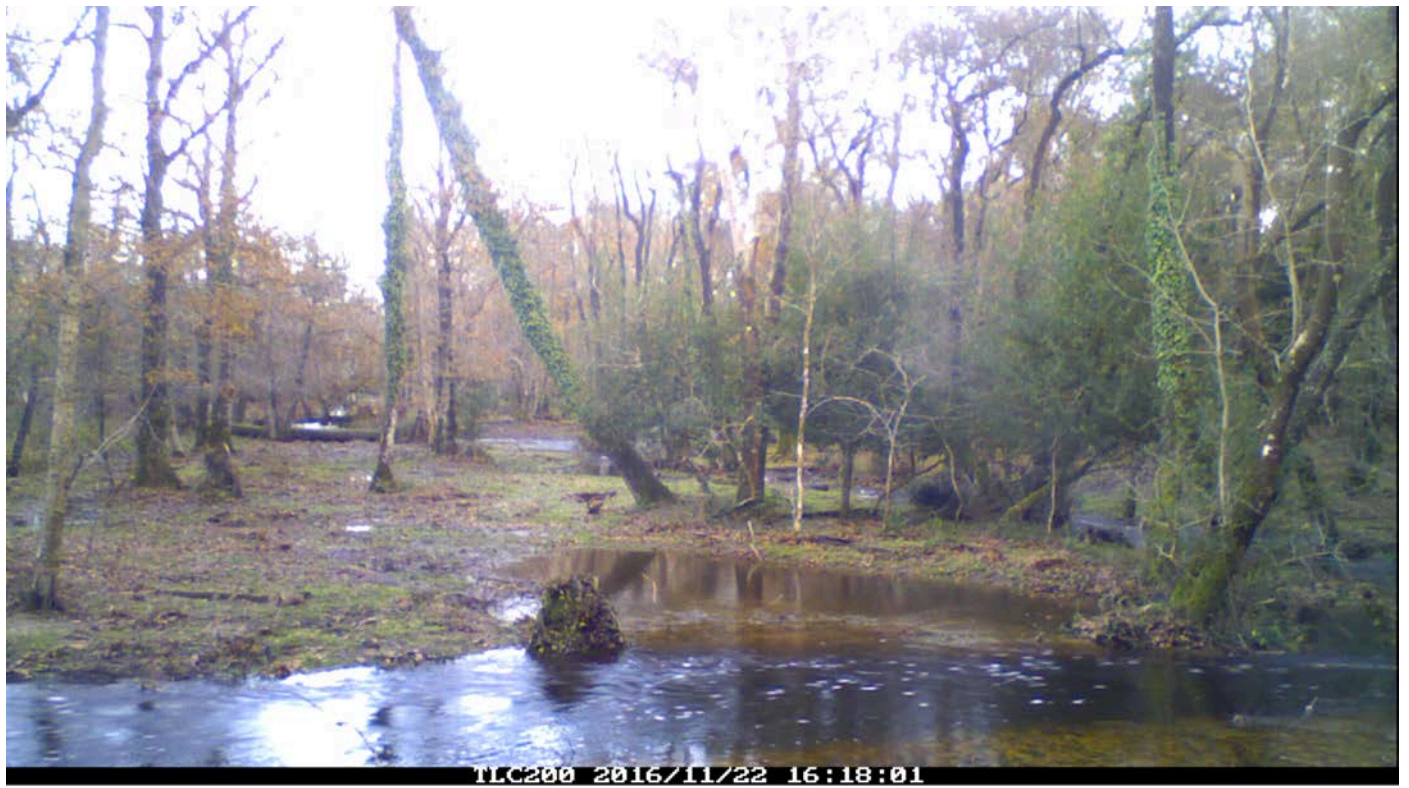
Cameras have recently been installed at unrestored sites at Amberslade and Studley Wood/Claypits. The following footage captures the behaviour of the stream at these sites during the same rainfall event of 10th/11th June,2019 analysed as part of the hydrograph logs for Pondhead post restoration.

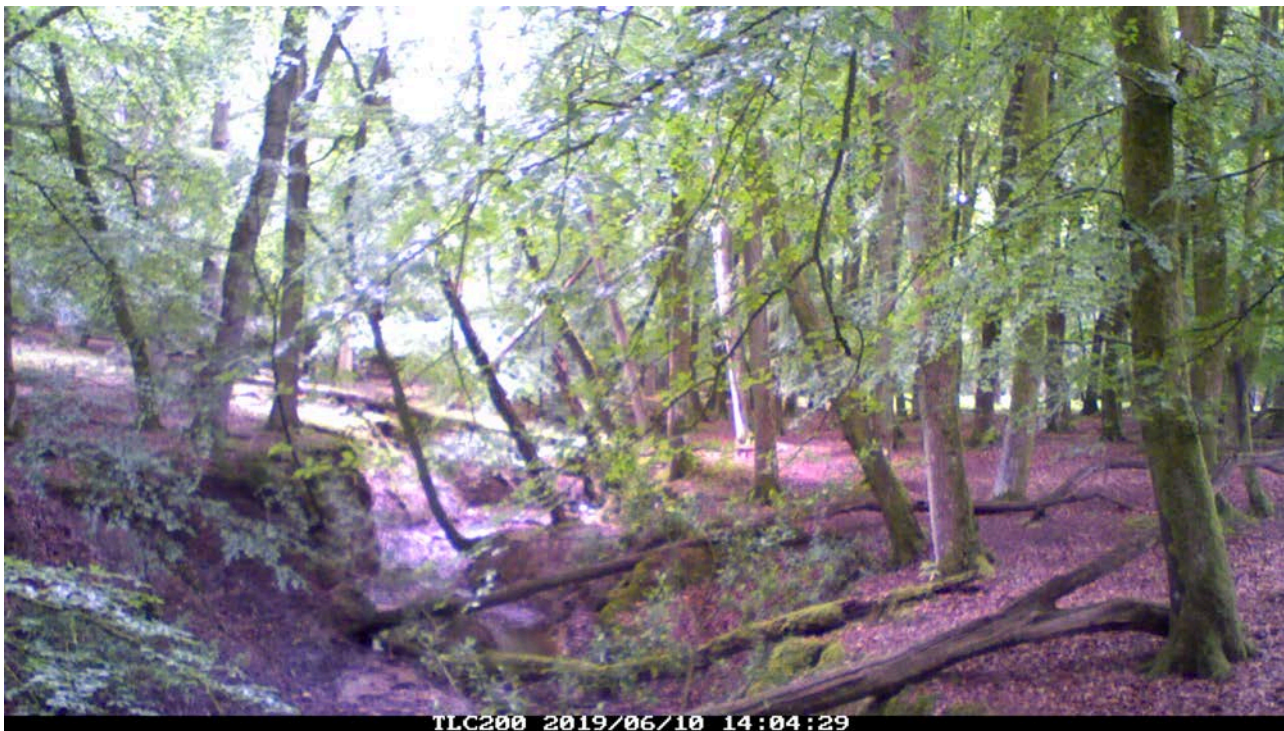
Studley Wood/Claypits

The camera footage for Studley Wood is not particularly clear but does show that water levels have risen overnight and water appears to be moving rapidly down the channel and flowing over a large nick point in the bottom left of the image. By the evening of the 11th June water levels appear to have subsided back to pre-event levels.

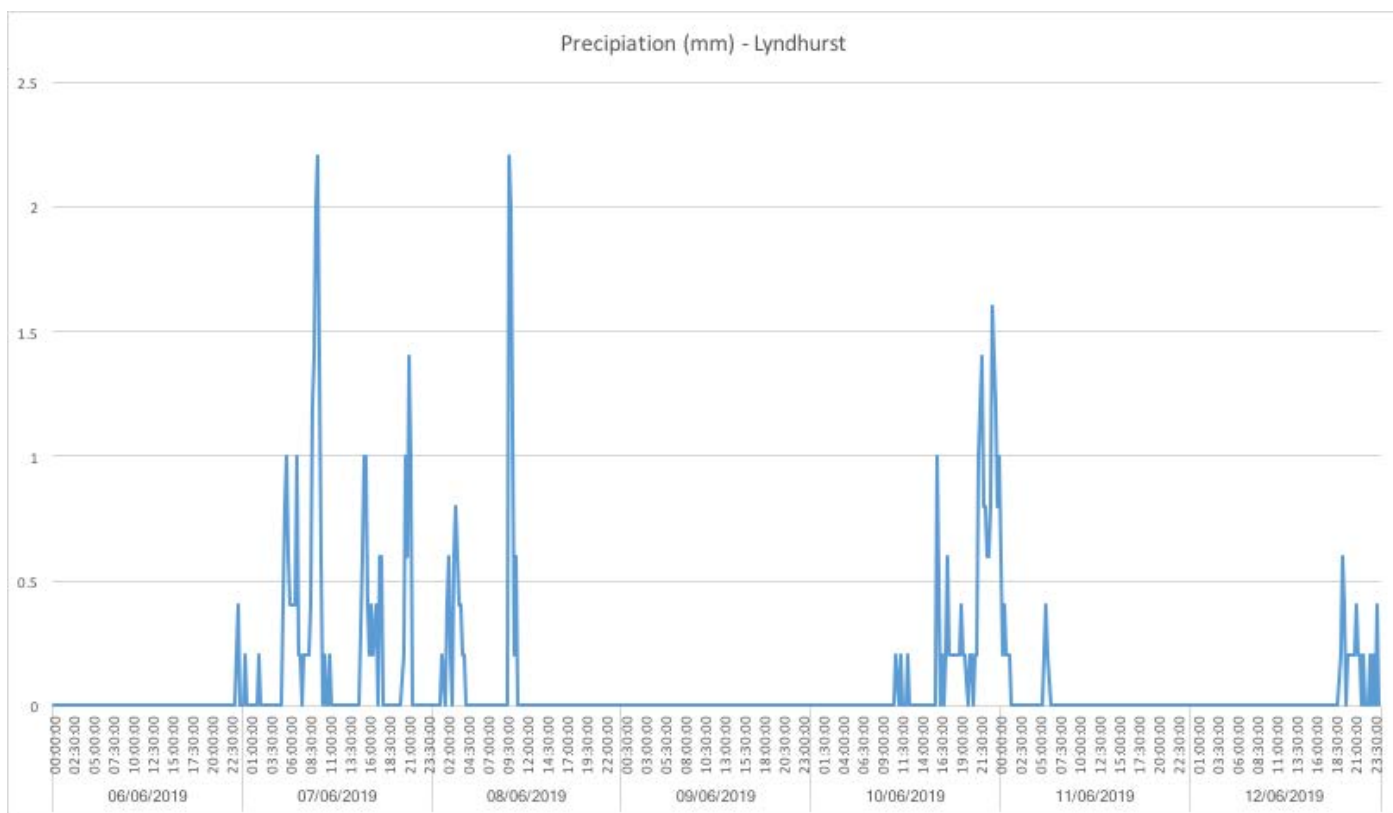
Figure 3.13 shows the rainfall recorded at the Environment Agency gauge at Lyndhurst After a dry spell at the end of May/beginning of June and the sequence of timelapse images show the response of the river.
