3. Restoration of Hydrological Function and Reconnection with the Floodplain

3.2 Restoration Objectives

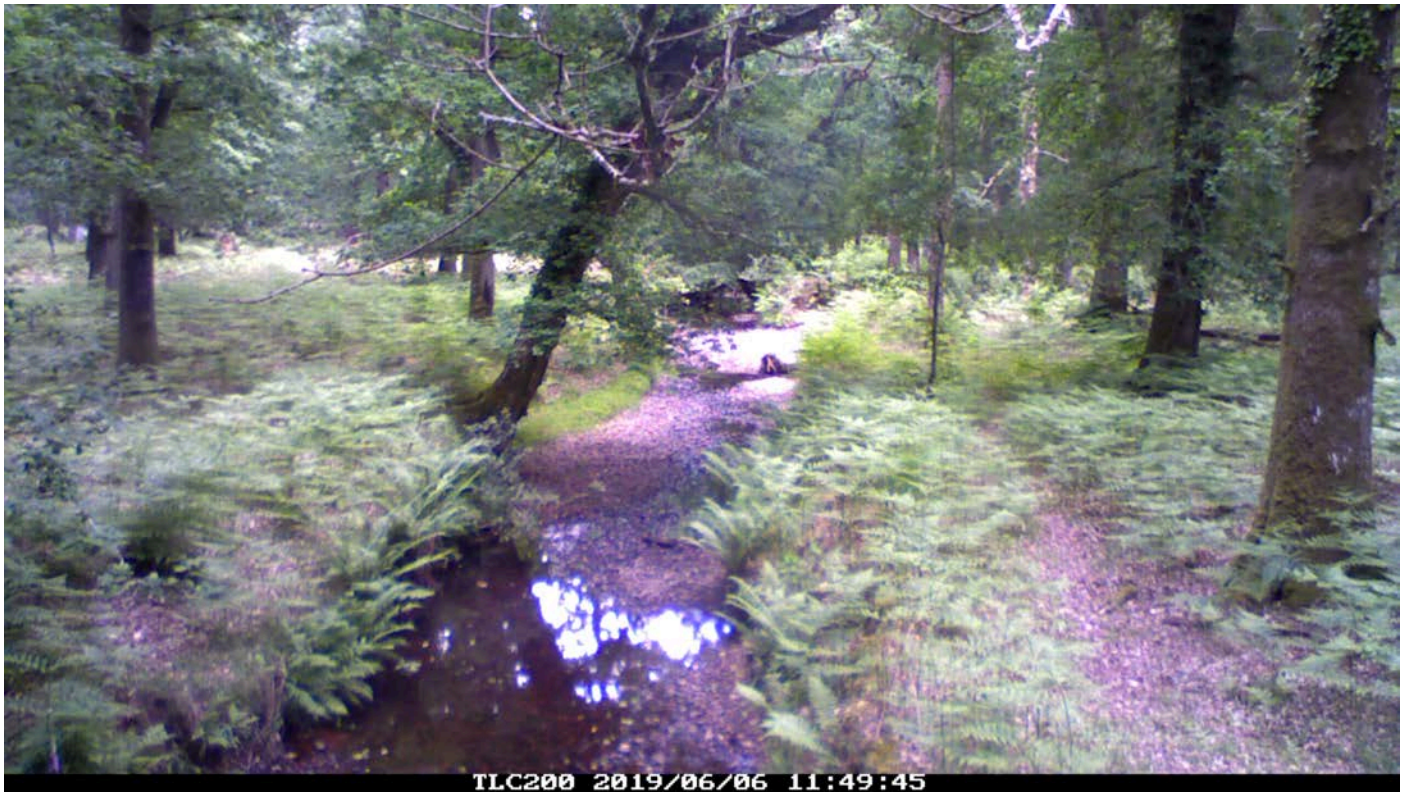
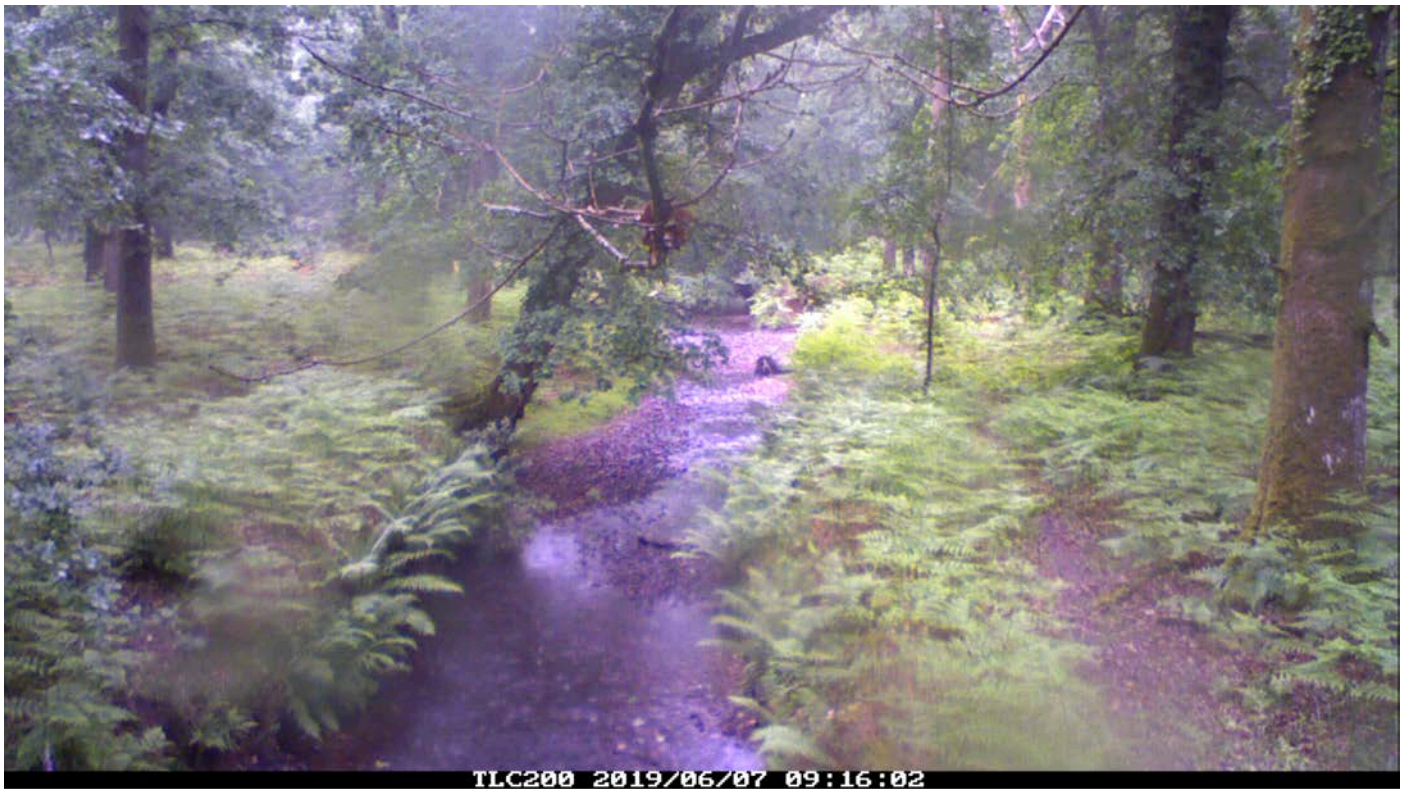
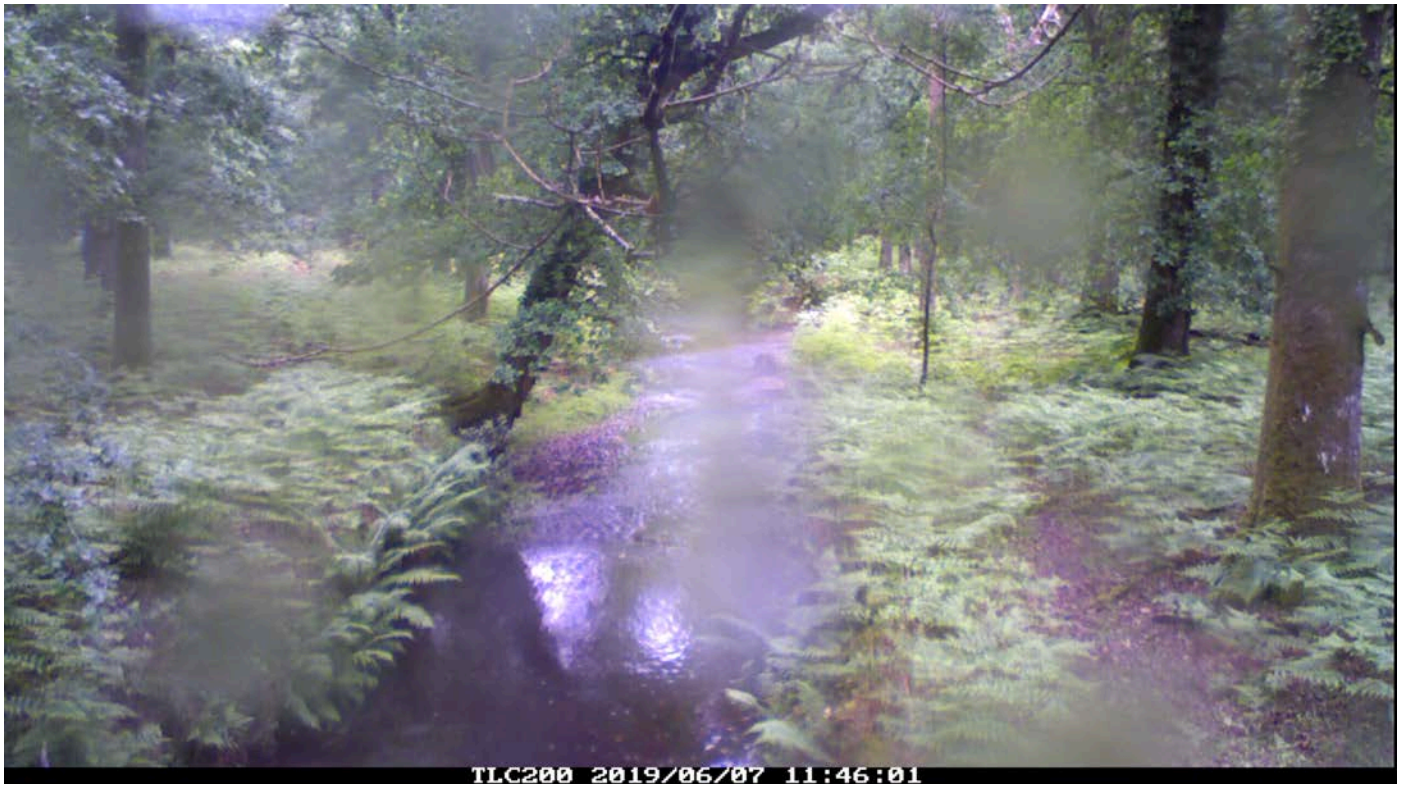
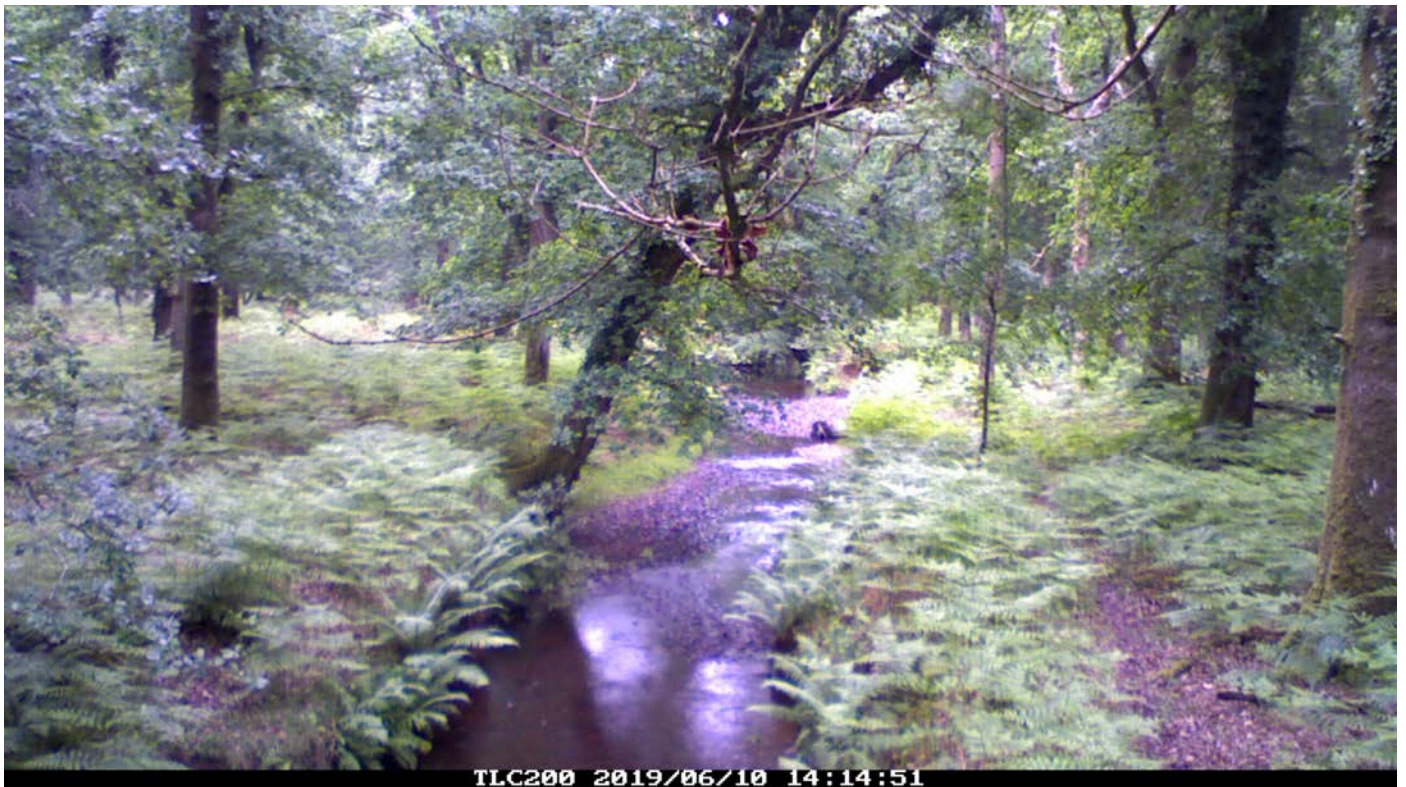
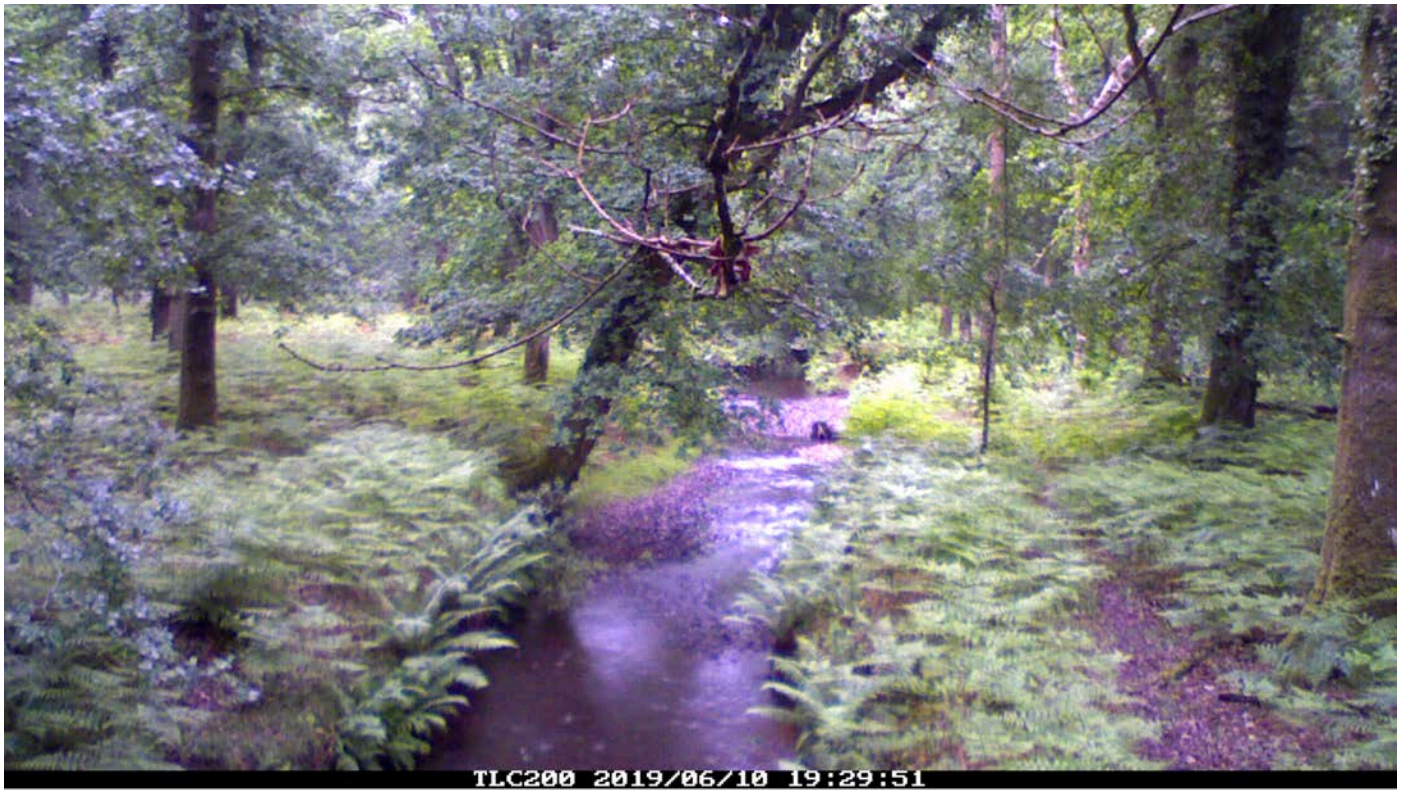
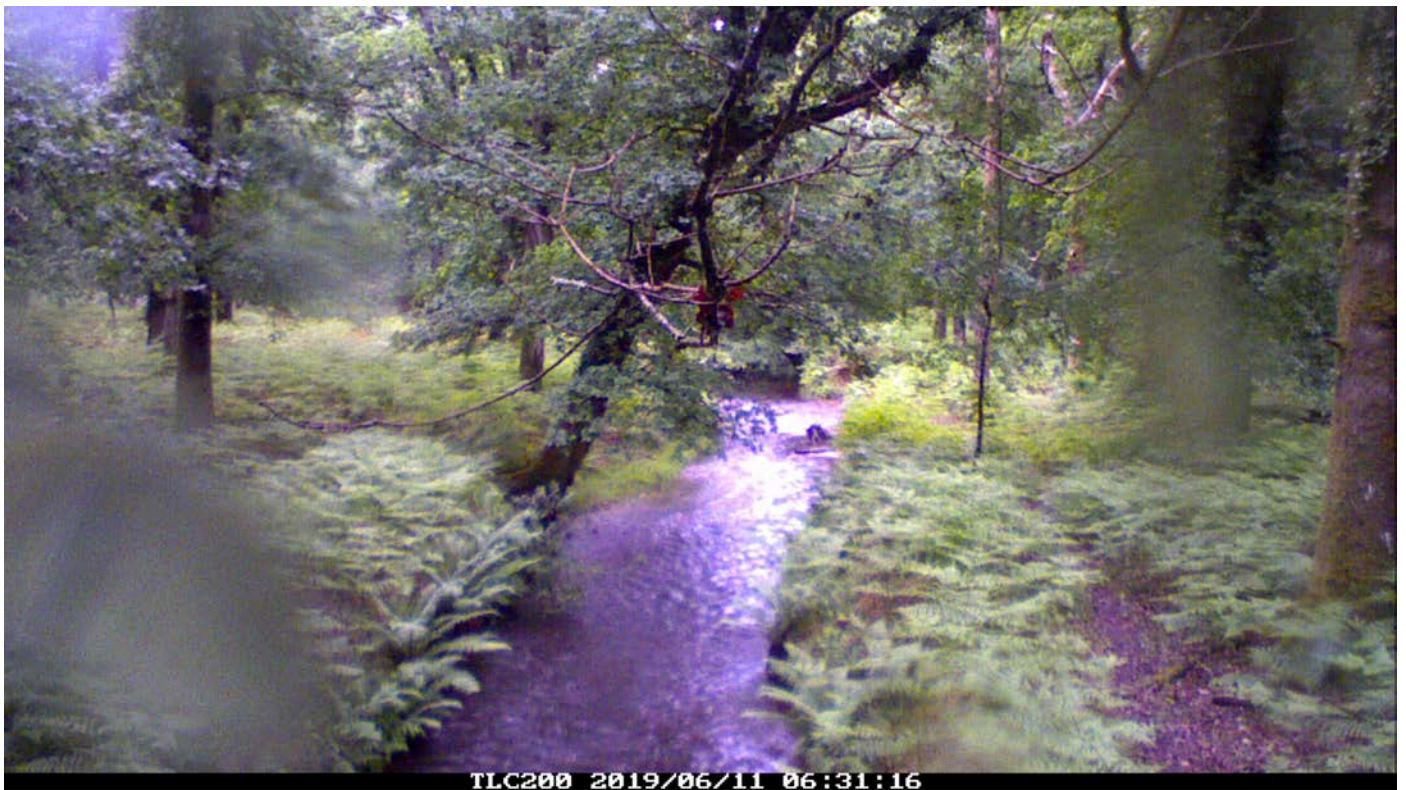
The first image shows the river channel (Latchmore Brook) flowing through Amberwood. It appears to have a very low flow after a period of low rainfall with only some residual pools remaining. An initial rainfall event started late on the 6th June with sustained rainfall started at around 05:00 hours on the 7th June, 2019 and by 09:00 hours timelapse images show the river starting to rise. Heavy showers over the next 24 hours keep the river levels sustained at similar levels but before the start of the next rainfall event the river level has settled (refer to Image - 14:14 hours 10th June). Rain continues overnight with the peak around 01:00 hours but continues until around 6:30 hours. Some of the first images of the morning (06:31 hours 11th June) show river levels have significantly increased overnight although the river is still with bank. The levels stay high for the next 6 hours although they appear to start to drop around and by midday. By the 12th June levels are almost back to where they started prior to the rainfall event. The sequence of images relative to the rainfall patterns suggest that the river is flashy in nature and highly responsive to rainfall events with most of the energy confined to the channel.
