New Forest Wetland Restoration Vegetation Monitoring: Picket Mire, 2022.

Higher Level Stewardship Agreement.

The Verderers of the New Forest AG00300016

Sophie Lake, Emma Bishop & Zoe Caals.

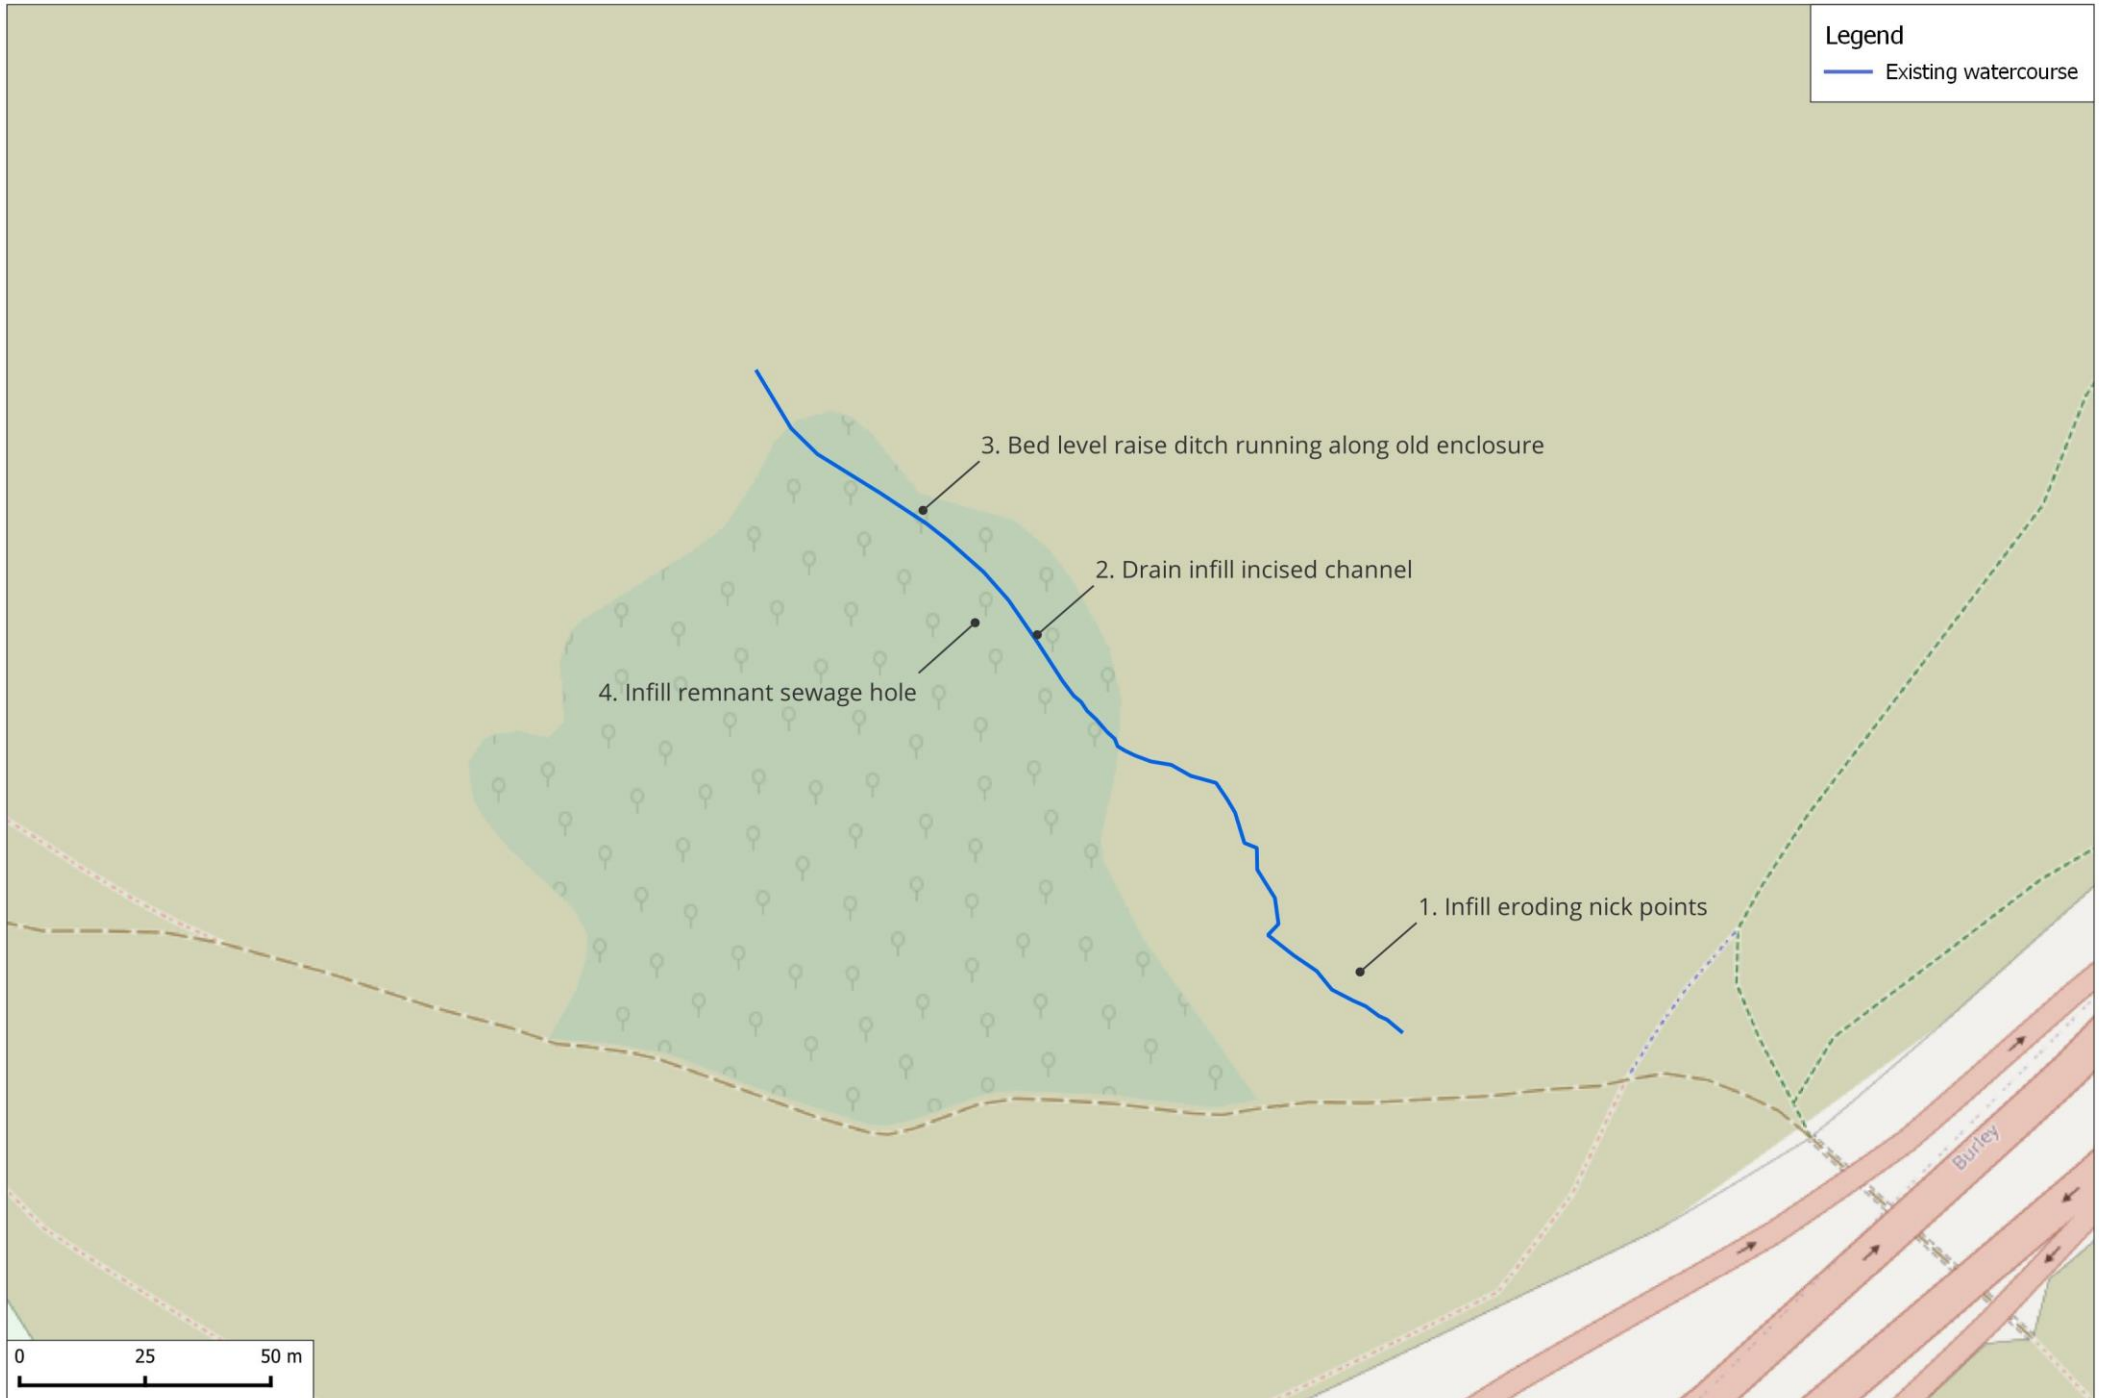
Map 2: Restoration works carried out at Picket Mire

1.11 The planned restoration is shown in Map 2. Further detail can be found in the FE document "*SSSI restoration plan 2023: Picket Mire Unit 91*". Work entails selective tree felling to allow access to the watercourse and facilitate the works, bankside reprofiling and channel infilling along approximately 100m of the ditch, plus infilling of nick points and bed-level raising in order to stabilise the erosion and allow the watercourse to interact with its floodplain while preventing further damage to the ditch and bank heritage feature. Additionally, an old fenced off sewage works hole will be infilled with inert material to make it safe for livestock. Specifically:

- The nick points at the top of the mire that continue intermittently for 37m will be infilled using hoggin, and bare surfaces will be revegetated using translocated turf
- The eroding drop off point ("waterfall") and deeply incised channel below it will be infilled using hoggin and rejects with clay plugs as necessary to bring it to the level of the surrounding ground
- The level of the watercourse bed beyond this will be raised for 34m using hoggin/rejects

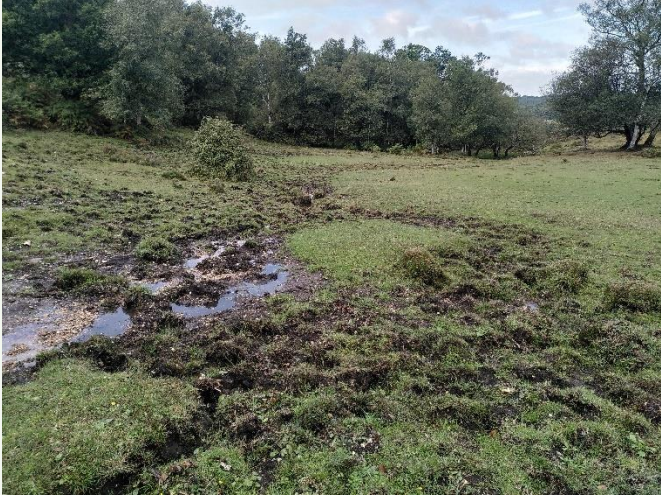
Photo and Grid Refence	Description	2022 image
<p>1. SU19189 06295</p>	<p>Looking down the watercourse from the top of the monitoring area. The channel is characterised by Poached and Disturbed Habitat and runs through Floodplain Lawn until it reaches the wooded Inclosure</p>

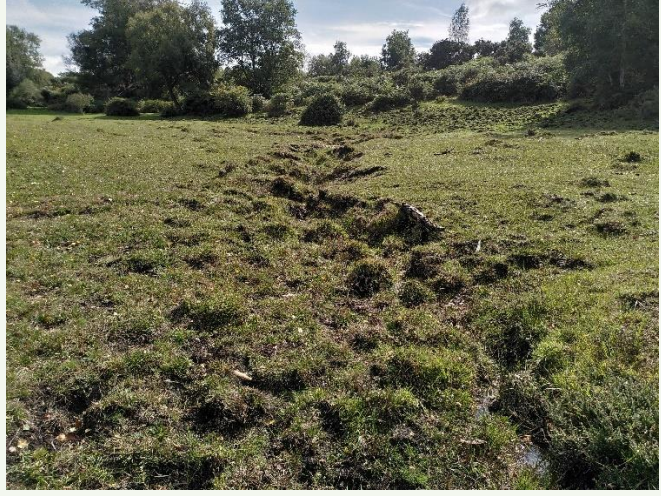
<p>2. SU19163 06330</p>	<p>Looking up the channel from the bottom of the Floodplain Lawn. Here the channel has become a little more incised</p>

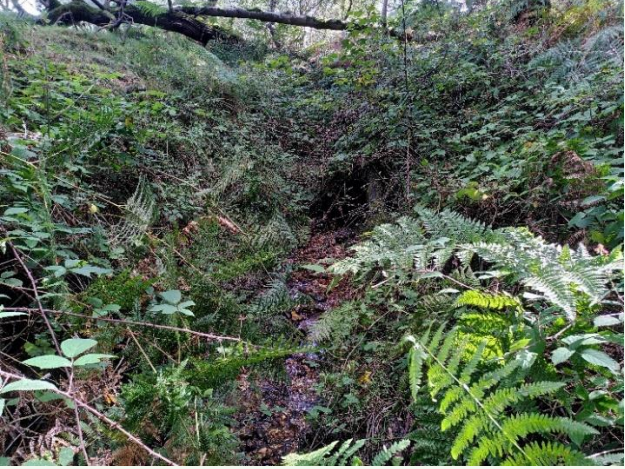
Photo and Grid Refence	Description	2022 image
3. SU19119 06378	Looking upstream at the erosion face, which is concealed by overhanging Bramble and Bracken. The channel is deeply incised here

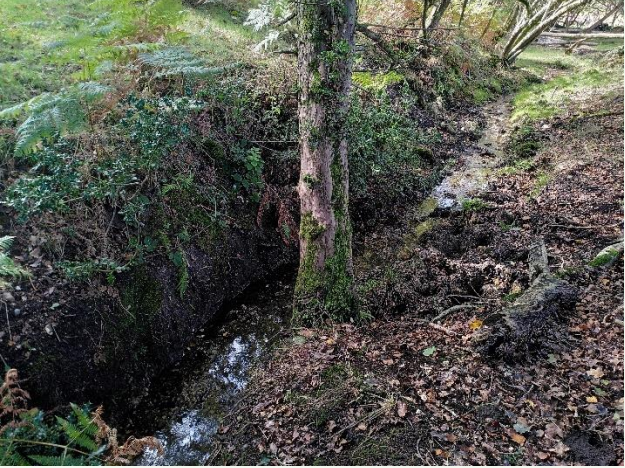
4. SU19102 06386	The channel remains incised downstream where it runs along the Inclosure bank but gradually becomes shallower.

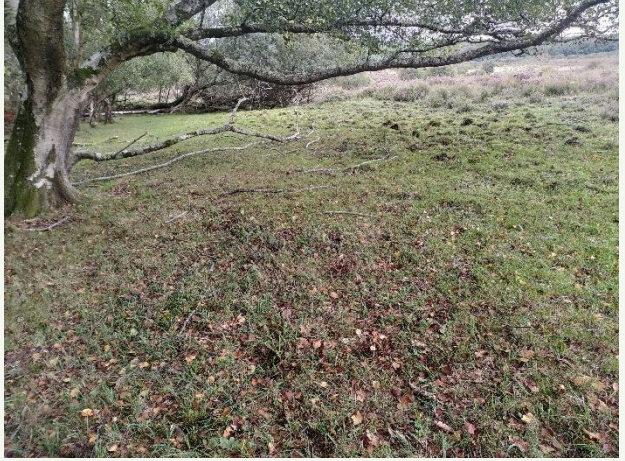
5. SU19119 06378	Floodplain Lawn under a light tree canopy on the north-eastern bank of the watercourse

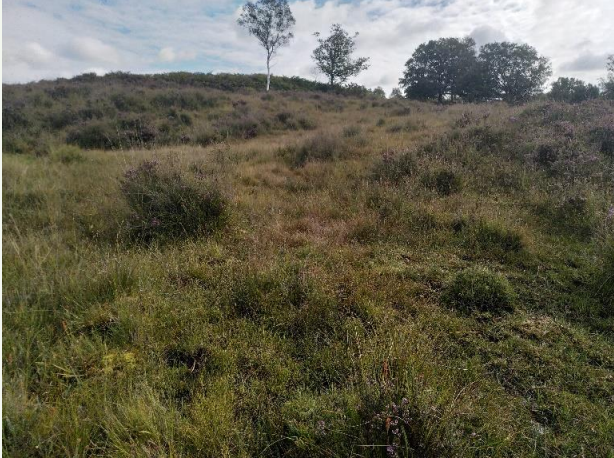
Photo and Grid Reference	Description	2022 image
6. SU19128 06405	Valley Bog in the form of seepage step mires within Wet Heath on the north-eastern slopes of the monitoring area

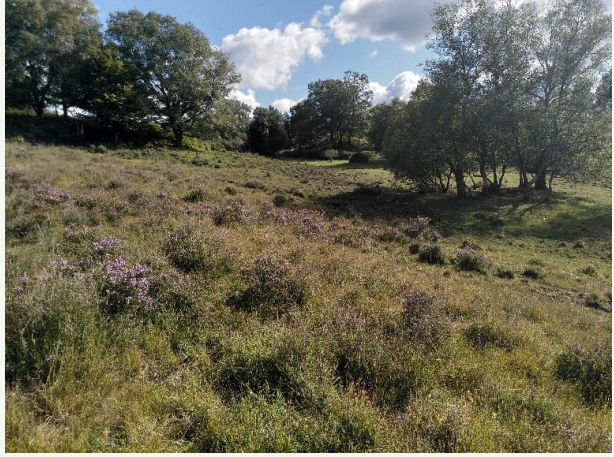
7. SU19171 06374	Wet Heath above the floodplain, looking south towards Picket Hill

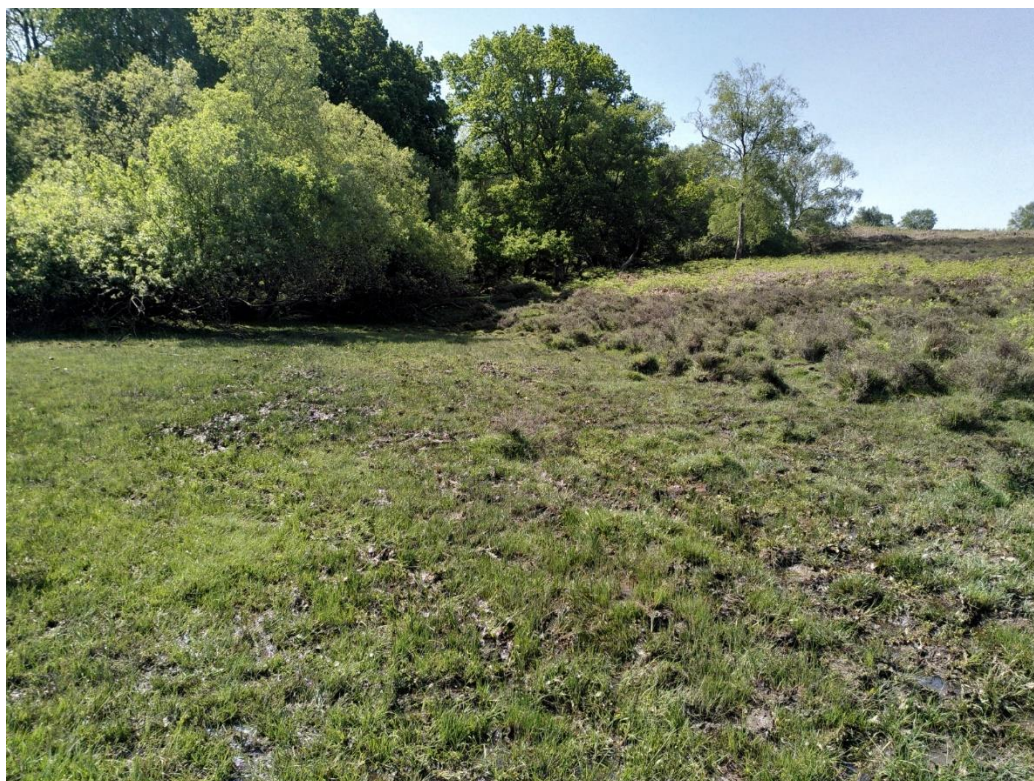
Figure 2: Soakway picking out the watercourse where it runs through Wet Lawn downstream of the modified section of the watercourse at Picket Mire (below the proposed restoration area) in 2023 prior to the restoration work.

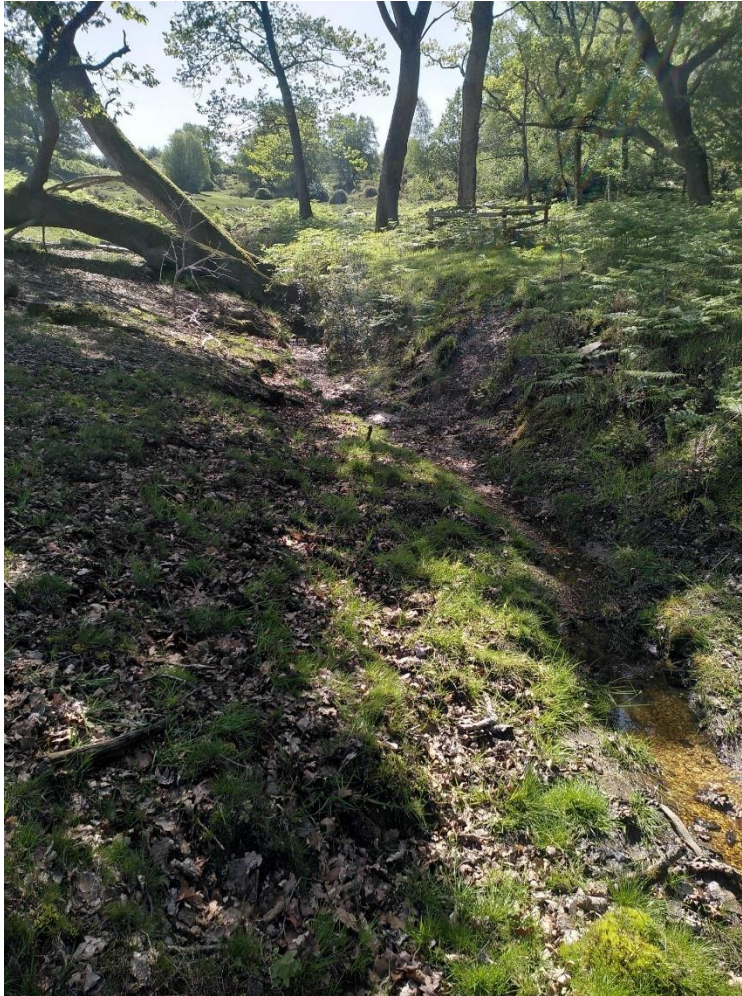
Figure 3: The watercourse below the erosion face where it runs along the ditch below the inclosure bank in 2023 prior to restoration work.
