New Forest Wetland Restoration Projects:

Summary Information on Completed Projects

Compiled by the Forestry Commission
October 2014

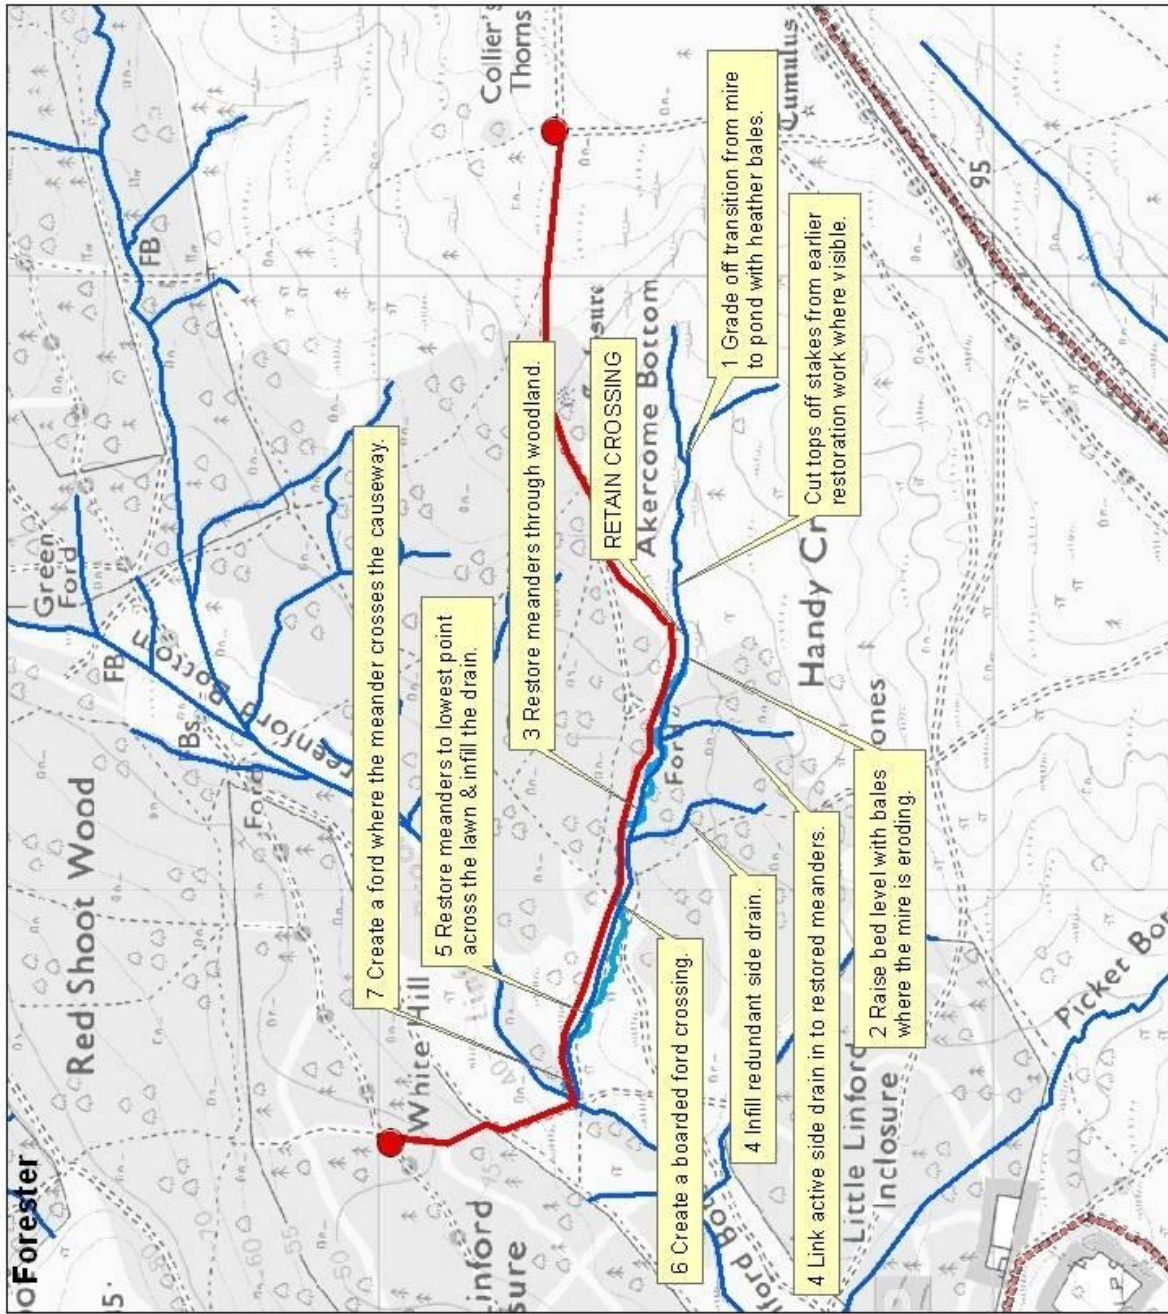
AKERCOME BOTTOM
Restoration Plan
September 2009

- The bed level of the artificial channel through the mire was raised using staked heather bales, with mire vegetation reinstated over the top.
- The original meandering watercourse was restored where evident, and the redundant straightened (drain) channel was then infilled.
- The gravel ford crossing at the eastern end of the lawn was repaired.
- The work also cleared an area of old, leggy scrub within the woodland to open up lawn habitat and provide a more varied age structure within the scrub habitat.

- Fenced off restored mire section at upstream end to prevent stock poaching on an area of mire repaired with heather bales (2011).
- Restored an additional meander (not originally incorporated) at the downstream end of the woodland to rectify an eroding nick point – this has now stabilised (2011).
- Created an additional gravel ford stock crossing on the lawn at the request of the CDA (2012).

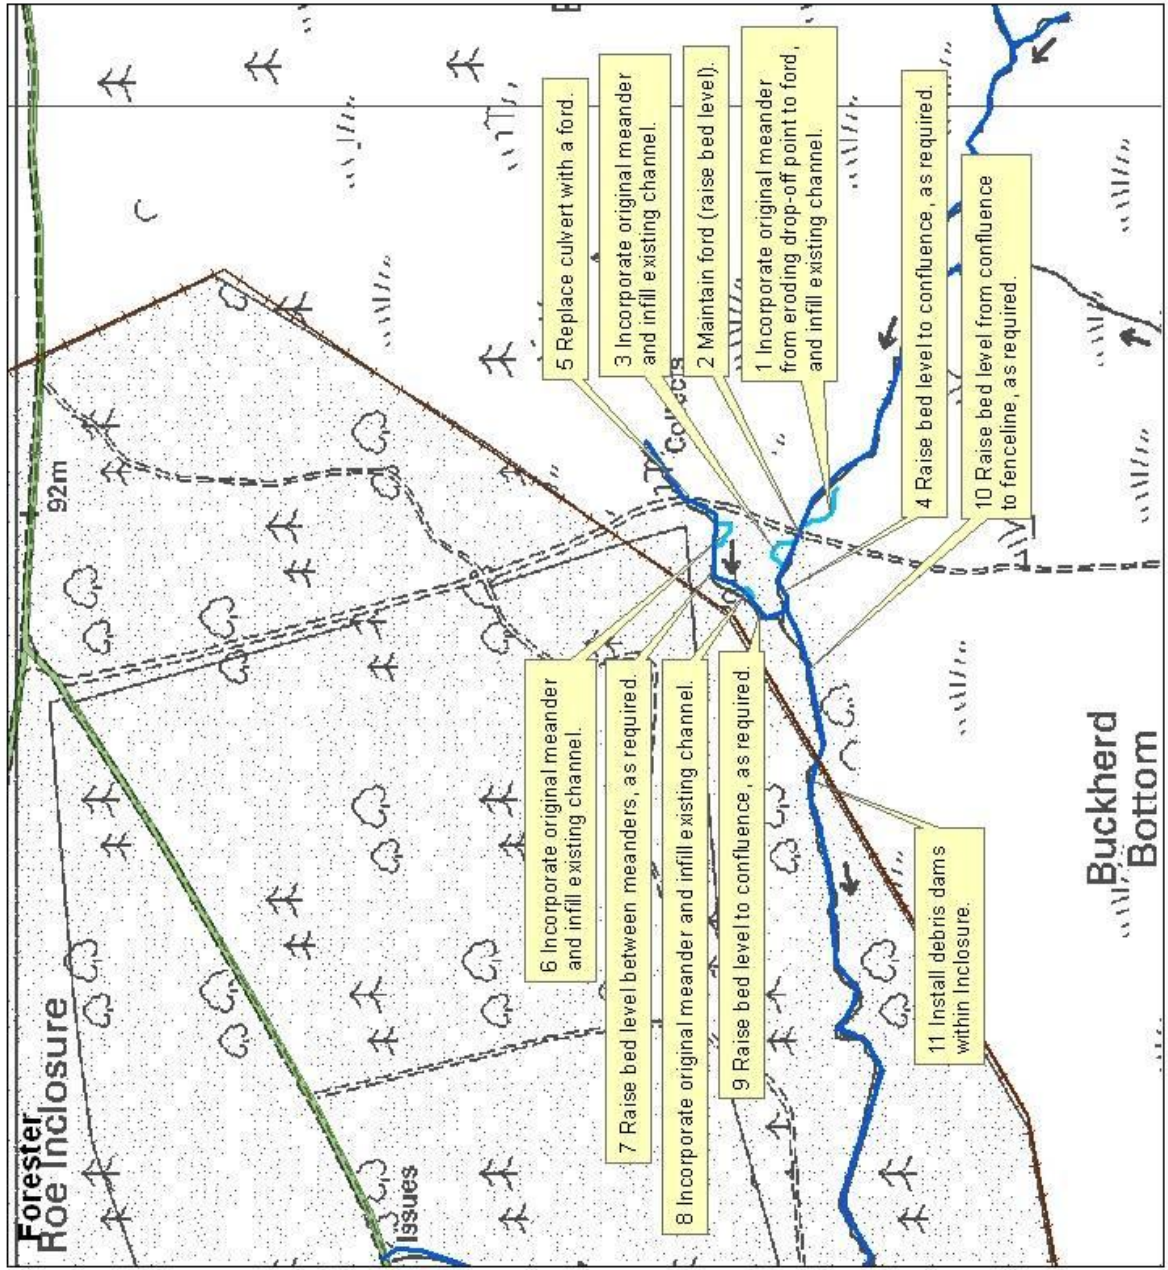
BUCKHERD BOTTOM
Restoration Plan
March 2013

- Where evident, additional original meanders were restored to reduce the steepness of the gradient through the mire and woodland habitats by increasing the overall length of the watercourse.
- Redundant sections of channel were subsequently infilled.
- The bed level of the channel through the woodland was raised using staked heather bales, and narrowed using hoggin with organic material reinstated over the top.
- A concrete culvert was removed and replaced with a gravel ford.
- Inside the fenceline of Roe Inclosure, several large debris dam structures were installed to support the restored bed levels on the Open Forest.
- An excavation of an area of archaeological interest within the site was undertaken at the request of the New Forest National Park Authority's Archaeologist.

- Localised erosion at three clay plugs was repaired using staked heather bale ramps, topped with translocated bed gravels and larger cobbles (2014).
- Larger gravels and cobbles were added to minor nick points to provide more stability during high flows (2014).

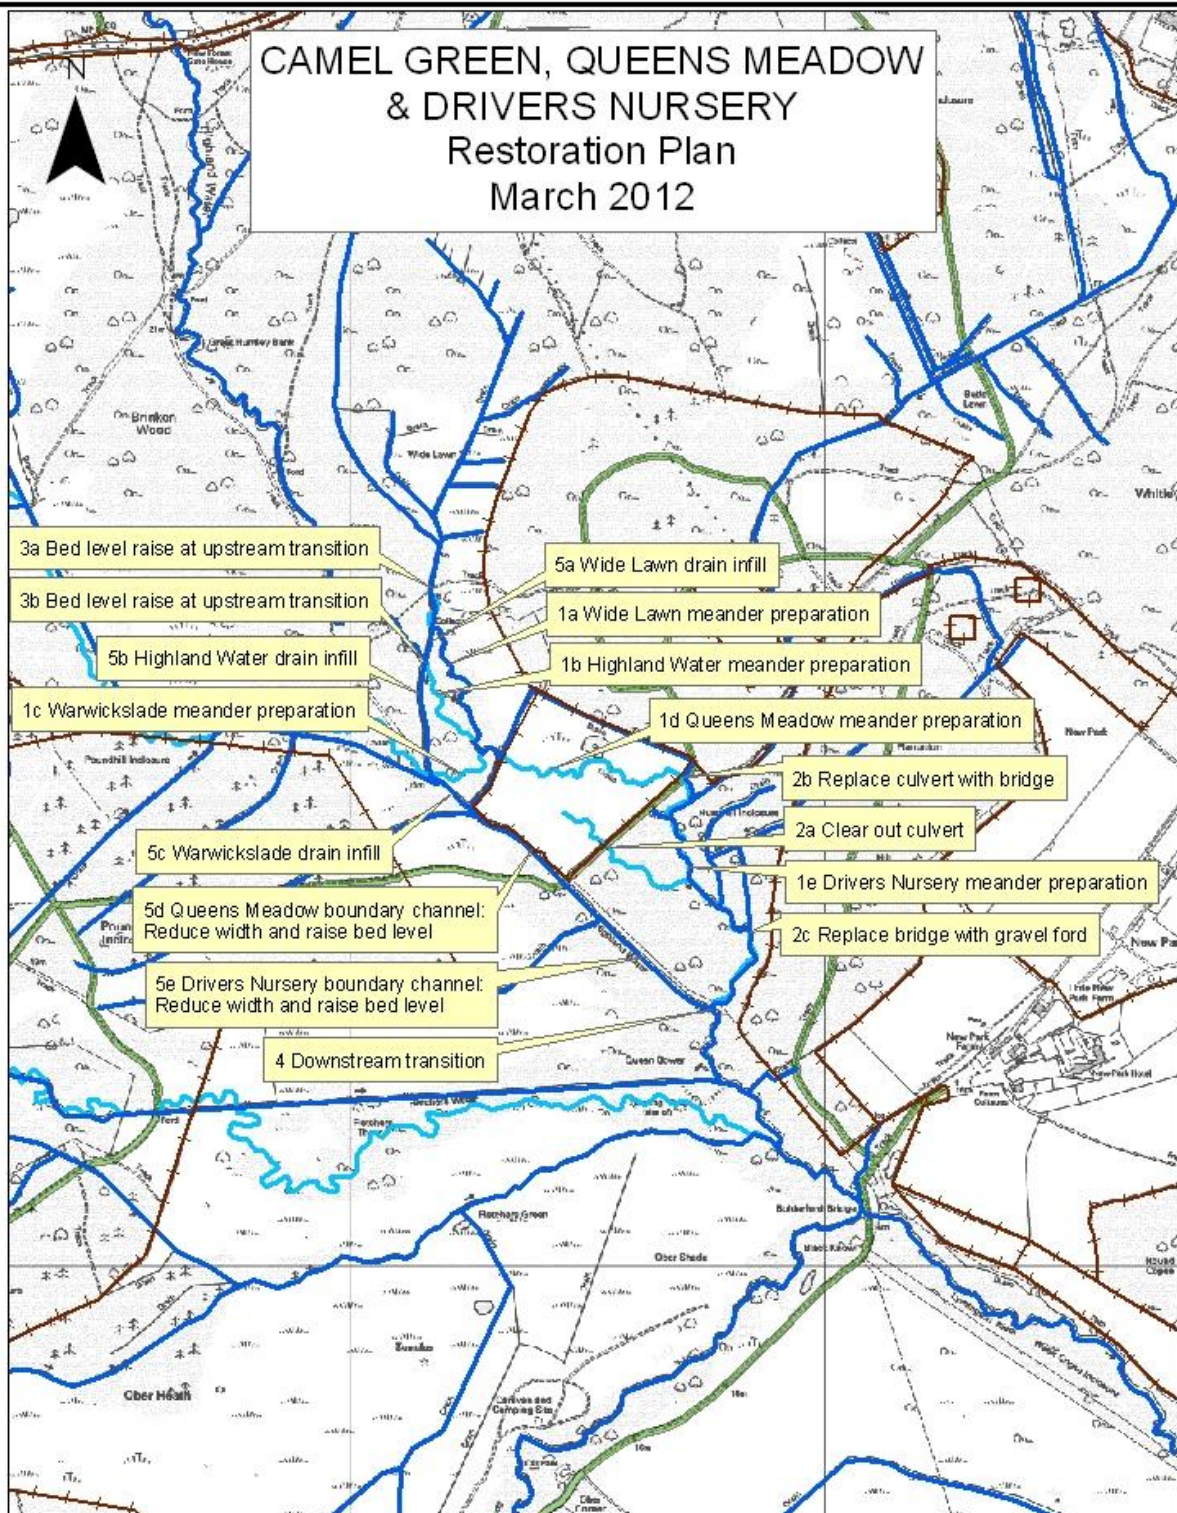
CAMEL GREEN, QUEENS MEADOW & DRIVERS NURSERY Restoration Plan March 2012

- Artificial drainage over 150 years ago had resulted in over deepened and widened straight drain channels. This was continuing to cause erosion of the river beds and limited in-channel habitat diversity.
- As a result of these incised channels, there was no seasonal inundation of the surrounding woodland and grassland, and no interaction with the floodplain.
- In contrast, Drivers Nursery remained permanently inundated due to the lack of flow through this area. As a result, many of the oaks here were dead or dying.

- The reactivation of the Queens Meadow meanders has increased flooding across the gravel track between Queens Meadow and Drivers Nursery. Options are being modelled to ensure repairs to this track remain stable in the future.
