7. Vegetation Monitoring

Figure 7.1: Location of Vegetation monitoring sites

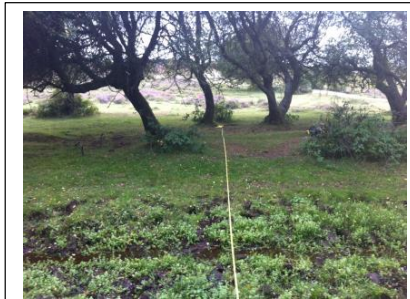
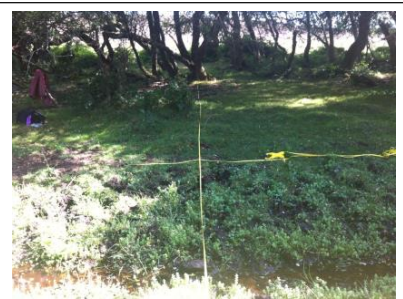
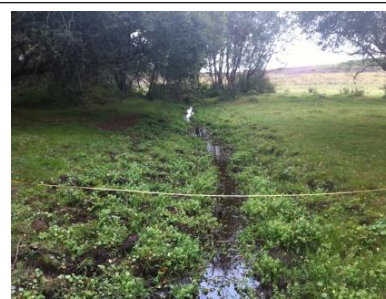
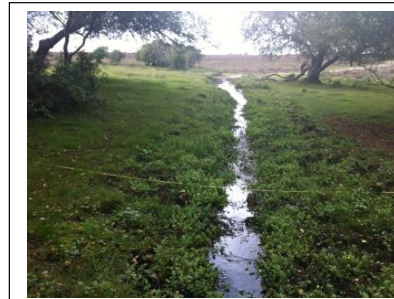
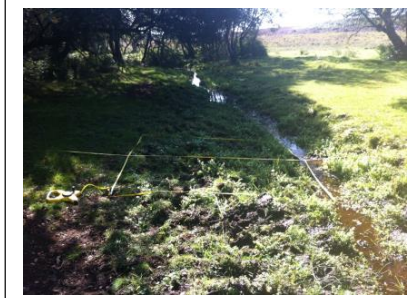
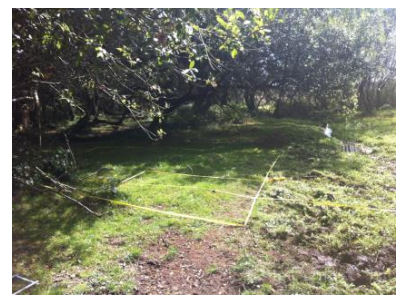
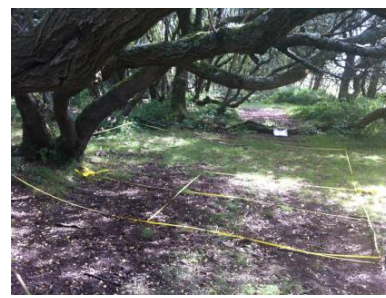
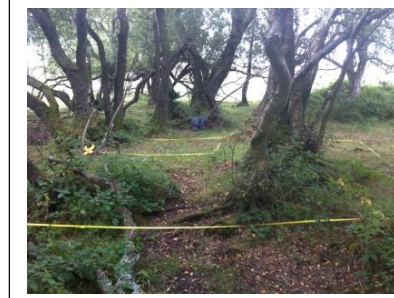
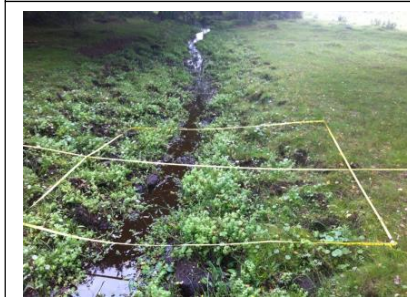
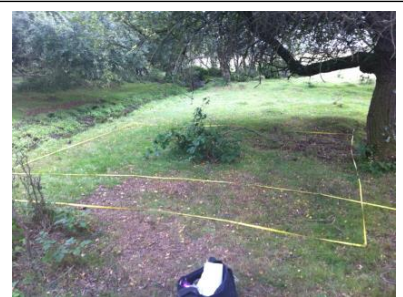
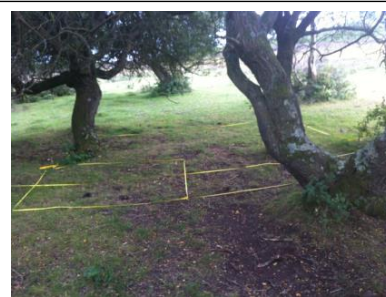
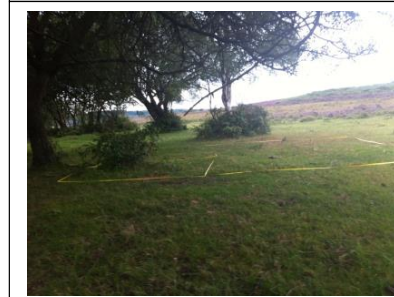
Figure 7.3: Photographic Record of Ferny Croft Vegetation Transects

Ferny Crofts July 2018 (restoration completed) All images facing downstream except for view of transect which is perpendicular to channel.

| | View of transect | M2 Q1 | M2 Q2 | M2 Q3 | M2 Q4 |

Right bank to left bank

Left bank to right bank

Downstream

Upstream

Q1/V1

V2 – looking downstream

V3 – looking downstream

V4- looking upstream

Q5/V5

V6 – looking downstream

V7- looking downstream

V8- looking downstream

Spreadsheets to capture the percentages of specific species and species groups were produced to record the result of each transect. A series of photographs taken at each quadrat location has helped to replicate samples and compare visual difference (refer to Figures 7.2 to 7.8)

The photo sequences recorded by Footprint Ecology (2017) and Amanda Marler (2018) are also included after the graphs of each transect location where available to give a visual representation of the survey site and they also allow visual changes to be observed.

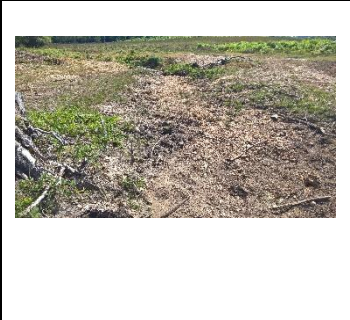
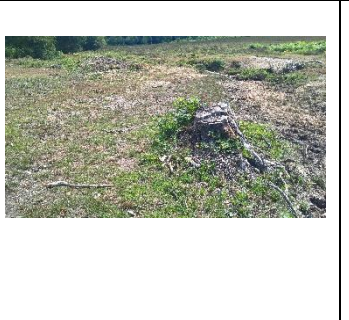
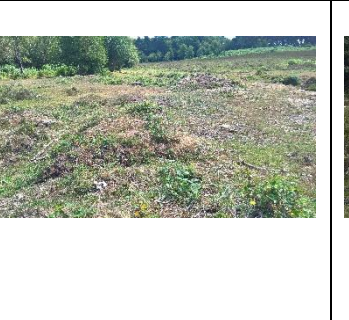
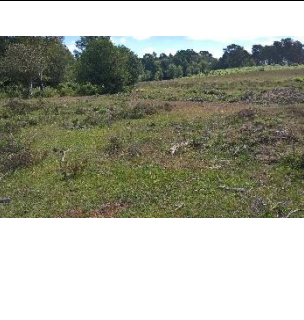
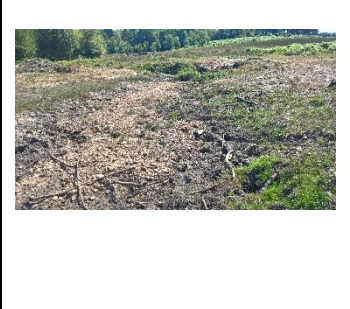
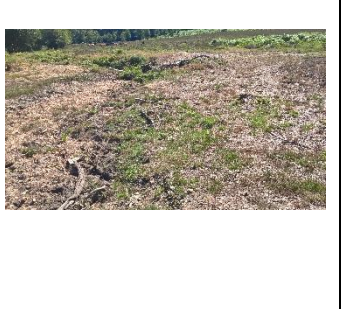
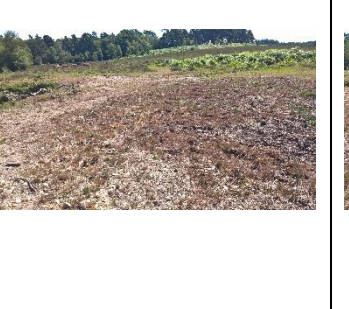
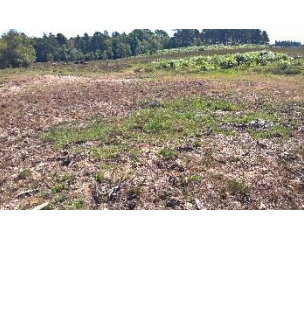
Ferry Crofts July 2018 (restoration completed) – cont'd

| Left bank | | | | | |
| | View of transect | M5/6 Q1 | M5/6 Q2 | M5/6 Q3 | M5/6 Q4 |
| Right bank | | | | | |

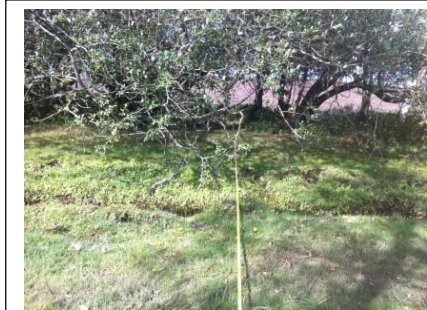
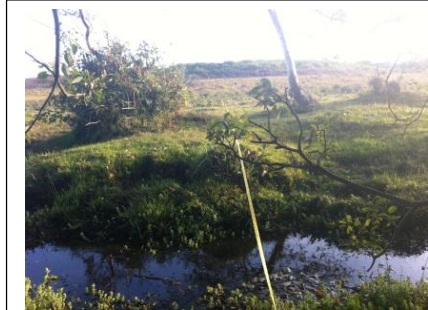
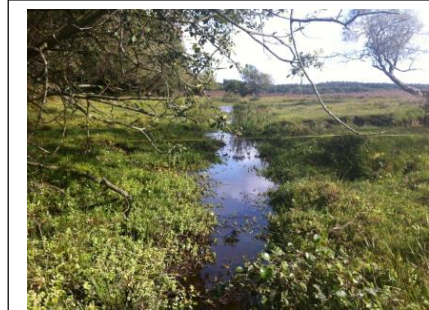
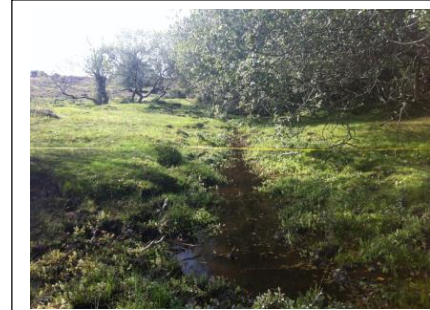
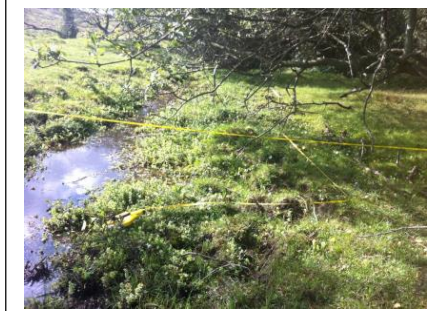
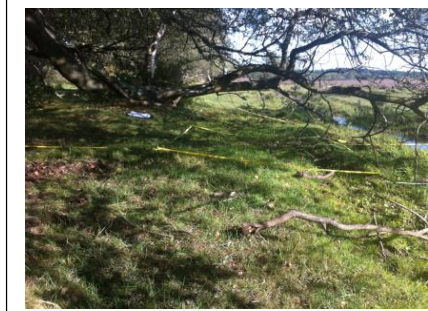
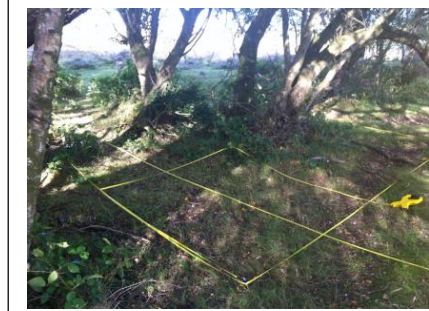
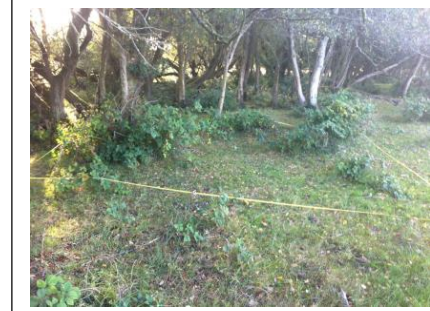
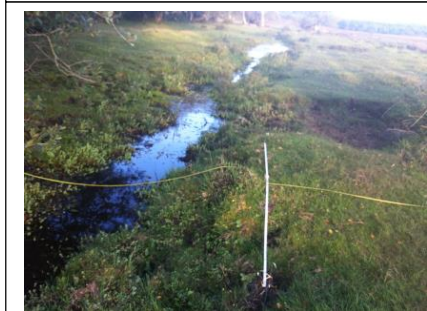
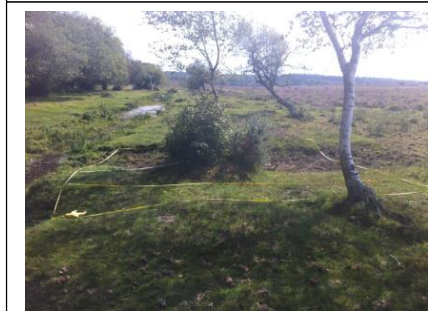
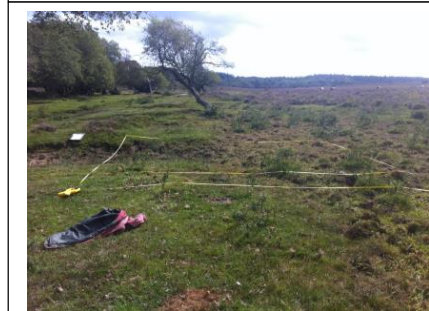
Grid ref: SU3781005496

Survey Date: 29.08.19

Right bank to left bank

Left bank to right bank

Downstream

Upstream

Q1/V1 (looking upstream)

Q2/V2 – looking downstream

Q3/V3 – looking downstream

Q4/V4- looking upstream

Q5/V5

V6 – looking downstream

V7- looking downstream

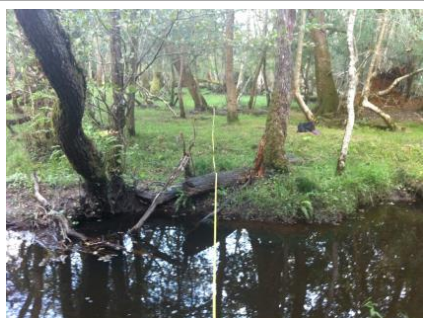
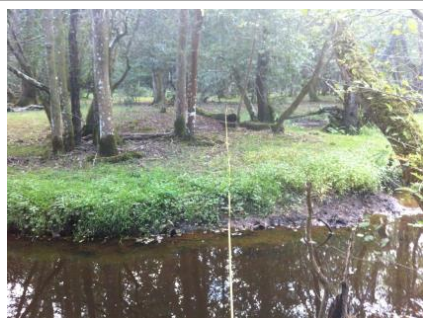
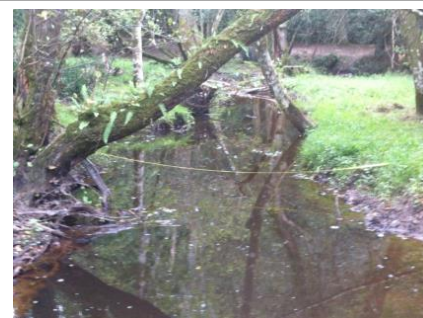
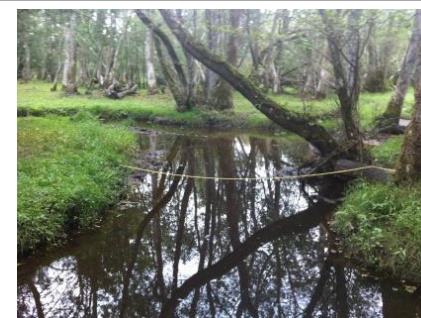
WOOTTON SECTION 2- M9

Grid ref: SZ25520 99539

Survey Date: 4.09.19

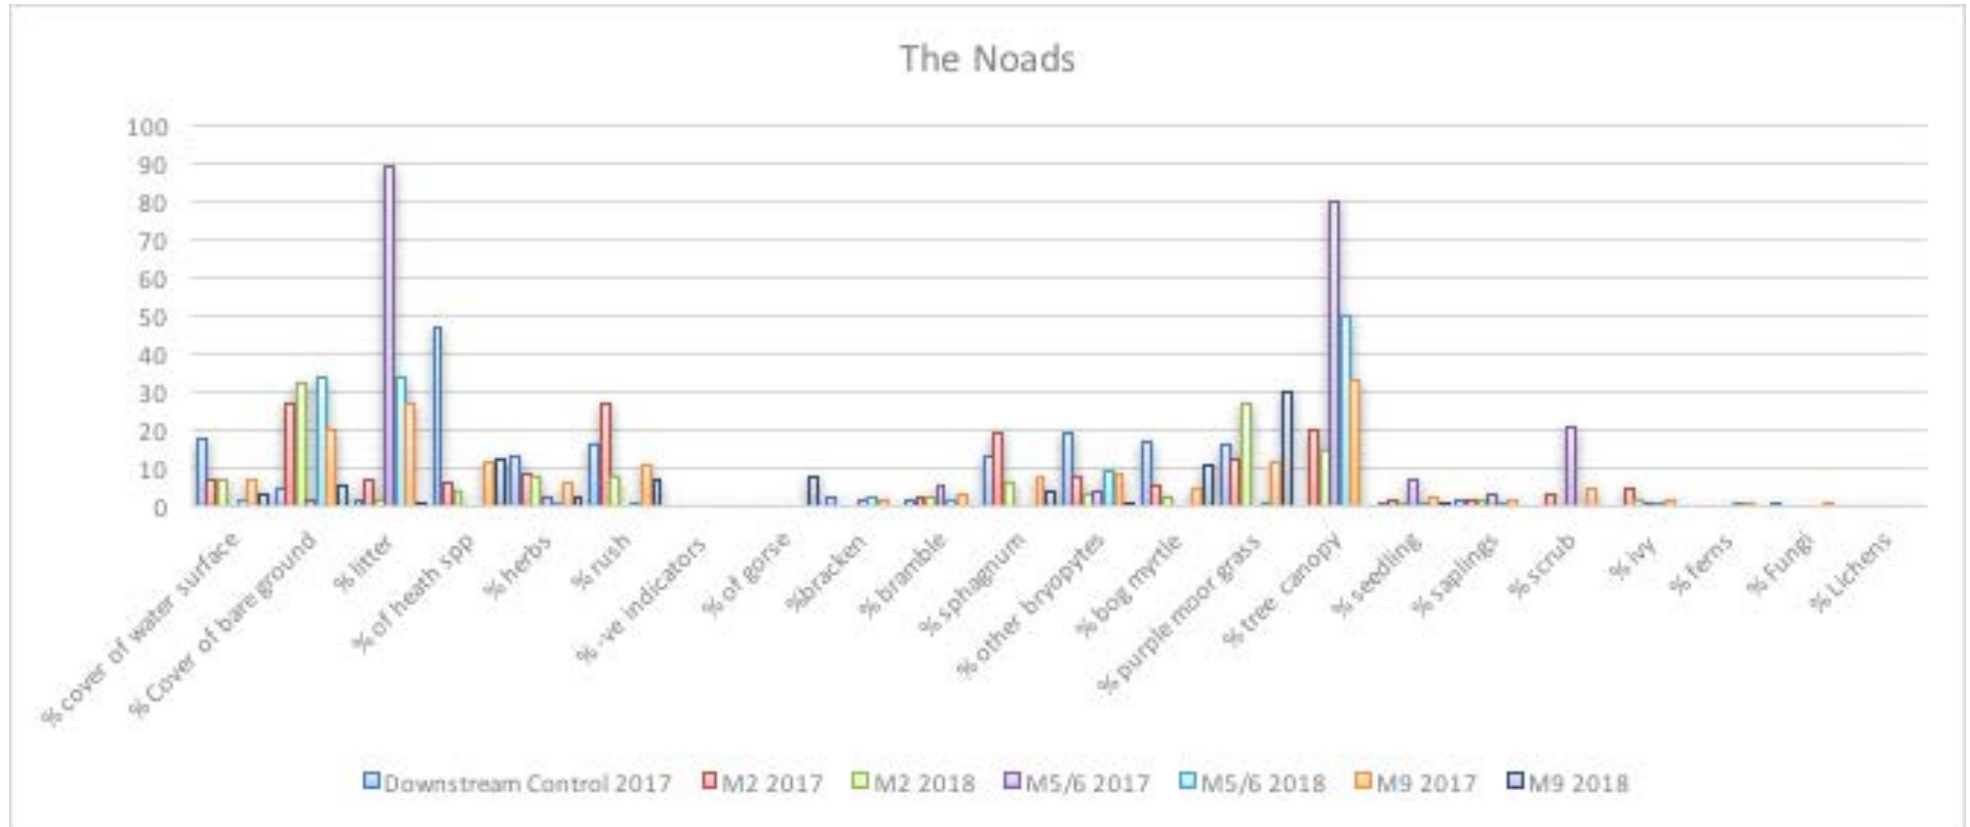
Figure 7.7: The Noads Transect Vegetation Cover & Photographic Record

The Noads July 2018 (before restoration completed) All images facing downstream except for view of transect which is perpendicular to channel (unless stated).

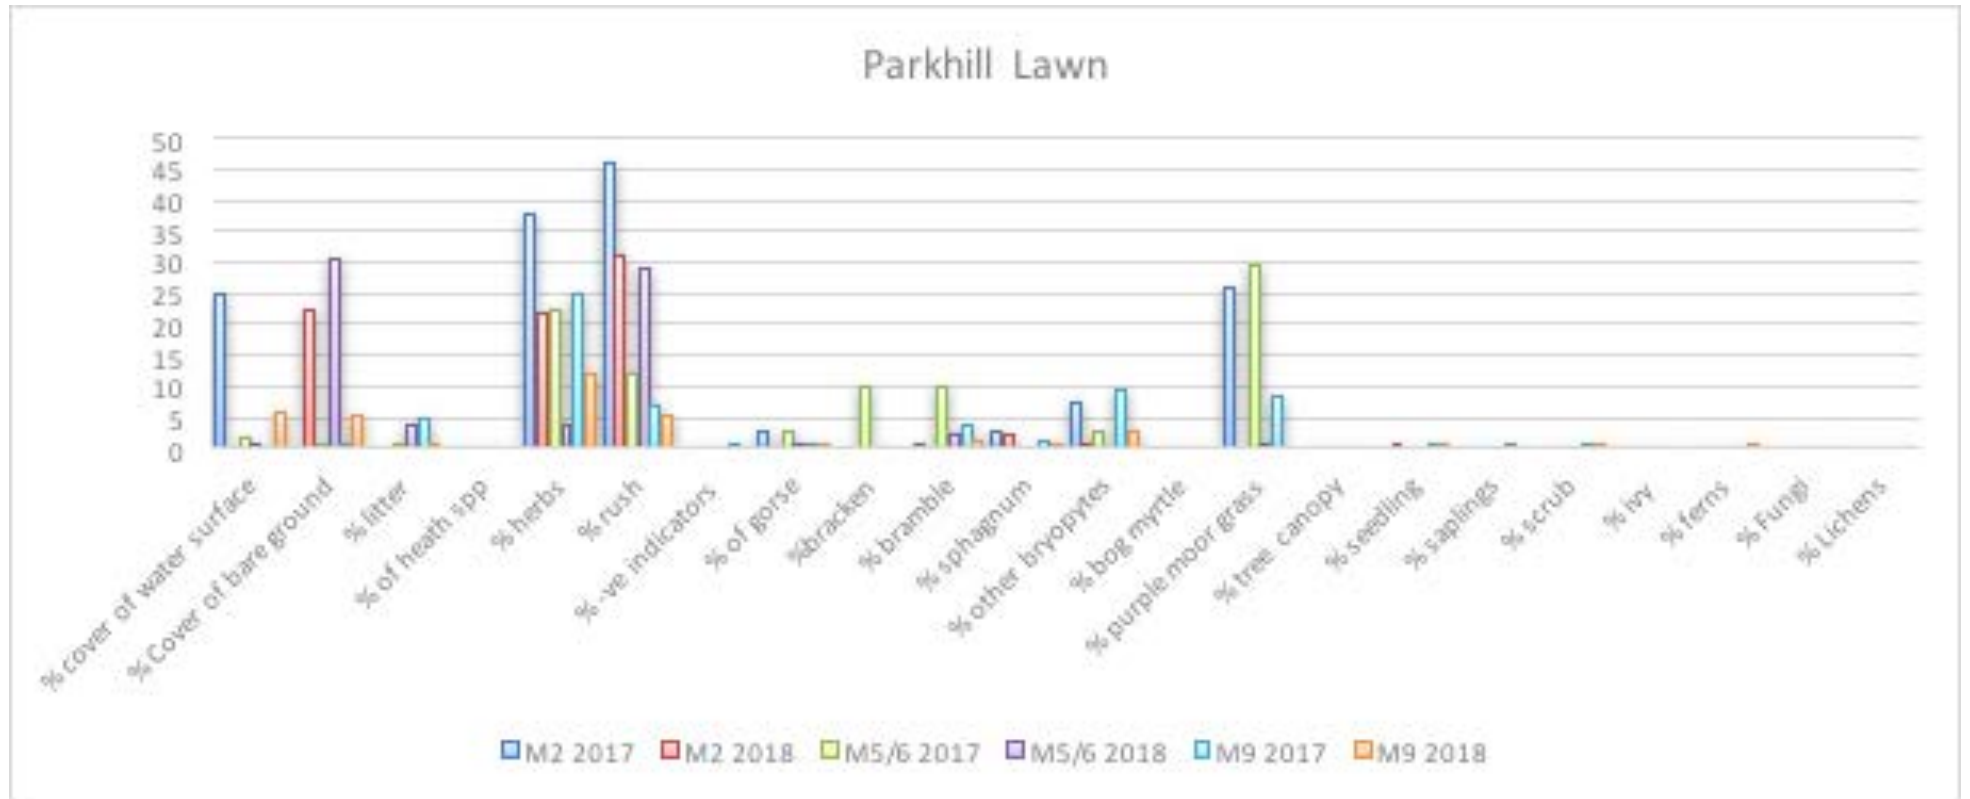
Figure 7.8: Parkhill Lawn - Transect Vegetation Cover & Photographic Record

Parkhill Lawn July 2018 (after restoration) All images facing downstream except for view of transect which is perpendicular to channel (unless stated).

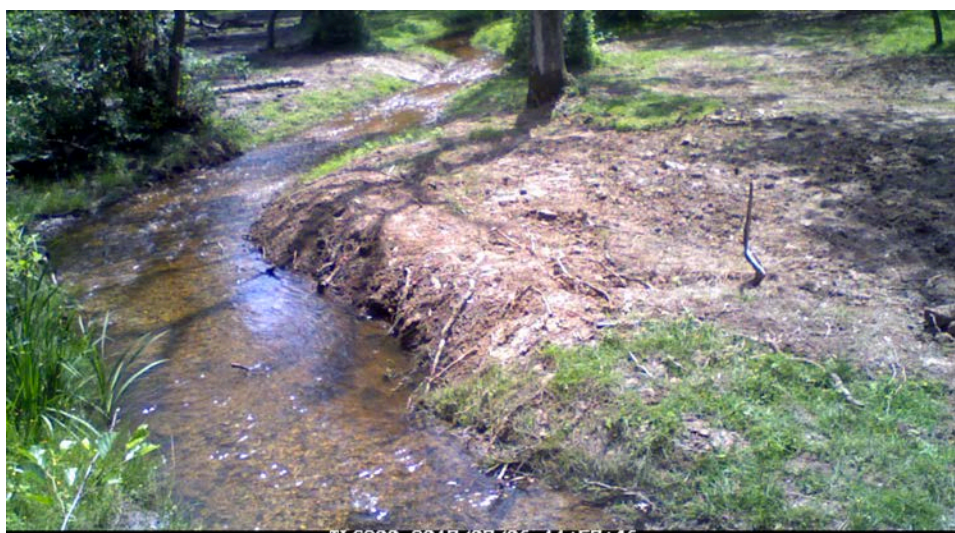
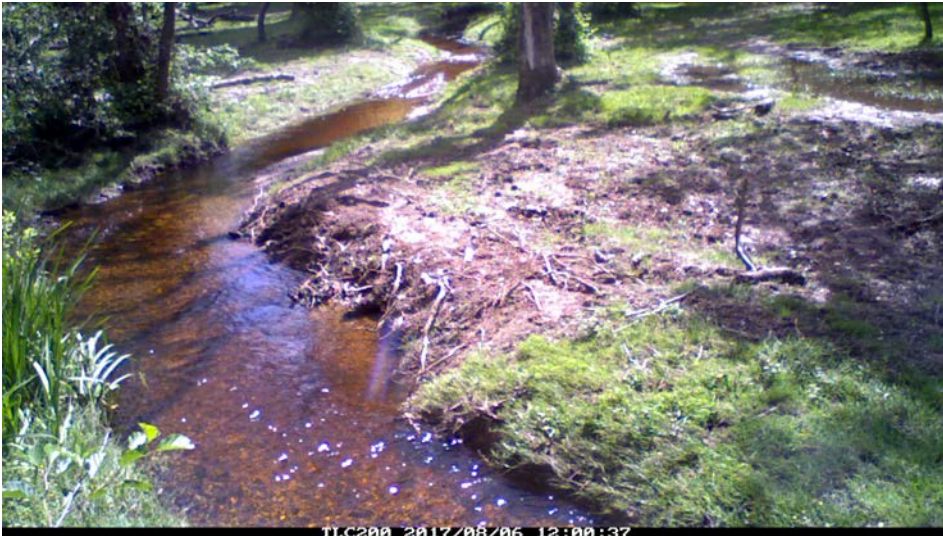
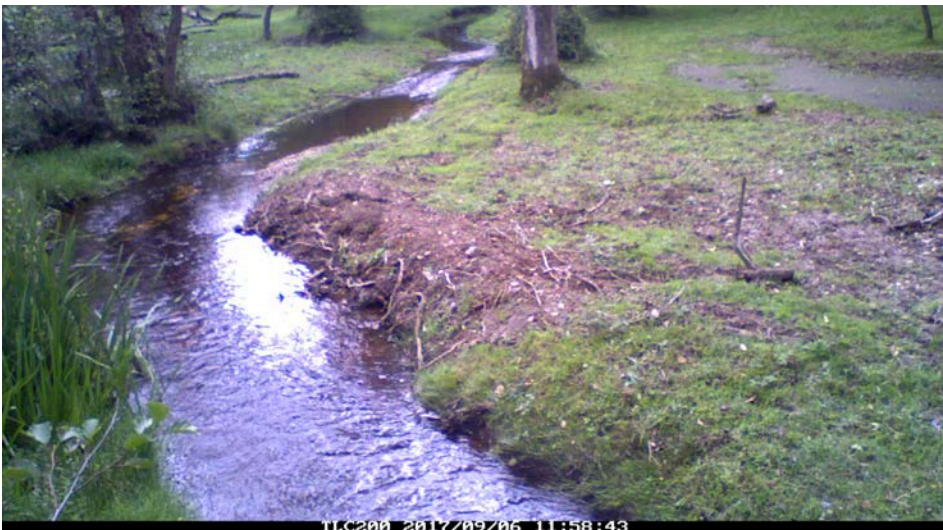
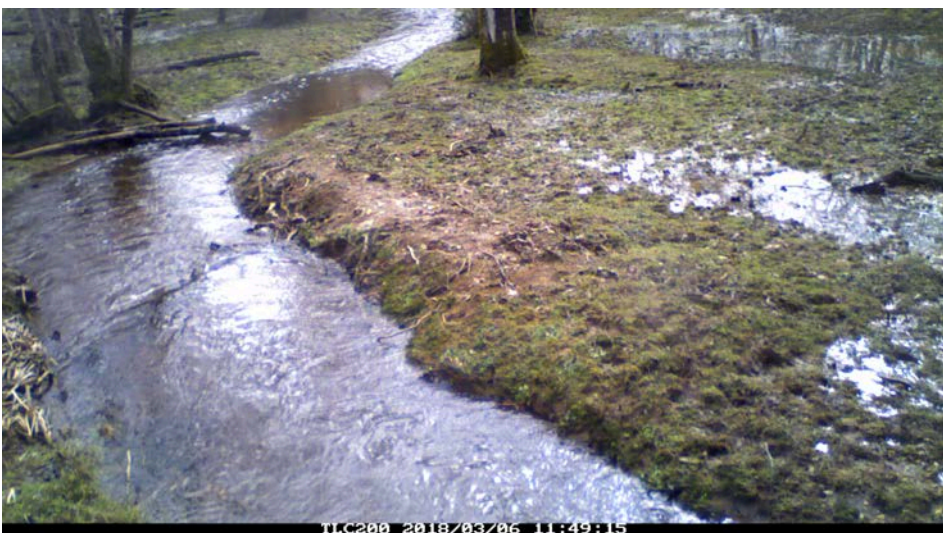
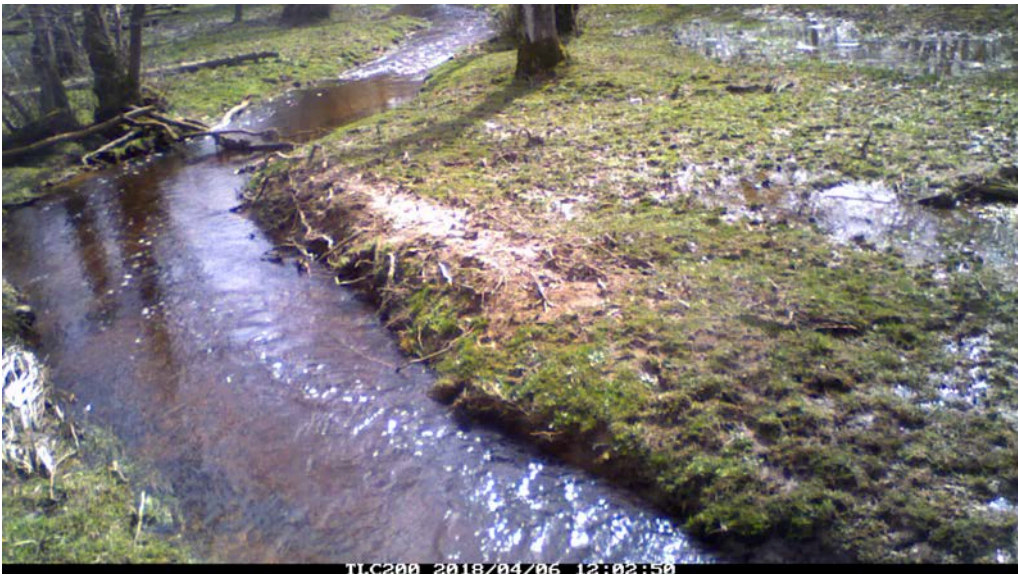
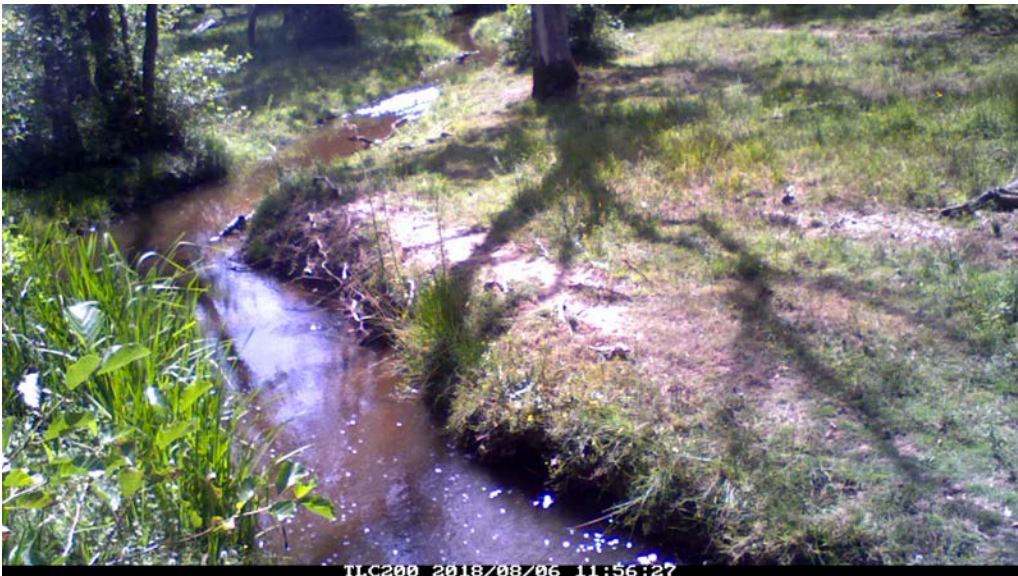
Figure 7.9: Timelapse camera sequence – Wootton Phase 1 – 6th July, 2017 to 6th August, 2019

Bare ground is one of the key visual indicators of site disturbance, immediately post restoration and is often a concern to stakeholders and the public when a site can appear raw. The transect monitoring showed that most sites have largely re-colonised bare ground within two years but timelapse photography is a useful monitoring tool to visually observe how quickly a site recovers. The sequence of photographs below are captured from a timelapse camera at Wootton – Phase 1 and show images captured a month apart for the timeframes when the camera was operational. The sequence starts from July 2017, immediately after work was completed. Within a month there are signs of recolonization and although there is a gap in footage during July to August 2017, within three months of completion of the work vegetation cover is rapidly increasing. There is a 6 month gap in footage again until March 2018 by which time footage shows the site is saturated from winter flood waters but is almost completely vegetated other than a short stretch of bank. Following another 3 month gap in footage taking time forward to July 2018, almost exactly a year post completion, vegetation is establishing well with micro-habitats developing – rush and sedge appears to be colonising the lower lying damper areas that hold standing water for short periods during flooding and small barer areas are indicative of low spots that pond and hold standing water for longer periods. No doubt close examination on the ground would find a greater diversity of plants, responding to variations in soil moisture and micro-topography. From the spring of 2019 the photographic sequences suggest that the bankside/bank top vegetation is starting to develop and two years on in the last image taken in August 2019 the sward appears to be quite dense and developed across the site. Interestingly, there is a localised high spot on the right bank which has been slow to colonise and is still relatively bare in comparison the rest of the site. It is difficult to determine exactly why this is but it may be related to the substrate or degree of compaction or the fact that this “high spot” rarely floods.
